International Offices: Dublin Nigeria Hong Kong REPORT ON REMEDIAL WORKS
UNDERTAKEN AT
BEECHWOOD
MOLD ROAD
ALLTAMI
MOLD
CLWYD
CH7 6LG

P284/F03

Validation Report,

Beechwood, Mold Road, Alltami,

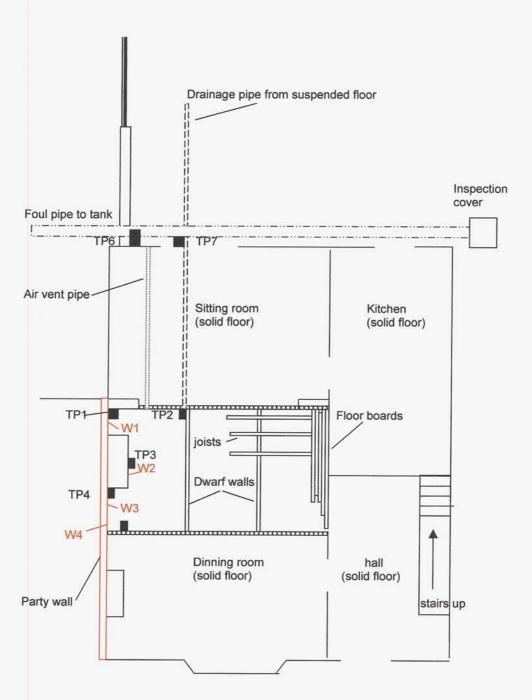
Fig 2

Location	Depth mm	Results (mg/kg)
TP1	0.4m into party wall	3000
TP1	0.6 into party wall	190
TP2	Drainage pipe suspended floor	8150
TP3	Fire place suspended floor	83900
TP4	Surface suspended floor	4150
TP4	200	1150
TP5	Above 1 <sup>st</sup> course of bricks	125
TP6	0.6 sewer pipe	35
TP6	.0.65	15
TP7	foundation	20

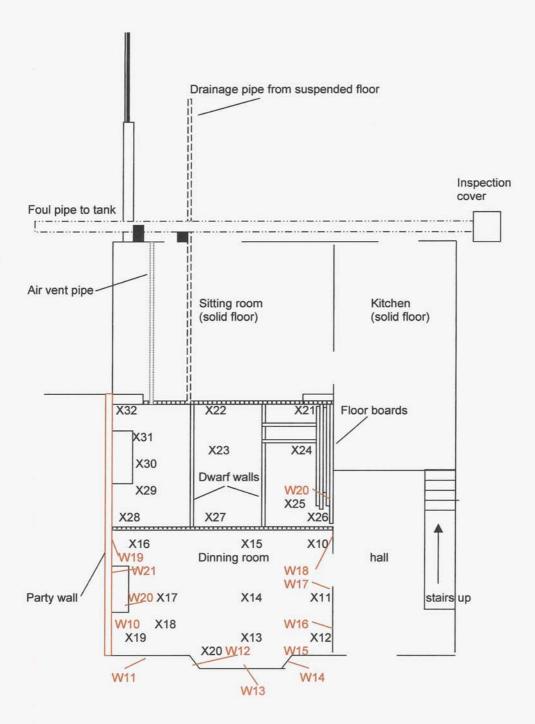
# PROBE HOLE RESULTS AFTER FLOOR EXCAVATION.

Diesel Fumes (Volatile Organic Compounds)			
Location	Depth (mm)	Result (ppm)	
X10	300	85	
X11	300	134	
X12	300	700	
X13	300	295	
X14	300	91	
X15	300	500	
X16	300	200	
X17	300	63	
X18	300	800	
X19	300	850	
X20	300	480	
X21	300	300	
X22	300	440	
X23	300	25	
X24	300	398	
X25	300	50	
X26	300	150	
X27	300	50	
X28	300	45	
X29	300	30	
X30	300	25	
X31	300	200	
X32	300	108

Diesel Fumes (Volatile Organic Compounds)			
Location	Depth (mm) Result (ppm)		
W10	floor level	125	
W11	floor level	130	
W12	floor level	52	
W13	floor level	270	
W14	floor level	120	
W15	floor level	290	
W16	floor level	485	
W17	floor level	250	
W18	floor level	590	
W19	floor level	130	
W20	floor level	14	
W21	floor level	6	
W22	floor level	23

Results indicate that the concrete sub floors below the property had been adversely impacted as a consequence of the oil spill. Hydrocarbon contamination was also identified below these solid floors within the subsoil/fill material. This contaminated material represented an ongoing source of contamination that, principally through the migration of vapours, could have had an impact upon the occupants of the property.

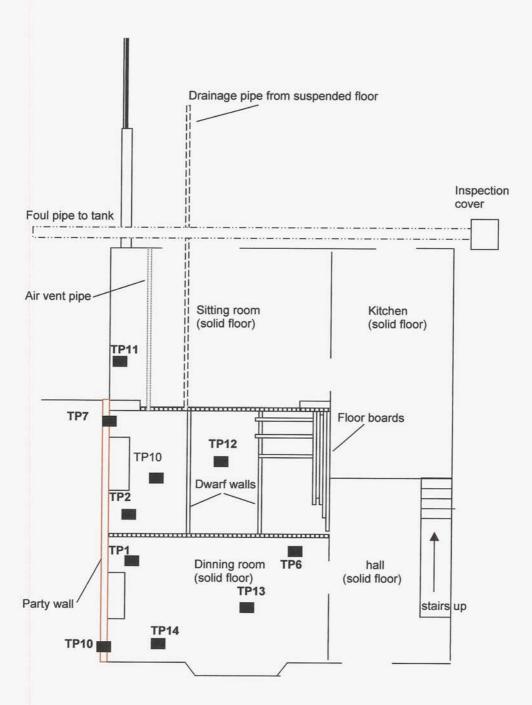
Validation sampling locations are provided in Figure 4 Appendix 1.

Diesel range Organics				
		Result (mg/kg)		
Location	Depth(m)	7.04.03	23.04.03	18.6.03
TP1	0.1	30		
TP2	1.0	20		
TP6	Surface	10		
TP7	1.0	120		
TP10	0.5		50	5
TP11	0.3		10	5
TP12	0.3			5
TP13	0.8			10
TP14	8.0			15

Locations of trial pits and excavations can be found in Fig 4 Appendix 1.
