# Flood & Water Management Act 2010

## Section 19 Flood Investigation Report FI0086

Location: Broughton, Flintshire

Incident Date: October 2023

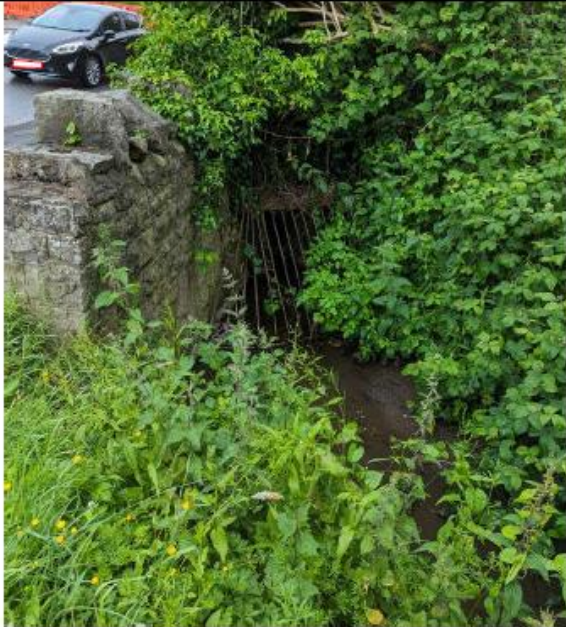
| <b>Photo No.1</b> | |

| <b>Description:</b><br>Mold Road Culvert | |

| Ref | Stakeholder | Action |
|---|---|---|
| 02 | FCC Highways Authority & LLFA | Inspect the existing culvert inlet FCC Asset Ref No: AM0060. NGR: 333346, 363367 (Mold Road) on a frequent basis, remove debris as required. |
| 03 | FCC Highways Authority & LLFA | Undertake a CCTV condition survey of the Mold Road culvert to review the existing condition/siltation. Plan to take any remedial actions as required. |

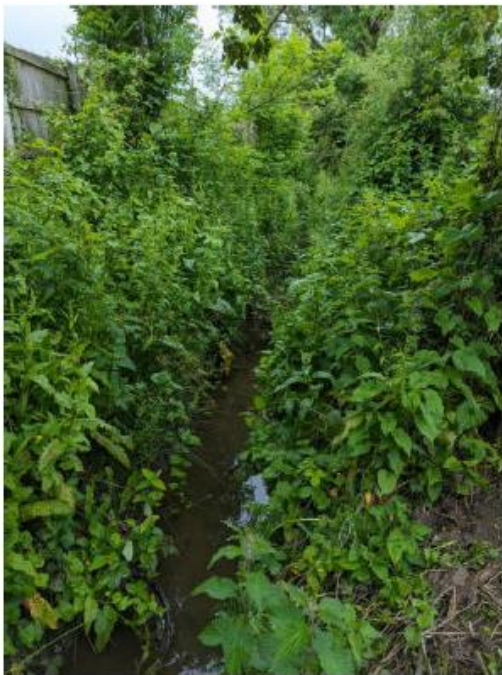
| <b>Photo No. 2</b> | |

| <b>Description:</b><br>Watercourse east of Cherry Dale Road as it re-emerges | |

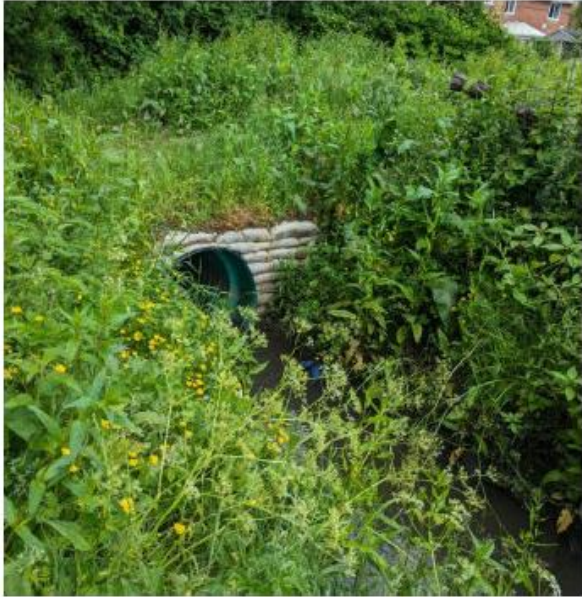
| <b>Photo No.3</b> | |

| <b>Date:</b> 28/05/2024<br><b>Description:</b><br>Culvert adjacent to Broughton United FC football field. | |

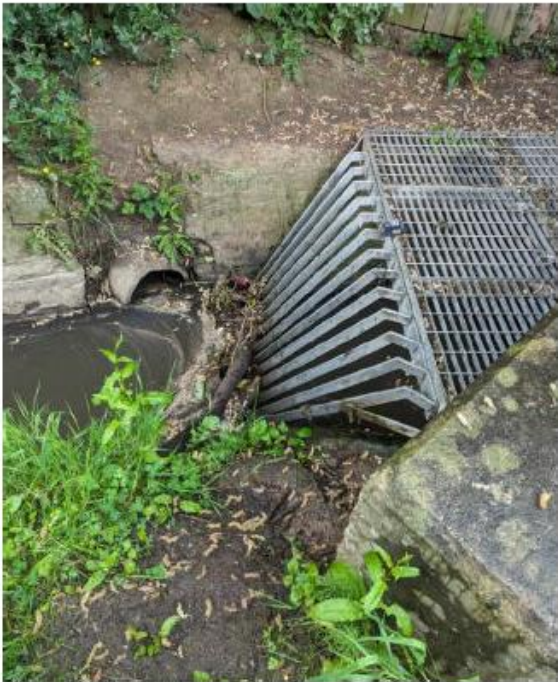
| <b>Photo No. 4</b> | |

| <b>Date:</b> 28/05/2024<br><b>Description:</b><br>A55 Culvert | |

| Ref | Stakeholder | Action |
|---|---|---|
| 07 | North and Mid-Wales Trunk Road Agent | Inspect the inlet of the A55 0060 C50 Broughton culvert on a frequent basis to ensure it is free of blockage / debris. |
