# Flood & Water Management Act 2010

## Section 19 Flood Investigation Report FI0084/B

**Location:** Meadowside, Queens Park, Holland Cottages and Alyn  
Meadows, Mold, Flintshire

**Incident Date:** October 2023

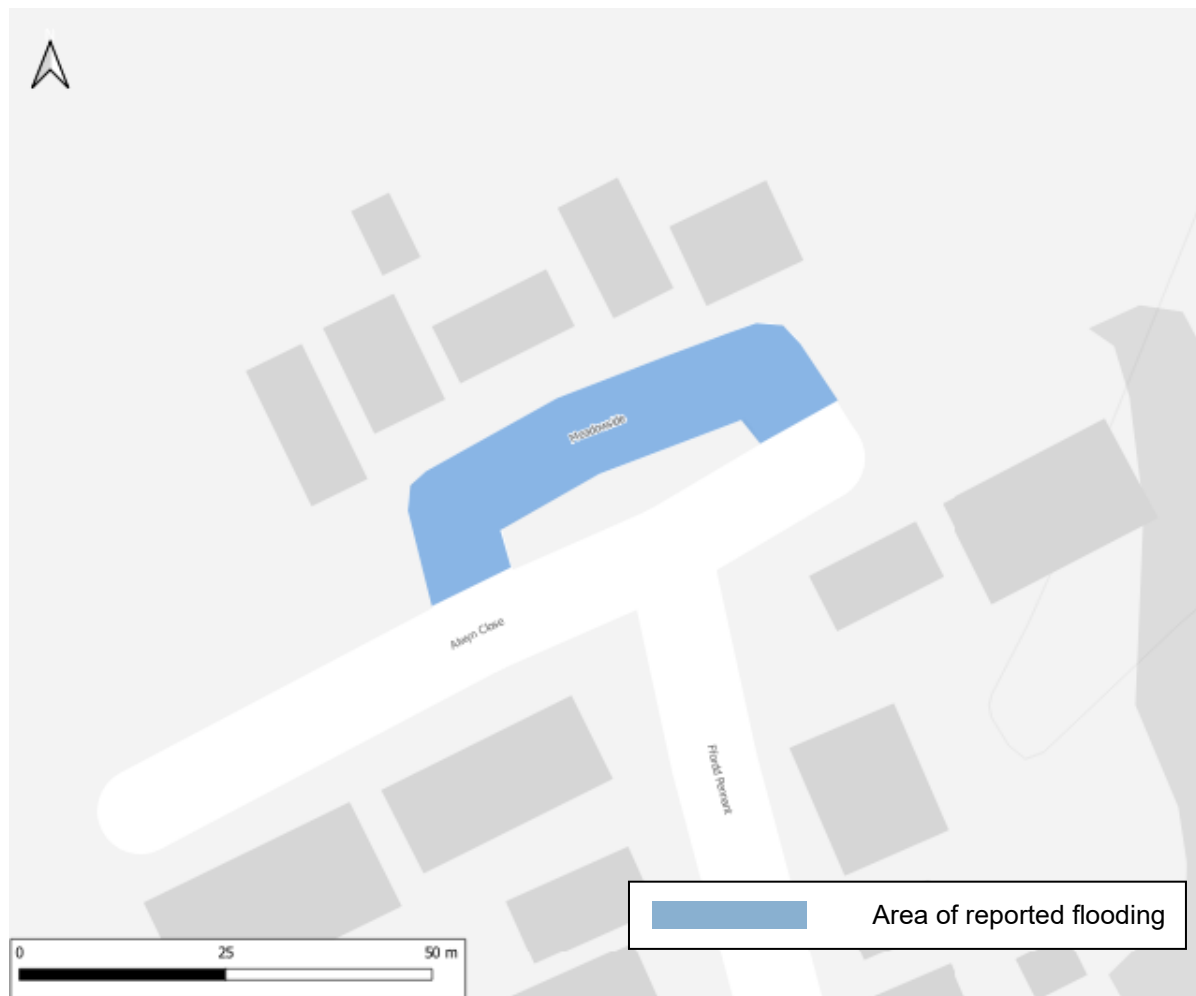
**Figure 16 – Flood Description - Meadowside Area**  
Contains OS Data © Crown Copyright (2024)

- 4.1 Based on the findings of the community engagement exercise and stakeholder engagement, the flooding to Meadowside is attributed to runoff from the fields to the north of Meadowside. Internal flooding was reported to 3no. properties.
- 4.2 Residents reported that flooding to the fields to the rear of the properties occurs regularly. There were also concerns for the condition of the culverted watercourse, noting that it may be obstructed.
- 4.3 High soil saturation levels prior to Storm Babet resulted in an increase in surface water runoff from the catchment upstream of Meadowside. An image taken by a resident (Appendix A) shows the extent of flooding in Meadowside.
- 4.4 Figure 16 provides a summary of the reported flooding.

| Ref | Stakeholder | Action |
|---|---|---|
| 04 | FCC LLFA | <b>Meadowside area</b> - review condition of the ordinary watercourses (culvert) and inform the riparian landowners if any issues are identified. |

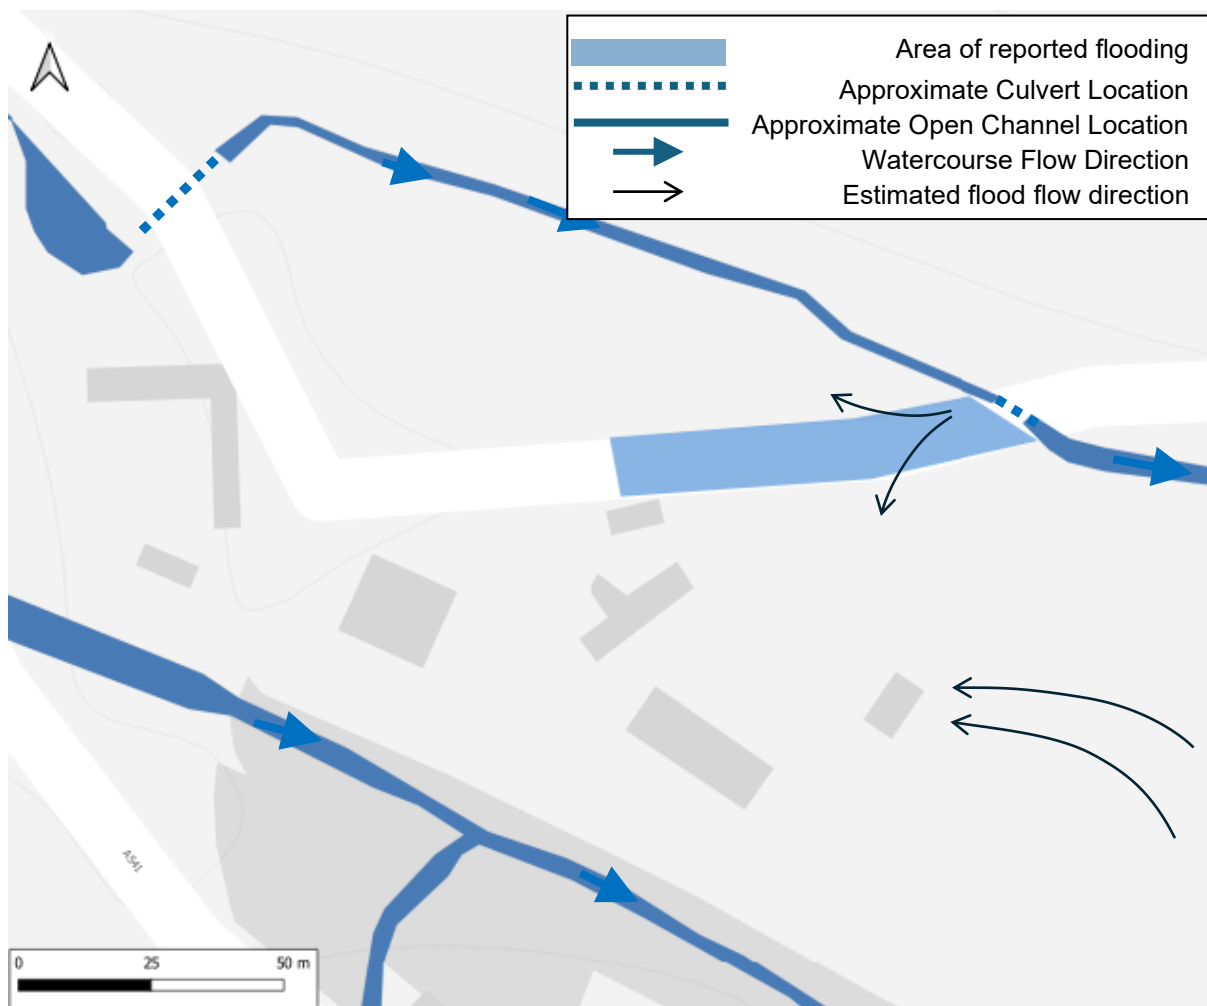
**Figure 17 – Holland Cottages Area**  
Contains OS Data © Crown Copyright (2024)

- 4.5 Two incidents of internal flooding were reported at Holland Cottages. Information collected during the community engagement exercise suggests that the cause of flooding was from the River Alyn, high ground water and obstruction to the Black Brook watercourse at the arched bridge where the watercourse crosses Blackbrook Road.

- 4.6 Residents reported that flooding originated around the Black Brook arched bridge. It is not clear whether this flooding was due to the structure being obstructed. There were also reports that river flooding caused private drainage systems to surcharge.

- 4.8 There were also reports of groundwater flooding, likely linked to high water levels in the Alyn and the saturated ground conditions. Figure 17 provides a summary of the reported flooding.

| Ref | Stakeholder | Action |
|---|---|---|
| 07 | FCC LLFA | <b>Holland Cottages area</b> - further investigation required to ascertain cause of flooding of the Black Brook watercourse around the Black Brook arched bridge. |
| 11 | NRW | Inspect and review the design, condition and suitability of the embankment defending land off Blackbrook Road (Holland Cottages) from flooding originating from the River Alyn to understand whether it is working as designed or if design standard was exceeded during Storm Babet. Additional works may be required. |

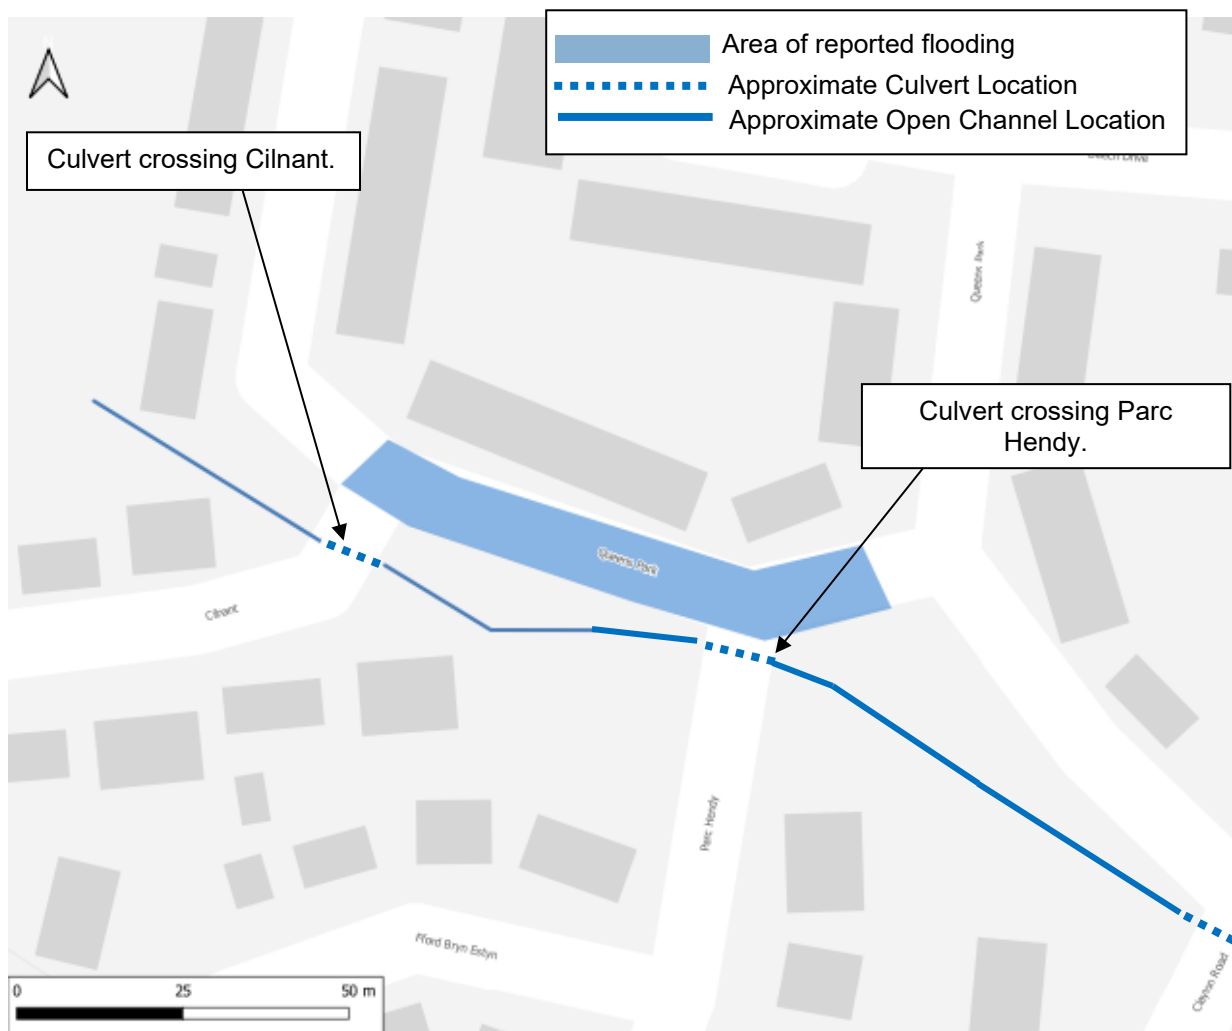
**Figure 18 – Queens Park Area**  
Contains OS Data © Crown Copyright (2024)

- 4.11 Residents reported that flooding originated from the unnamed watercourse to the south of Queens Park. It is unclear whether the flooding occurred as a result of overtopping due to lack of channel capacity or overtopping due to an obstructed culvert. The culvert headwall immediately upstream of Clayton Road is fitted with a grille which is known to become rapidly restricted with floating debris and results in flows becoming impeded.

| Ref | Stakeholder | Action |
|---|---|---|
| 06 | FCC LLFA | <b>Queens Park area</b> - consider a scheme for replacement of the culvert inlet grilles with alternative wider grilles as to avoid impeding the flow of water. |

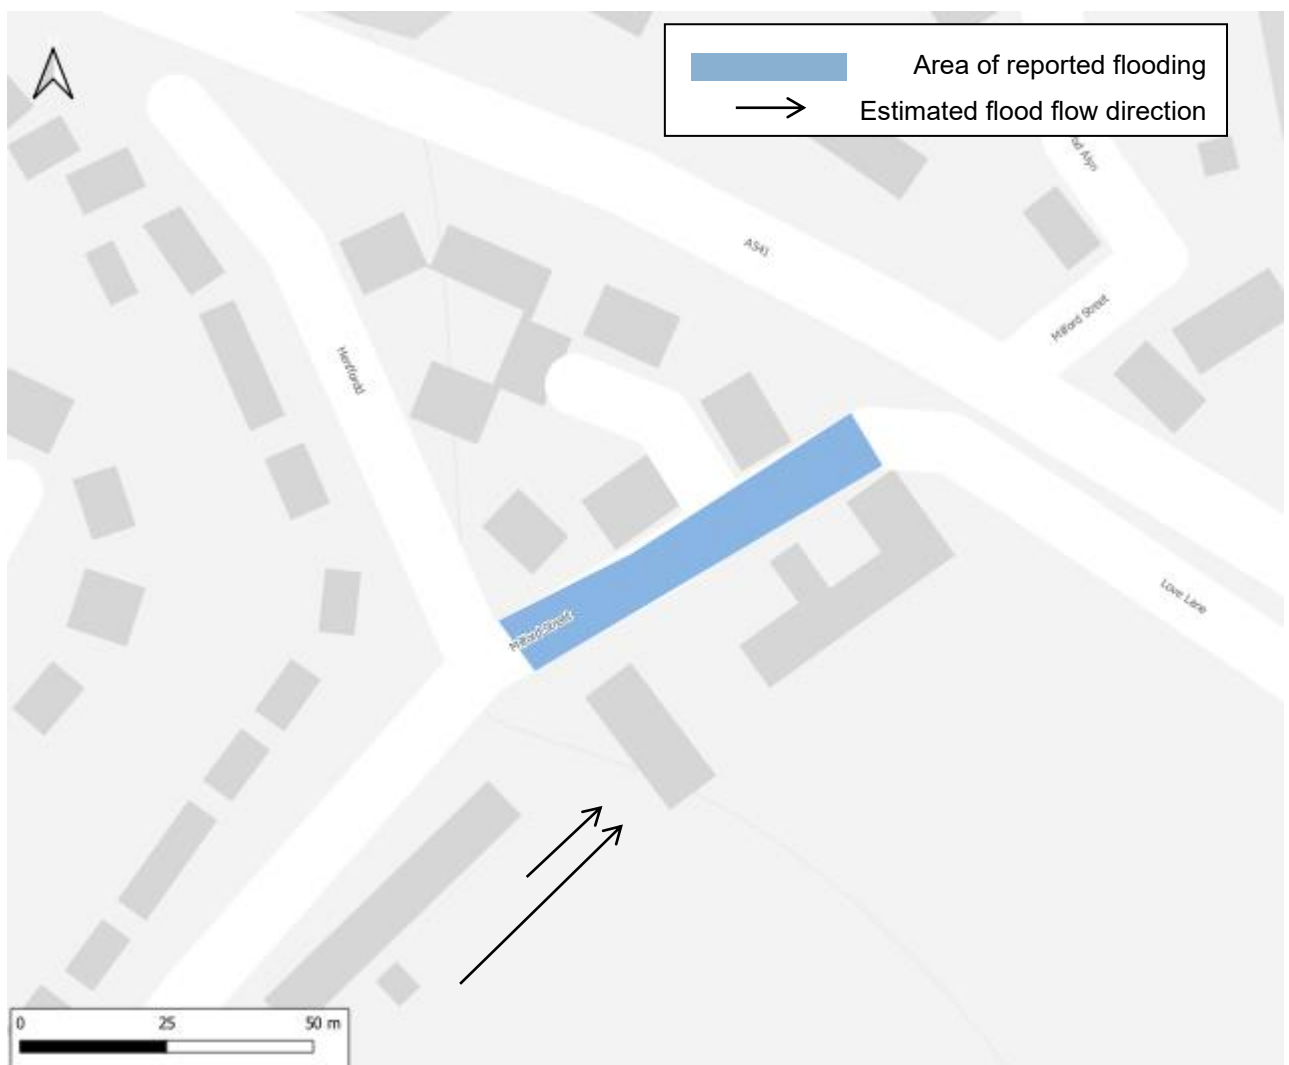
**Figure 19 – Alyn Meadows Area**  
Contains OS Data © Crown Copyright (2024)

- 4.14 Alyn Meadows comprises a number of apartment blocks off Milford Street. Based on the findings of the community engagement exercise and stakeholder engagement, the reported source of flooding was surface water runoff from undeveloped land to the south-west of the properties.
- 4.15 Residents reported flooding to the rear of the buildings. No internal flooding was confirmed during the community engagement exercise. Water is reported to pool in isolated topographical low points adjacent to the buildings (at the foot of grassed slopes). There is limited drainage provision at the bottom of the grassed slopes to divert floodwater away from the buildings.
- 4.16 Figure 19 provides a summary of the reported flooding.

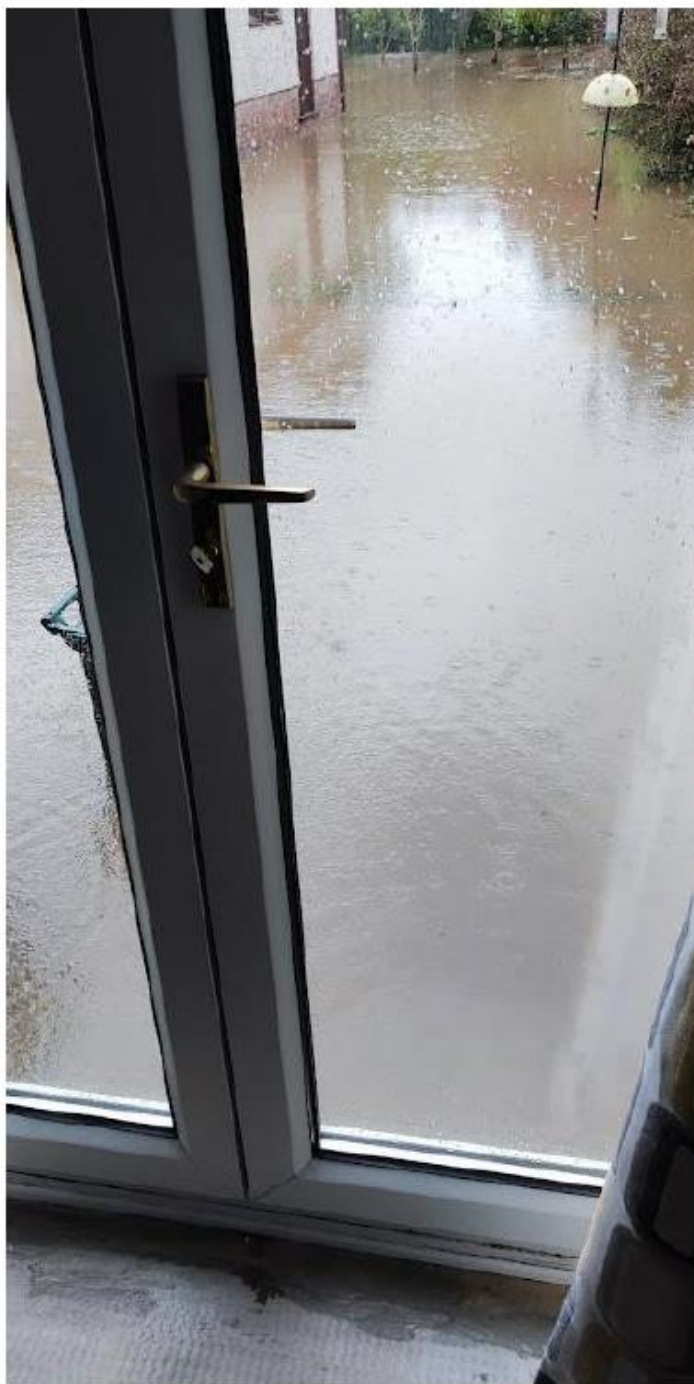
Description: Back door of  
property at Meadowside

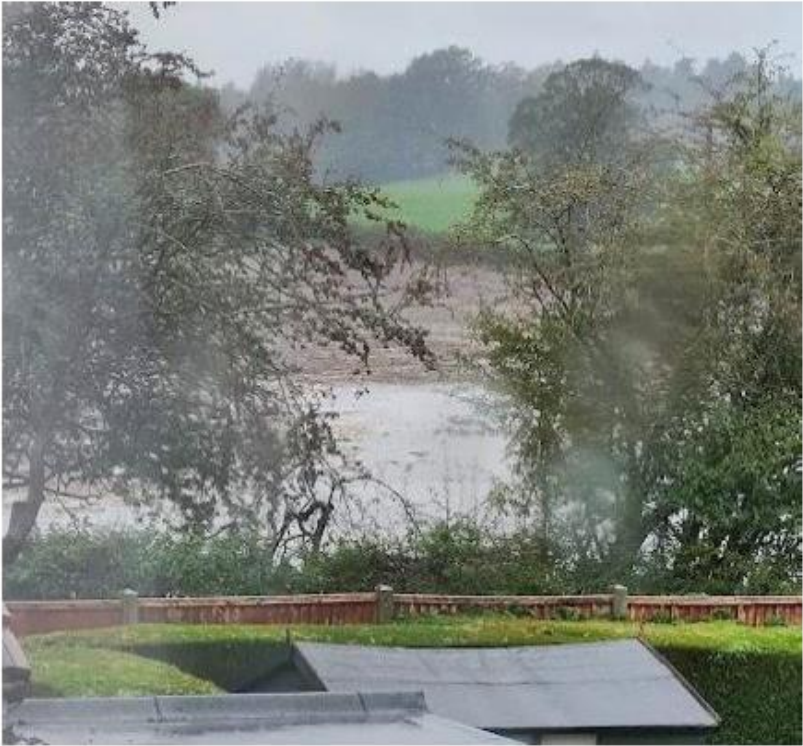
| Photo No. 4 | |

| <p>Date: 20<sup>th</sup> October 2023</p> <p>Description: Flooding in field to rear of Meadowside during Storm Babet</p> <p>Source: Resident of Meadowside, Mold</p> | |

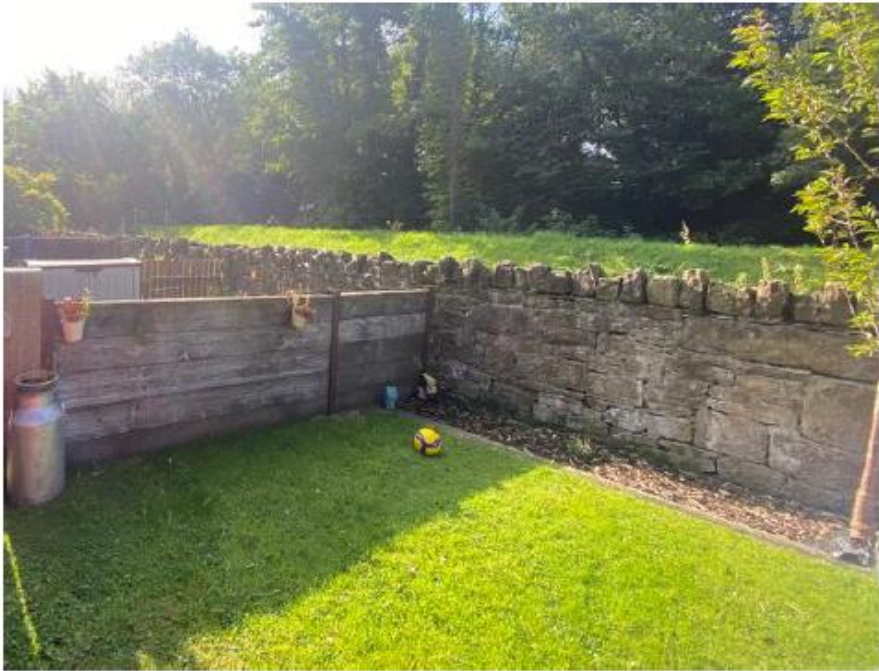
| Photo No. 5 | |

| <p>Date: 29<sup>th</sup> August 2024</p> <p>Description: Flood defence protecting Holland Farm and Cottages</p> <p>Source: Waterco Site Visit</p> | |

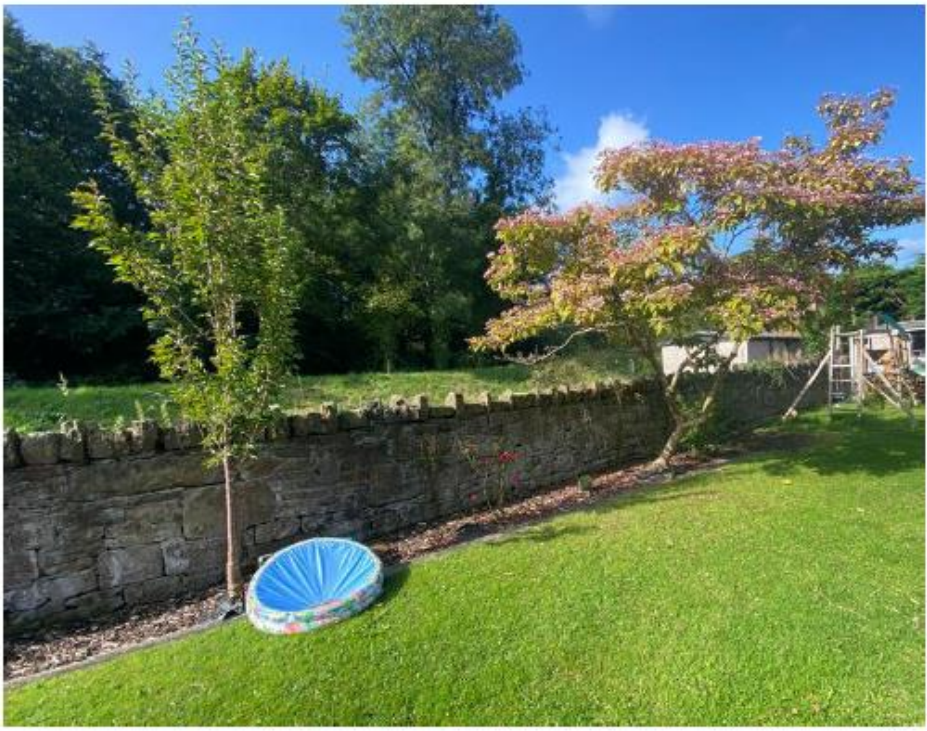
| Photo No. 6 | |

| <p>Description: Flood defence protecting Holland Farm and Cottages</p> <p>Source: Waterco Site Visit</p> | |

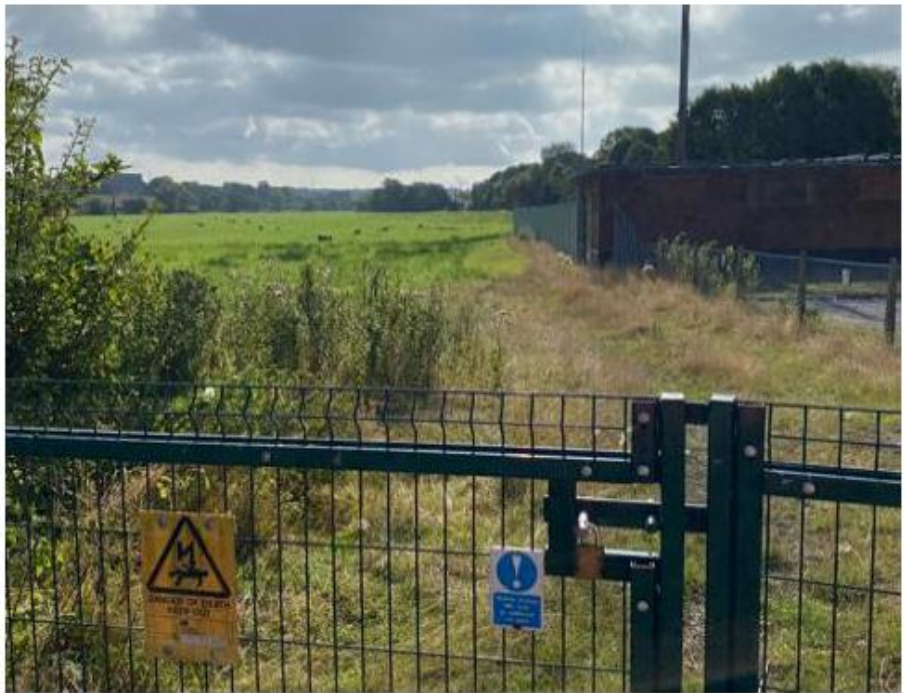
| Photo No. 7 | |

| <p>Description: Field and end of flood defence protecting Holland Farm and Cottages</p> <p>Source: Waterco Site Visit</p> | |

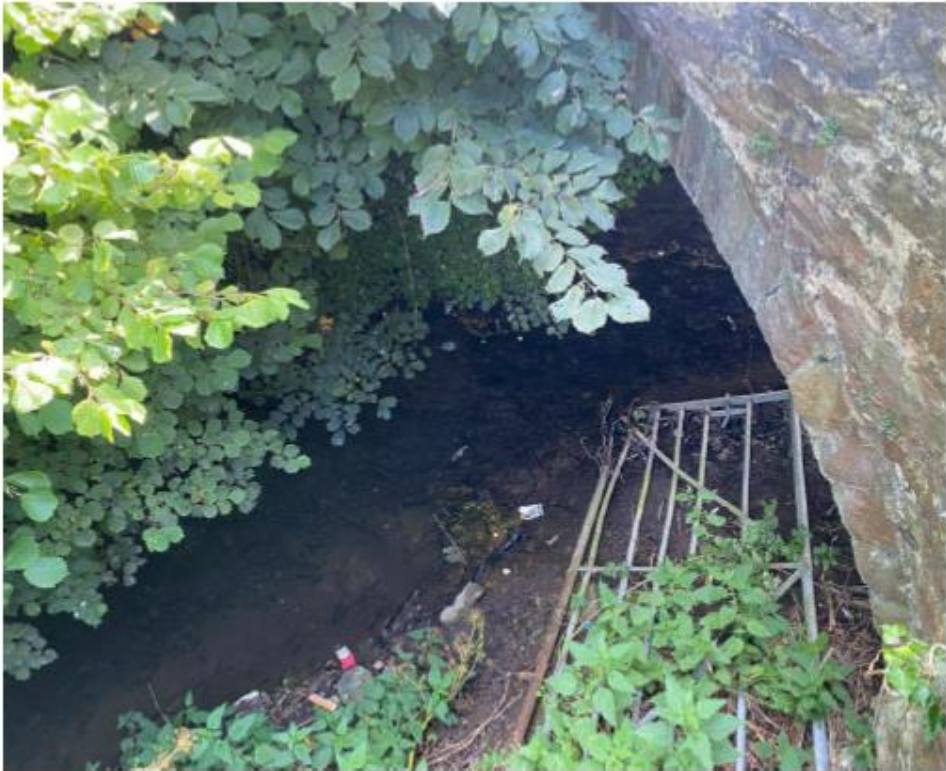
| Photo No. 8 | |

| Description: Black Brook watercourse beneath Blackbrook Road | |

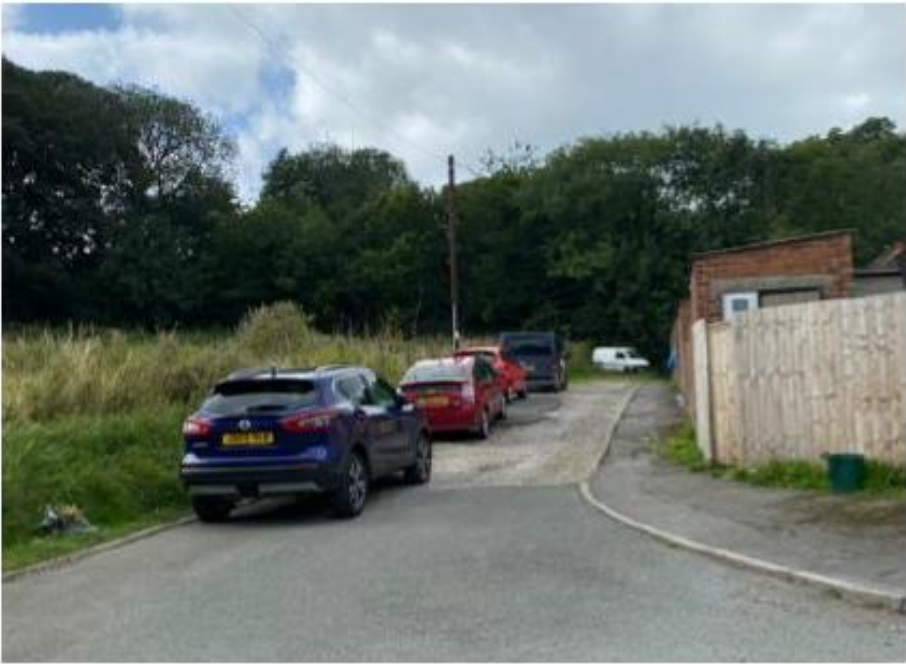
| Photo No. 10 | |

| Description: Track behind properties on Milford Street, sloping towards Alyn Meadows<br><br>Source: Waterco Site Visit | |
