# Flood and Water Management Act 2010

## Section 19 Flood Investigation Report FI0084/A

Location: Mold, Flintshire  
Incident Date: October 2023

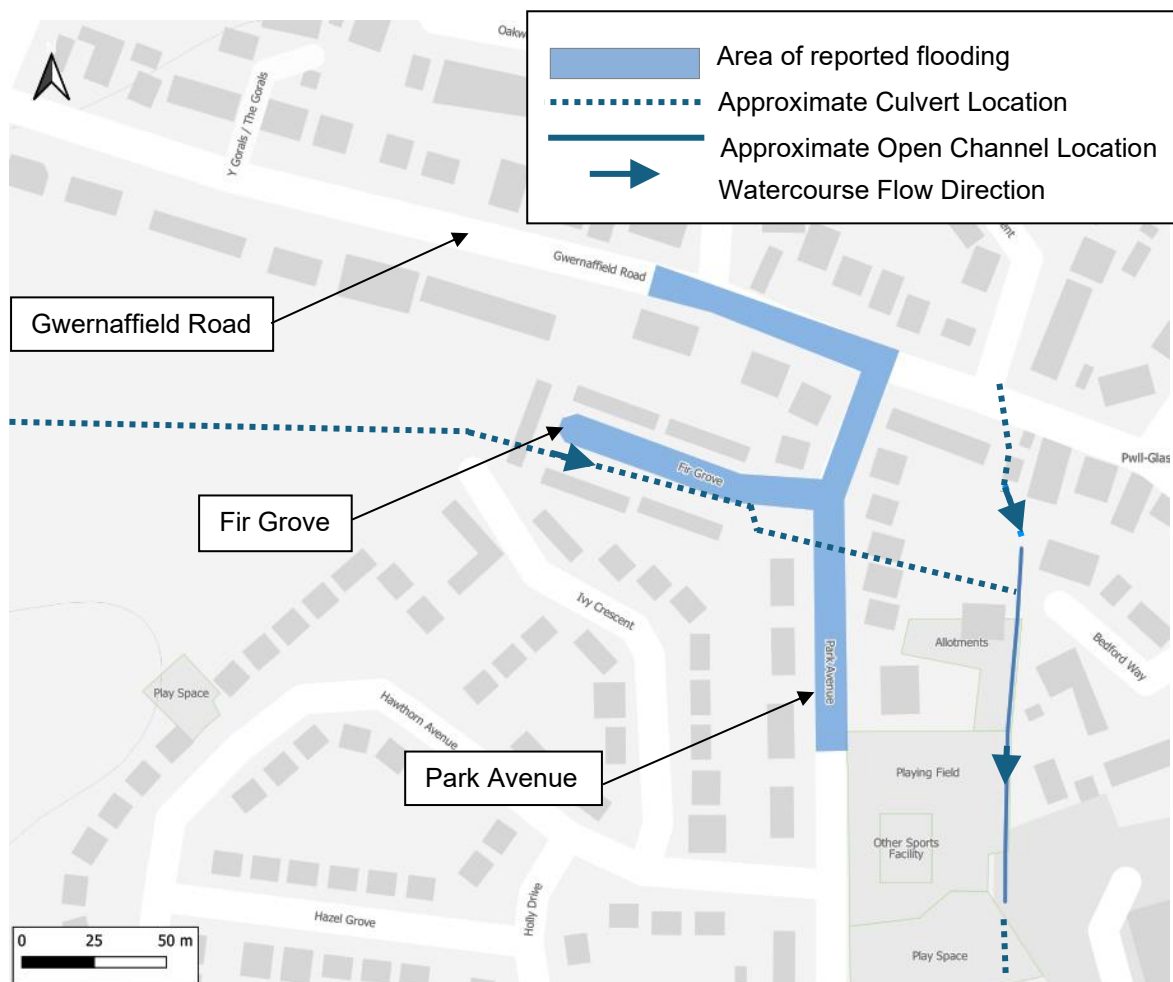
**Figure 27 - Fir Grove, Park Avenue and Gwernaffield Road**

- 4.1 Based on the findings of the community engagement exercise and stakeholder engagement, the flooding to Fir Grove, Park Avenue and Gwernaffield Road is attributed to flooding from an exceedance of the culverted watercourse at Fir Grove. Several of the properties along Fir Grove are situated below the road level, leading to flood flows from the road entering properties.
- 4.2 Bow waves caused by traffic resulted in flooding on roads being pushed towards properties. The emergency services closed Park Avenue to prevent traffic movements.
- 4.3 Flooding caused electricity to turn off, and water to back up through internal drains. Damage caused to properties meant that some residents had to find alternative accommodation for up to 6 months whilst restoration took place.
- 4.4 Figure 27 provides a summary of the reported flooding.

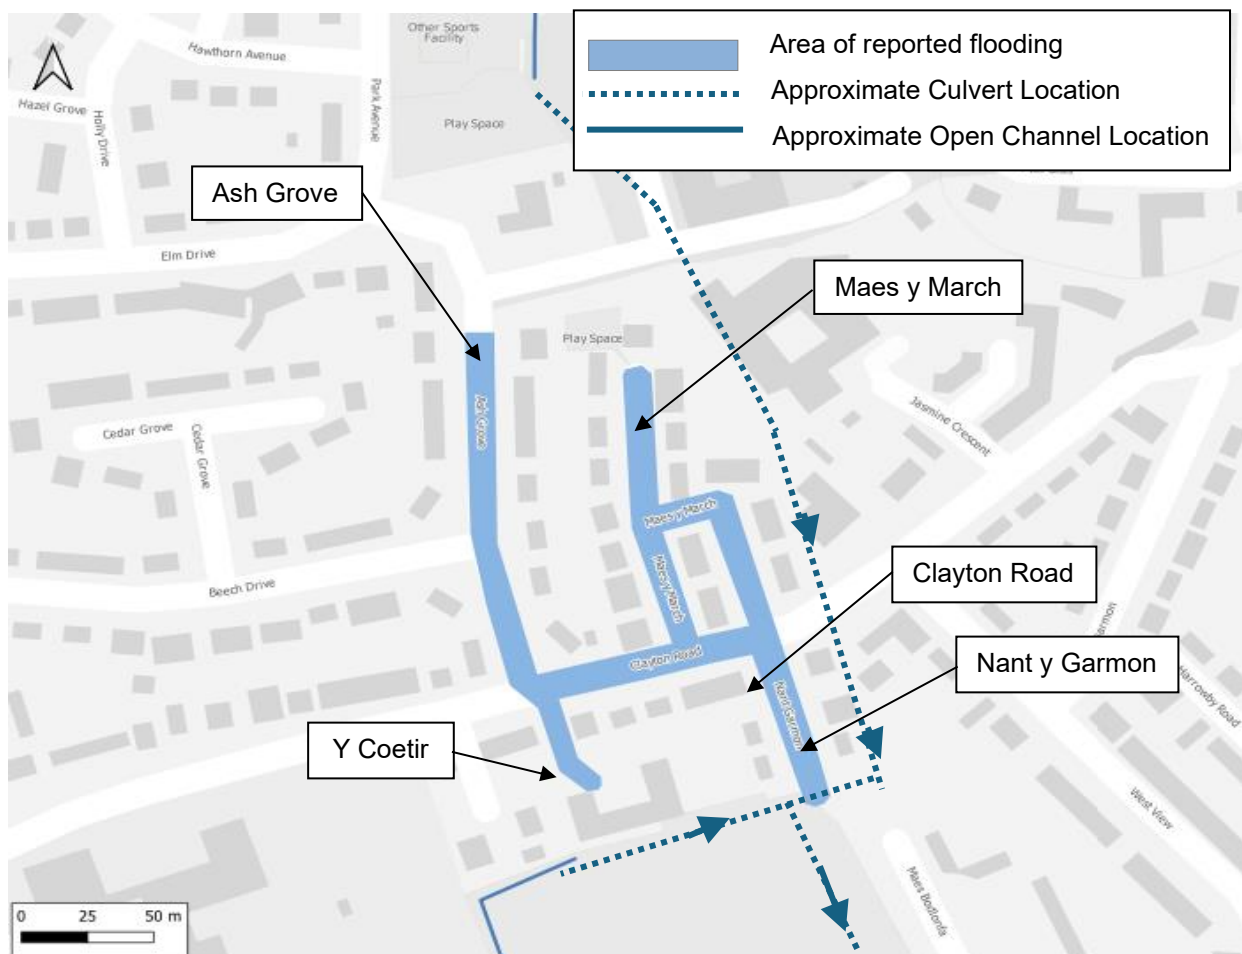
**Figure 28 - Maes y March and Ash Grove, Clayton Road, Nant Garmon and Y Coetir**

- 4.7 There were reports of internal flooding in some properties, and cars driving through the flood flows caused bow waves which worsened flooding to properties. Flooding entered properties through doors as well as through air bricks.

- 4.8 Properties at Y Coetir reportedly had internal flooding. Residents were evacuated by emergency services. It was reported that flood flows pooled in the car park of Y Coetir at a level high enough to cause cars to float. Emergency services reportedly demolished a concrete panel to allow flows to disperse into land to the south of the properties.

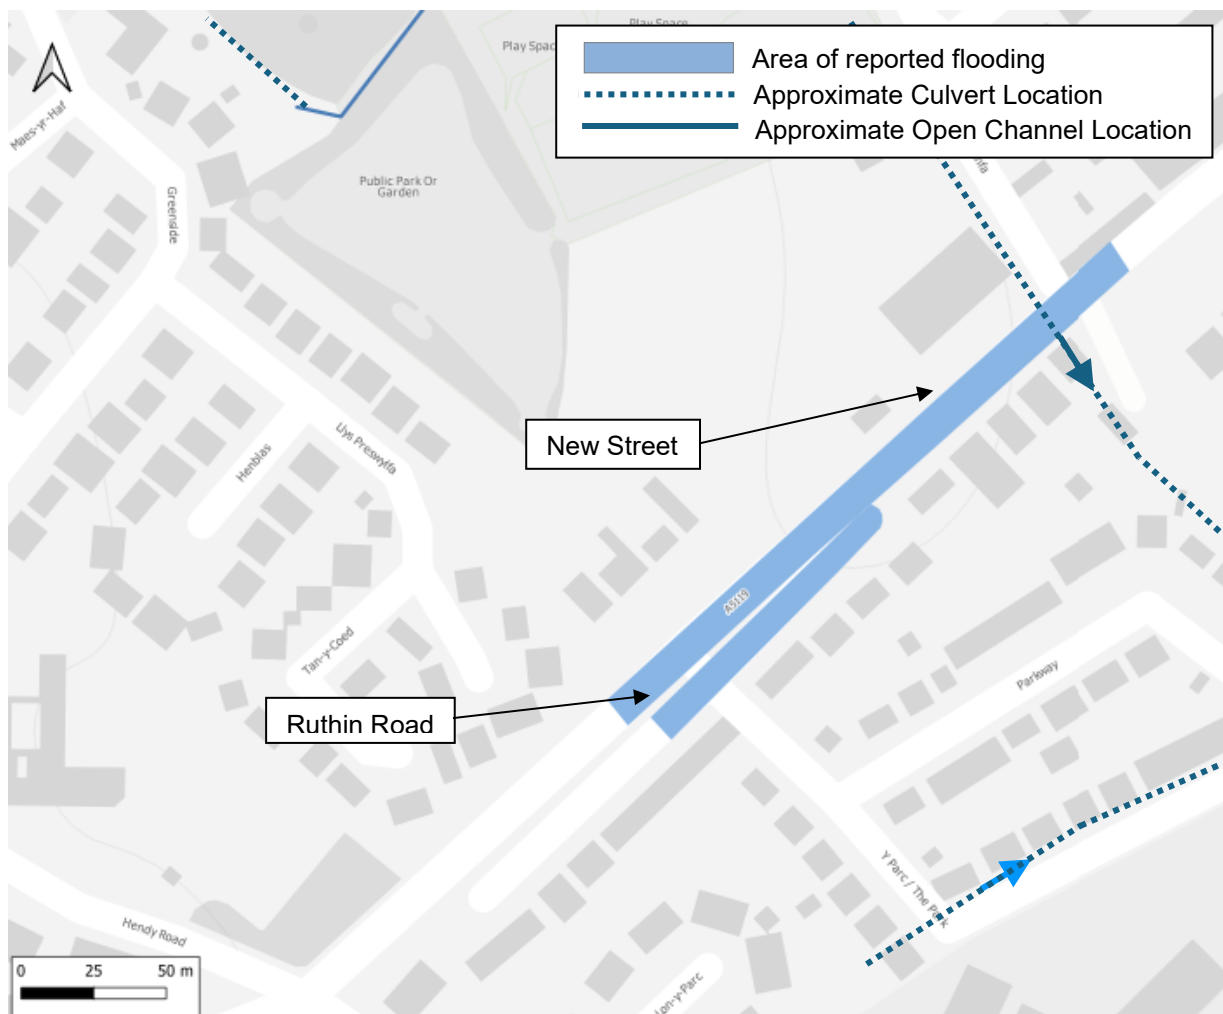
**Figure 29 - New Street and Ruthin Road**

- 4.11 Based on the findings of the community engagement exercise and stakeholder engagement, the reported source of flooding was from ordinary watercourses along Ruthin Road, the Red Rec Park and from surface water (possibly associated with an exceedance of the capacity of the culverted watercourse) on New Street.
- 4.12 The flooding was reported to be worsened by bow waves caused by passing traffic.
- 4.13 There were reports of sewerage in flood flows, likely a result of flood water entering and exceeding sewer systems, as well as gravel that washes from the road.
- 4.14 Figure 29 provides a summary of the reported flooding.

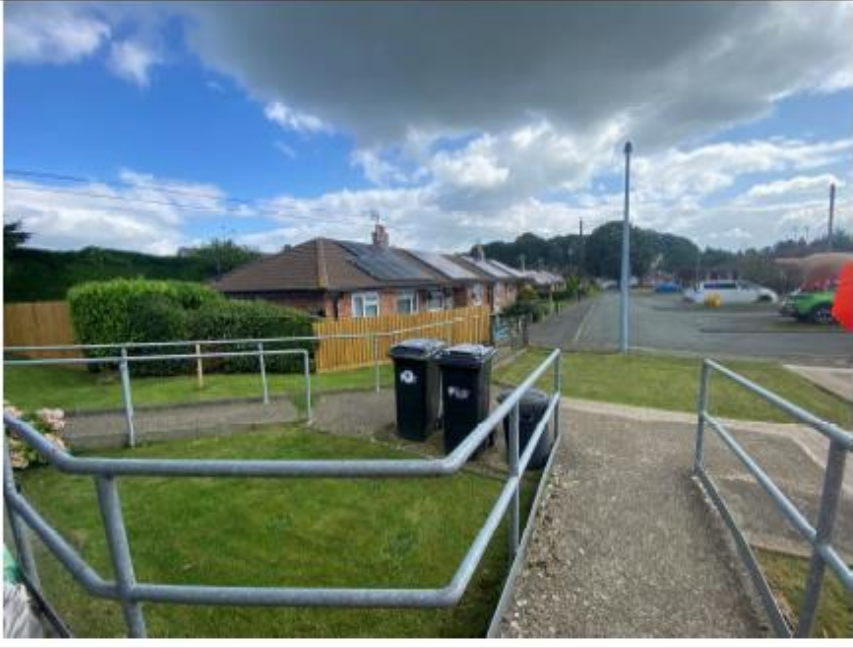
| <p>Description: View looking east along Fir Grove. Flood flows were reported to flow east onto Park Avenue</p> | |

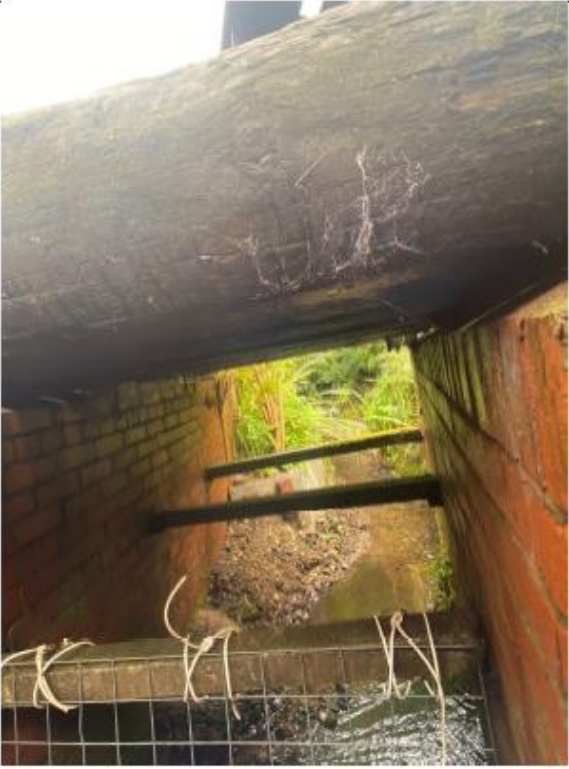
| <p><b>Photo No. 13</b></p> <p><b>Date: 2<sup>nd</sup> September 2024</b></p> <p><b>Description: View of culvert inlet for unnamed watercourse nr. Glynteg, which flows towards Cunliffe Street.</b></p> <p><b>Source: Waterco Site Visit</b></p> | <p>A photograph showing the interior of a brick-lined culvert. The view is looking down a narrow passage where water is flowing. The walls are made of red bricks, and there are some wooden beams or pipes across the top. The water is dark and turbulent as it flows towards the bottom of the frame.</p> |

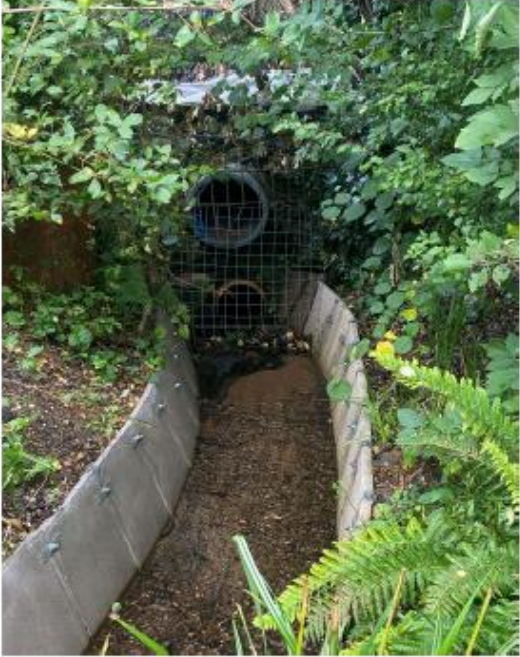
| <p><b>Photo No. 14</b></p> <p><b>Date: 2<sup>nd</sup> September 2024</b></p> <p><b>Description: View of culvert inlet for unnamed watercourse nr. Glynteg, which flows towards Cunliffe Street.</b></p> <p><b>Source: Waterco Site Visit</b></p> | <p>A photograph showing the exterior of a culvert inlet. The inlet is a large, dark, circular opening surrounded by dense green foliage and bushes. The culvert is constructed from concrete blocks, and the surrounding area is overgrown with plants and ferns.</p> |

| Ref | Stakeholder | Action |
|---|---|---|
| 06 | FCC LLFA | Review condition of the ordinary watercourses and inform the riparian landowners if any issues are identified. FCC to use permissive duties and powers under the LDA and FWMA to allow flow via culvert entrances, watercourses and culverts are maintained to convey flows as intended. |

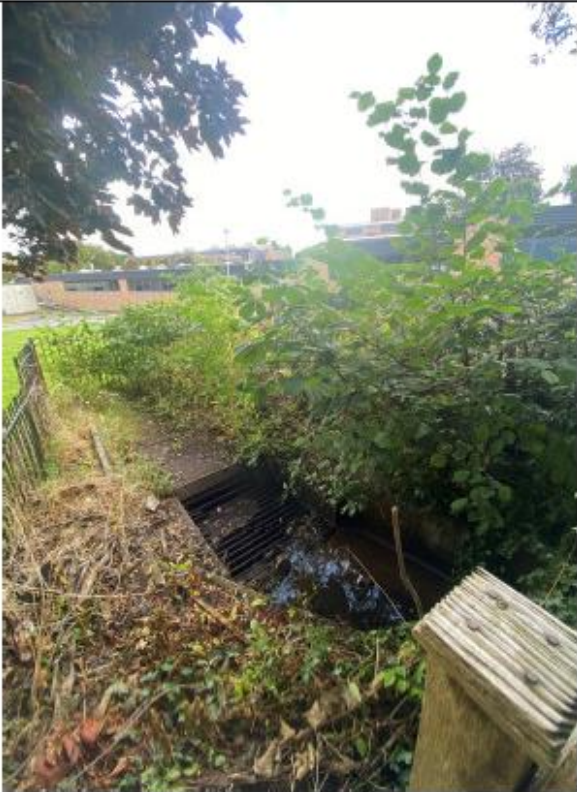
| Photo No. 15 | |

| <p>Description: View of culvert inlet on Maes Garmon and Alun School Grounds, nr. Highfield Villas</p> <p>Source: Waterco Site Visit</p> | |

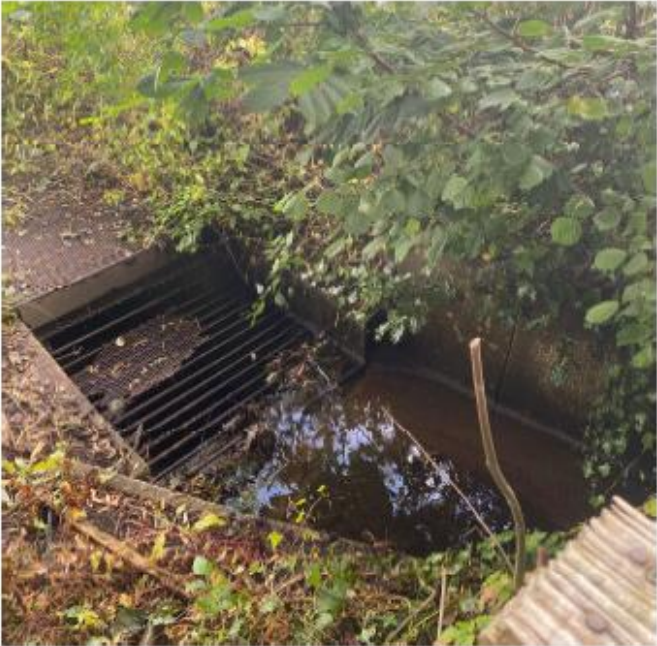
| Photo No. 16 | |

| <p>Description: View of culvert inlet on Maes Garmon and Alun School Grounds, nr. Highfield Villas</p> <p>Source: Waterco Site Visit</p> | |

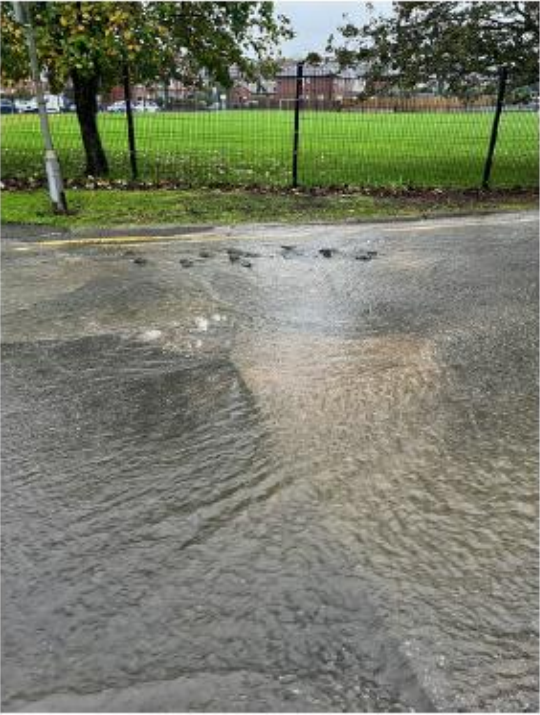
| Photo No. 18 | |

| <p>Description: Damage to road on junction of Cae Bracty and Brook Street following flooding during Storm Babet</p> <p>Source: Community Engagement</p> | |

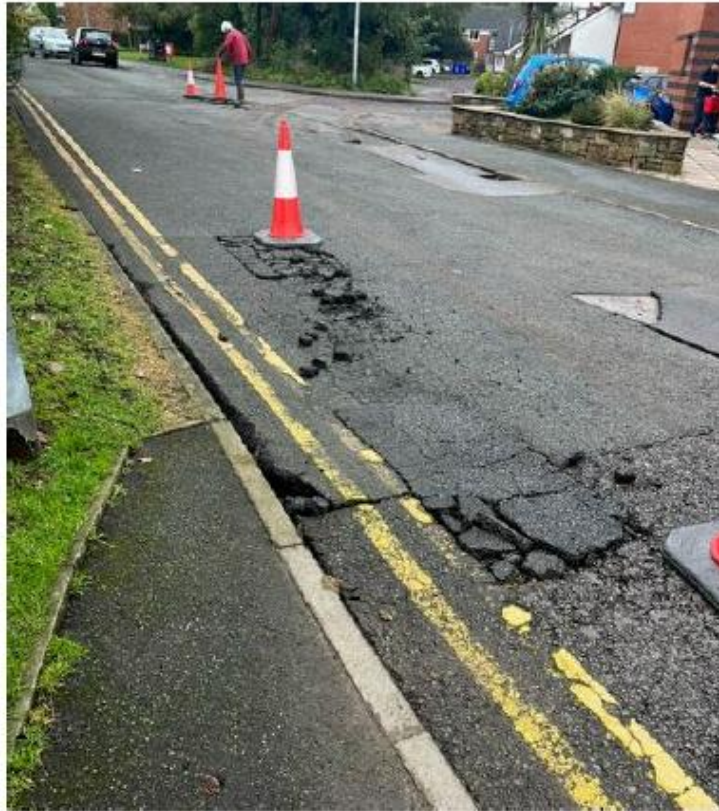
Photo No. 19

Description: Damage to  
road on junction of Cae  
Bracty and Brook Street  
following flooding during  
Storm Babet
