# Flood & Water Management Act 2010

## Section 19 Flood Investigation Report FI0089

Location: Pontblyddyn, Mold

Incident Date: October 2023

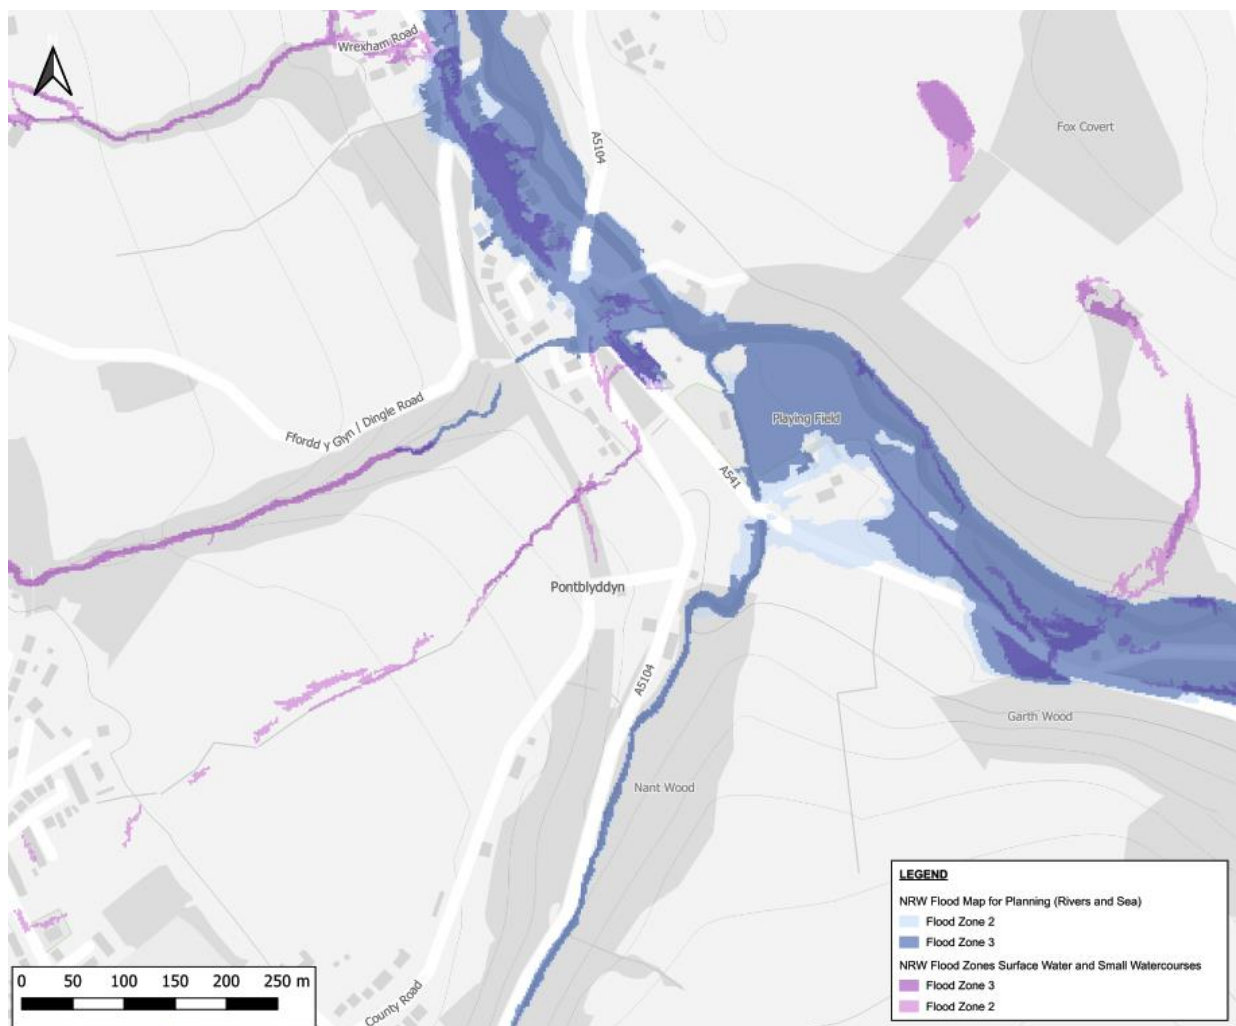
**Figure 7 - NRW Flood Map for Planning – Rivers, Surface Water and Small Watercourses Map**

- 3.8 NRW mapping shows significant pooling of surface water at the layby along Wrexham Road, which then appears to reach a depth which leads to flooding around Hollands Terrace.

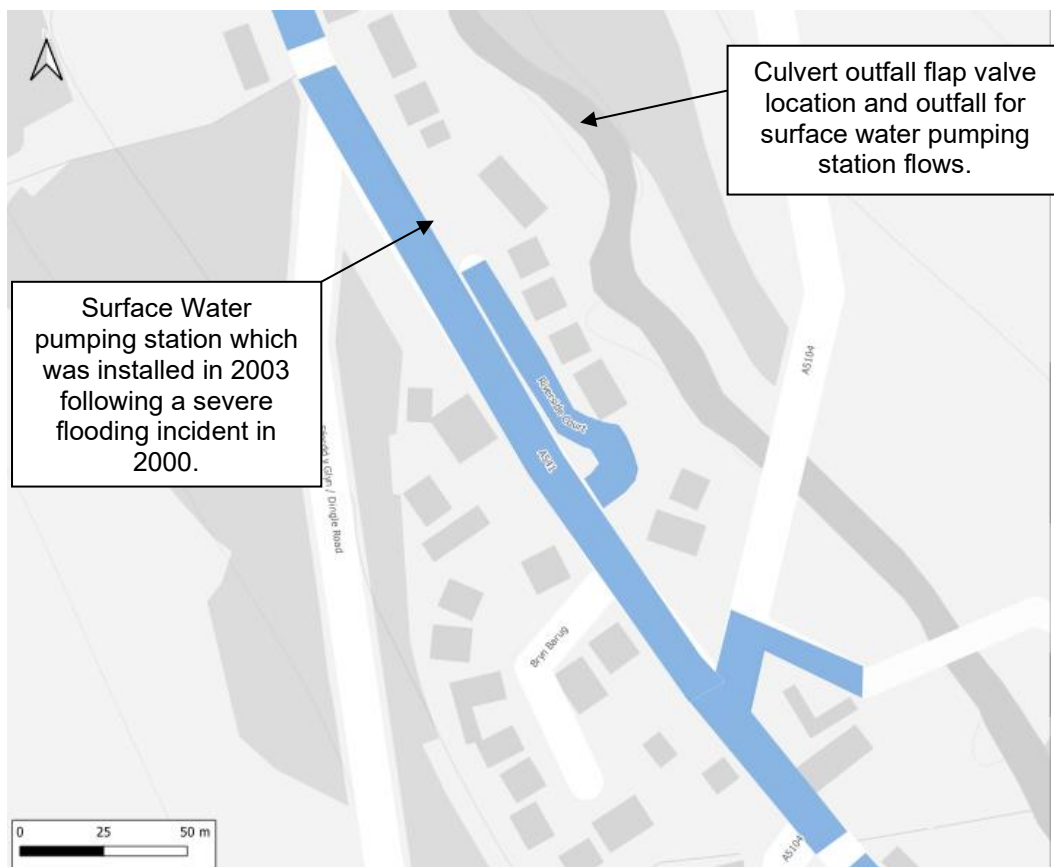
**Figure 11 – A541, Wrexham Road Area**  
Contains OS Data © Crown Copyright (2024)

- 4.11 According to residents, flooding was first noted as flowing from the layby off the A541, Wrexham Road and began to flow towards other areas as the water level rose. Residents reported having concerns as to whether Pontblyddyn highway pluvial surface water pumping station was functional during the storm. Stakeholder engagement with FCC confirmed that the pump was functioning during the flooding event and noted the pumping station was designed to accommodate a 1 in 5-year flood event. This indicates that the pumping station is not designed to pump flows witnessed in Storm Babet. FCC confirmed that the pumping arrangement is Duty and Assist and has not been changed since the pumping station was installed in 2003. The power supply is a single phase converted to three phase at the kiosk which was incorporated into the design on energy efficiency grounds and based on the likely operational use of the pumping station. Since construction in 2003 this is the first time that reports of the pumping station not functioning correctly have been made. There is evidence that the kiosk has been broken into with reports that this was carried out by unnamed local residents to establish if the pumps were running at the height of the storm.

- 4.12 Surface water which flowed along the A541, Wrexham Road resulted in flooding occurring in a number of adjacent areas, including Riverside Court and Hollands Terrace.

| Ref | Stakeholder | Action |
|---|---|---|
| 04 | FCC Highways Authority | Consider the implementation of traffic management plans that can be put in place when a storm event is predicted, to prevent passing vehicles creating bow waves that exacerbate flooding. |

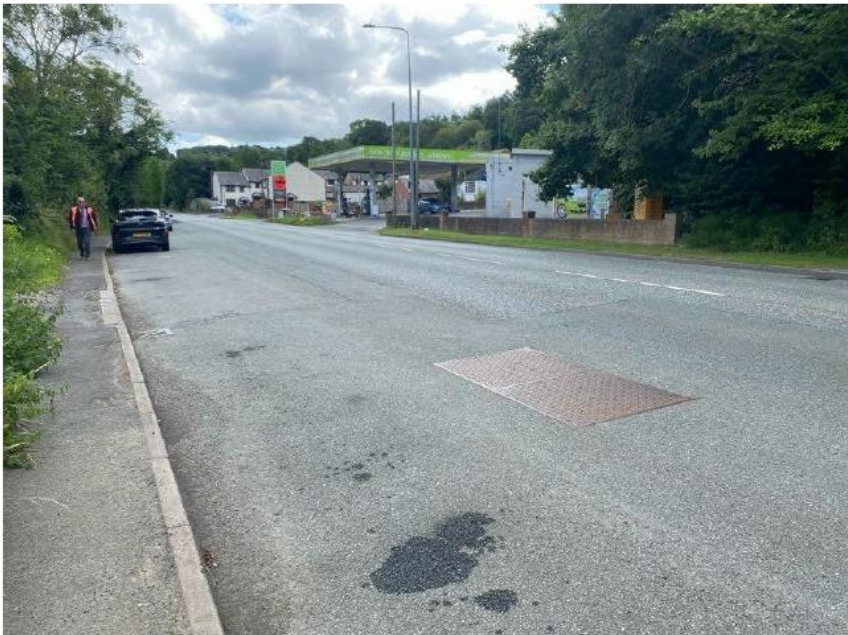
| Photo No.1 | |

| <p>Date: 20<sup>th</sup> August 2024</p> <p>Description: Access to pumping station in layby along A541, Wrexham Road</p> <p>Source: Waterco Site Visit</p> | |

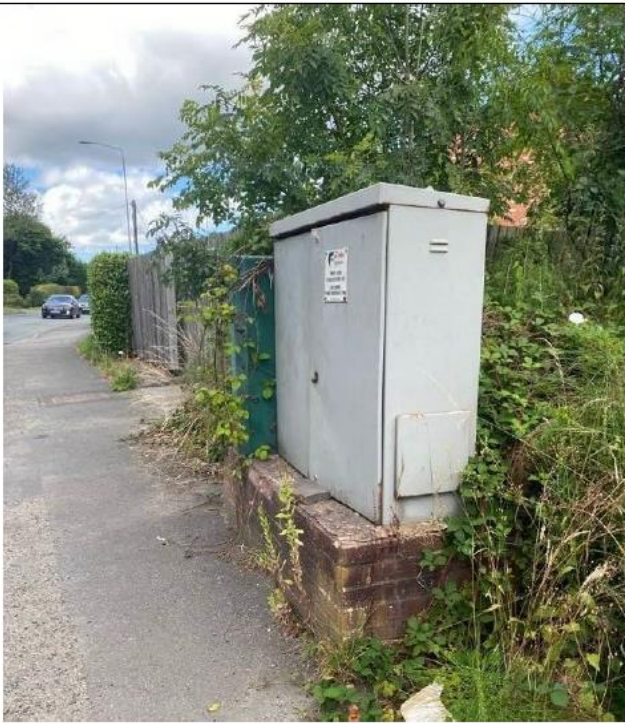
| Photo No. 2 | |

| <p>Date: 20<sup>th</sup> August 2024</p> <p>Description: Damaged control box for pumping station in layby along A541, Wrexham Road.</p> <p>Source: Waterco Site Visit</p> | |

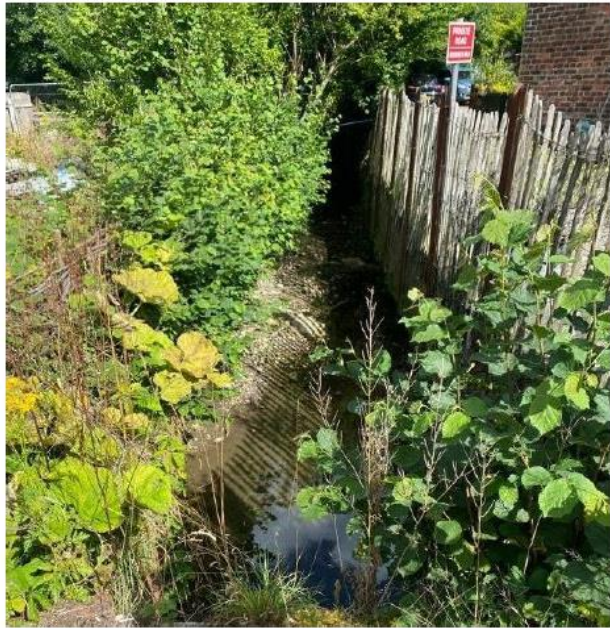
| Photo No.3 | |

| Description: Channel for Watercourse between The Bridge Inn and Alyn Terrace. | |

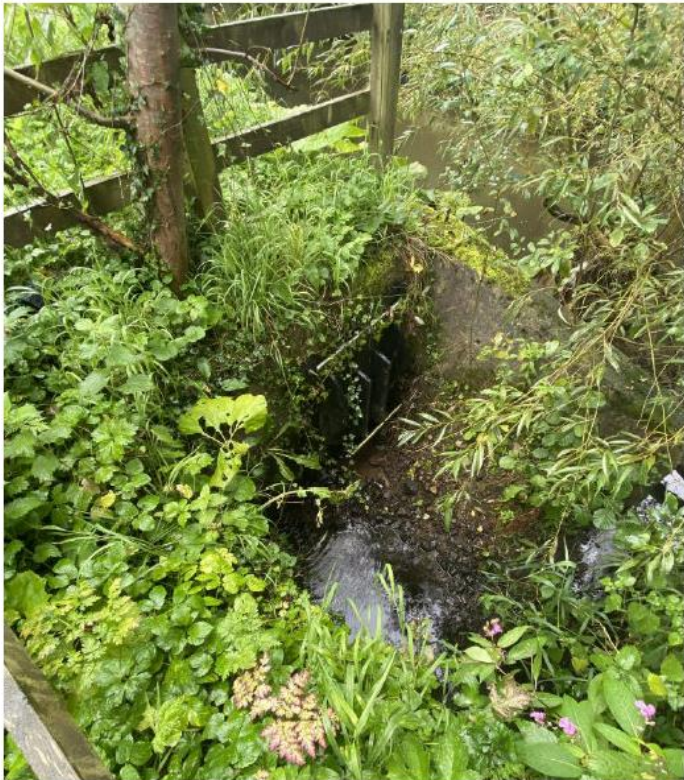
| Photo No. 4 | |

| Description: Outfall of Dingle House culvert outfall and pumping station outfall into River Alyn at NGR: 327608, 360695. | |

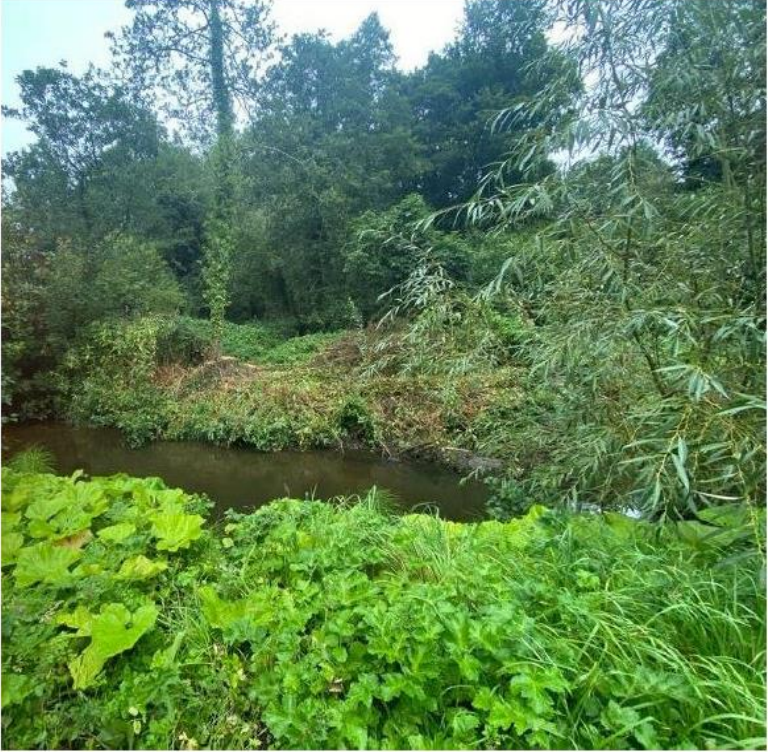
| Photo No. 5 | |

- 6.8 During the community engagement exercise conducted in September 2024, it was noted that vegetation clearance had been performed along the River Alyn, located behind the properties at Riverside Court, but the debris had not been removed. For supporting photographs, please refer to Appendix A.

| <p>Date: 10<sup>th</sup> September 2024</p> <p>Description: Banks along the River Alyn behind Riverside Court</p> <p>Source: Waterco Site Visit</p> | |

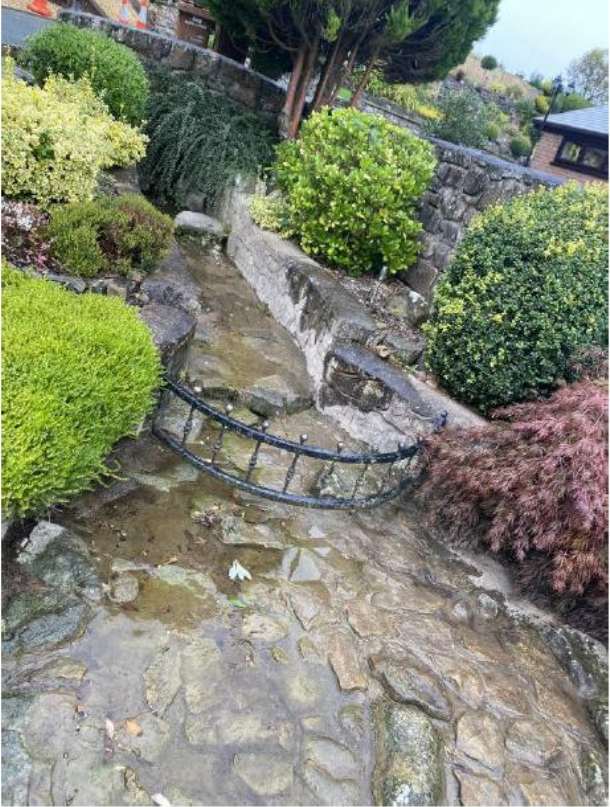
| Photo No. 6 | |

| <p>Date: 10<sup>th</sup> September 2024</p> <p>Description: Culvert 1 near Queen's Farm.</p> <p>Source: Waterco Site Visit</p> | |

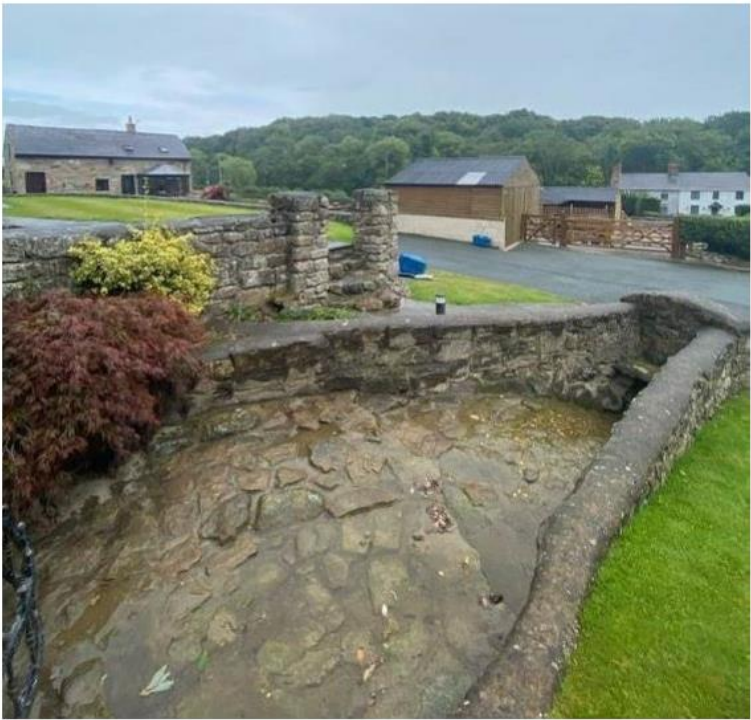
| <b>Photo No. 7</b> | |

| <b>Description:</b> Culvert 2 near Queen's Farm. | |
