# Flood & Water Management Act 2010

## Section 19 Flood Investigation Report FI0106

Location: Pontybodkin, Flintshire  
Incident Date: October 2023

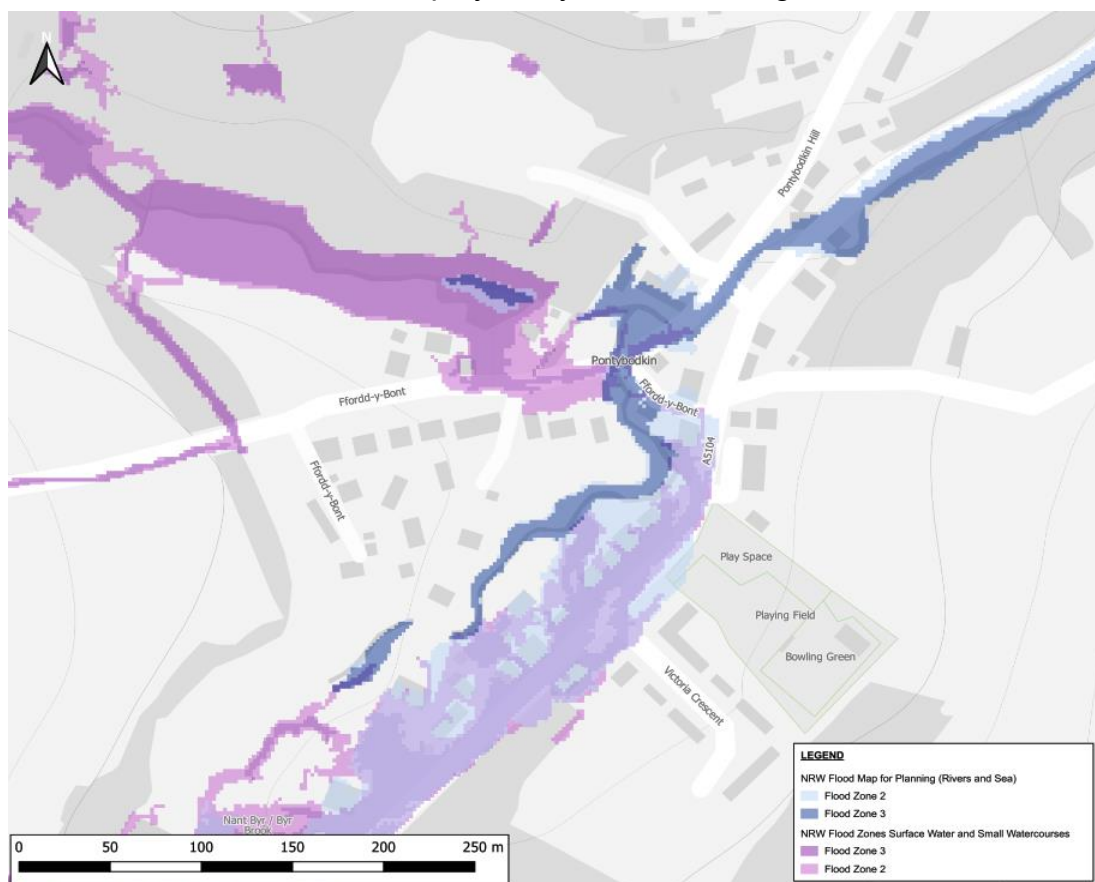
**Figure 8 - NRW Flood Map for Planning – Rivers, Sea, Surface Water and Small Watercourses Map**

- 3.7 The NRW 'Flood Map for Planning – Rivers and Sea' map identifies the flood risk associated with main river and sea, shown in Figure 8 and Appendix F. The NRW map shows that a number of the properties / streets in Pontybodkin are located in Flood Zones 2 and 3. Flood Zone 2 is defined as an area with between a 0.1% and 1% chance of flooding from rivers and / or sea in any given year, including the effects of climate change. Flood Zone 3 is defined as an area with a greater than 1% chance of flooding from rivers and / or sea in any given year, including the effects of climate change.

- 3.8 The flood risk shown on the NRW 'Flood Map for Planning –Surface Water and Small Watercourses' map identifies the flood risk associated with small watercourses such as Byr Brook and Black Brook and is based on a combination of rainfall and LiDAR data. The mapping identifies areas where surface water may flow or pool during heavy rainfall. LiDAR Mapping for context of elevations surrounding Pontybodkin can be found in Appendix D.

- 3.9 NRW mapping indicates that flood flows spill out of Black Brook and onto Ffordd y Bont, continuing east along the road. Flooding is also shown along Corwen Road and appears to be a combination of surface water (rainfall) and out of channel flooding from Byr Brook. Byr Brook is shown to overtop at the Scrap Metal Merchant Yard with flood flows directed onto Corwen Road, continuing north-east. The points where out of channel flooding from Byr Brook and Black Brook occurs is associated with the locations of culvert inlets. The culverts therefore play a key role in flooding at this location.

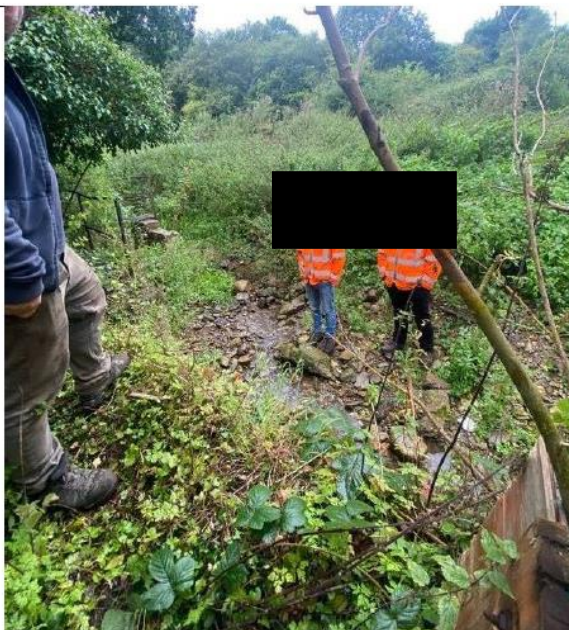
Photo No.1

Description: Culvert upstream of Scrap Metal Merchants yard, where bridge collapsed during Storm Babet.

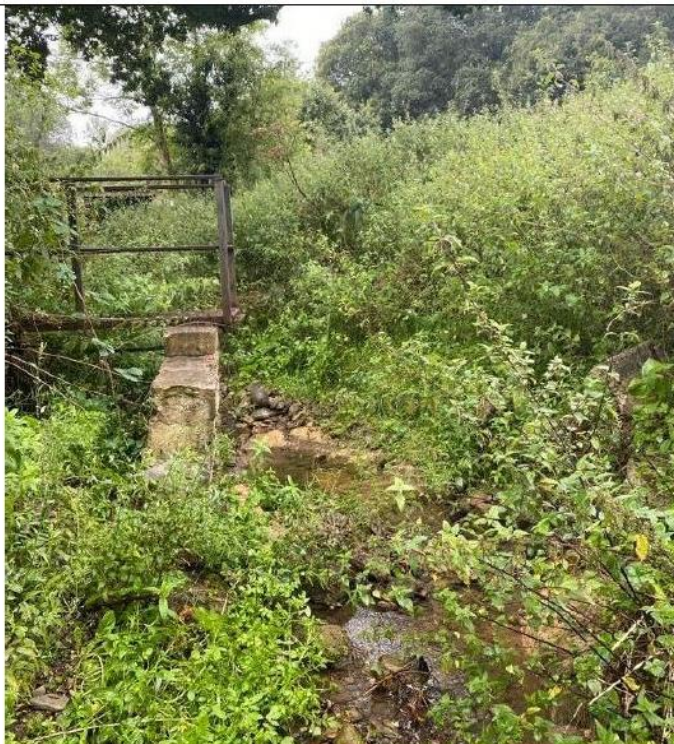
Photo No. 2

Description: Former bridge that was swept away during flooding of Storm Babet.

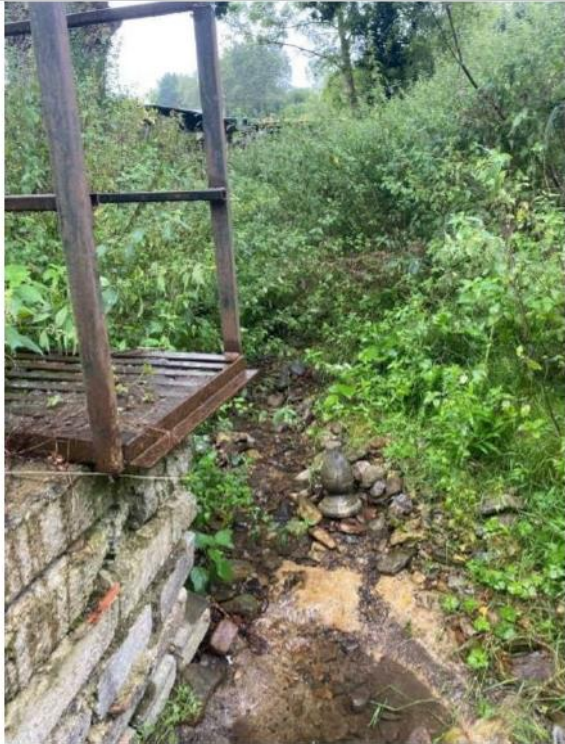
| Photo No. 3 | |

| <p>Date: 10<sup>th</sup> September 2024</p> <p>Description: Closer view of bridge in Photo No. 4</p> <p>Source: Waterco Site Visit</p> | |

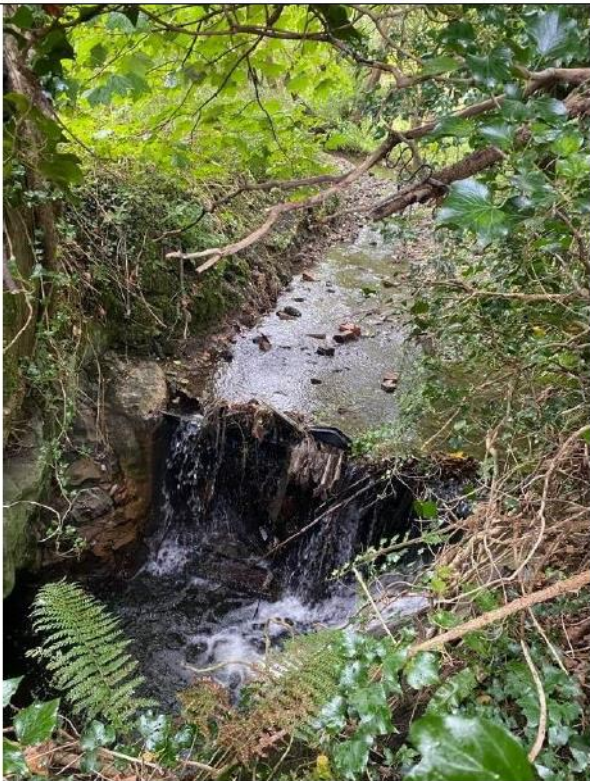
| Photo No. 4 | |

| <p>Date: 10<sup>th</sup> September 2024</p> <p>Description: Fully obstructed screen along Byr Brook at NGR: 326949, 359136</p> <p>Source: Waterco Site Visit</p> | |

| Ref | Stakeholder | Action |
|---|---|---|
| 01 | FCC Highways Authority | Inspect the existing culvert inlets along Byr Brook / Black Brook on a frequent basis and remove debris as required. |

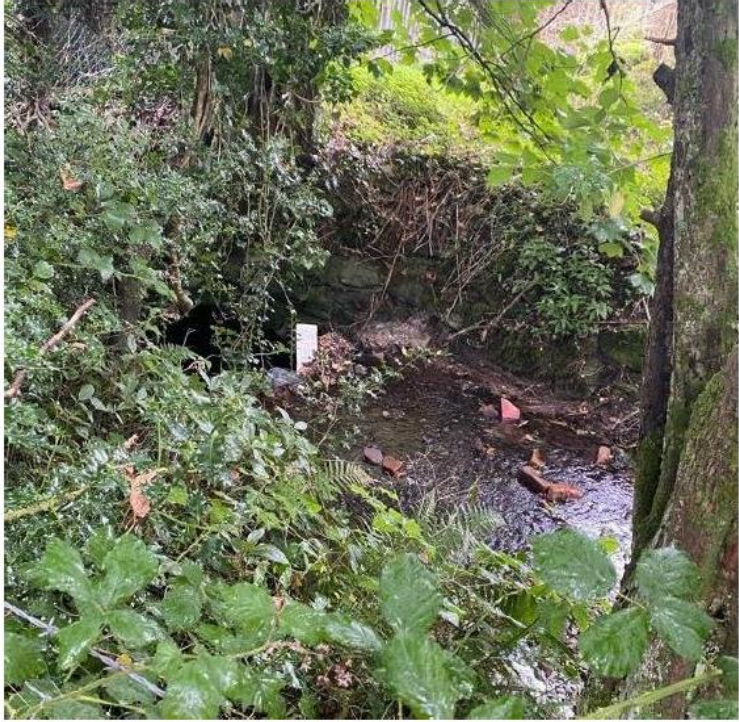
| Photo No. 5 | |

| <p>Date: 10<sup>th</sup> September 2024</p> <p>Description: View of other side of screen shown in Photo No. 6</p> <p>Source: Waterco Site Visit</p> | |

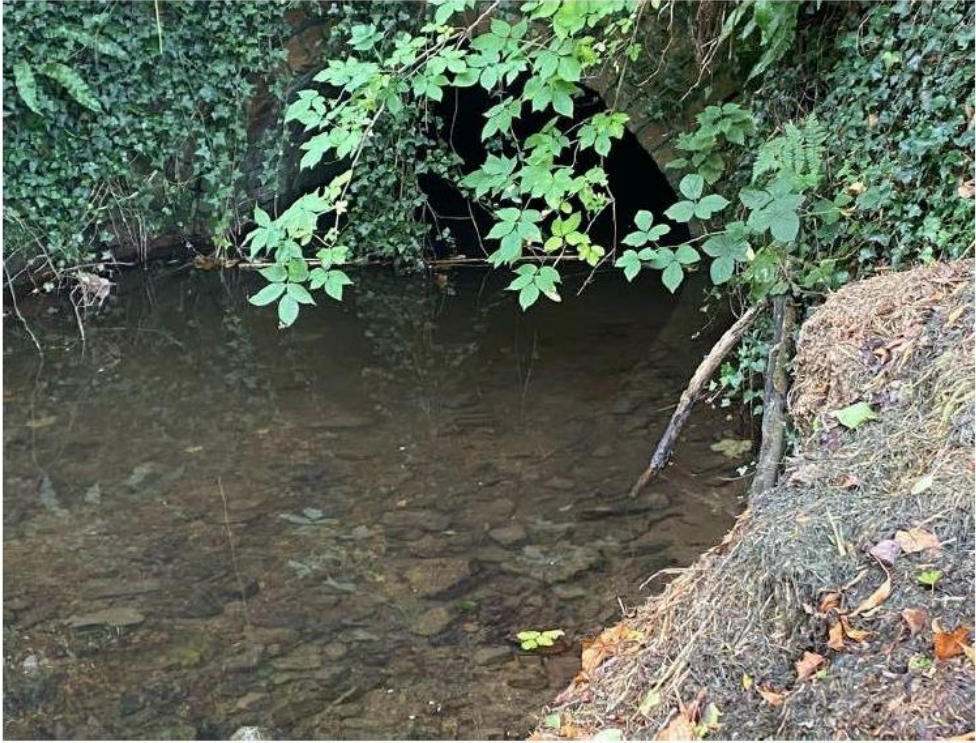
| Photo No.6 | |

| <p>Date: 10<sup>th</sup> September 2024</p> <p>Description: Partially silted culvert at NGR: 326915, 359117</p> <p>Source: Waterco Site Visit</p> | |

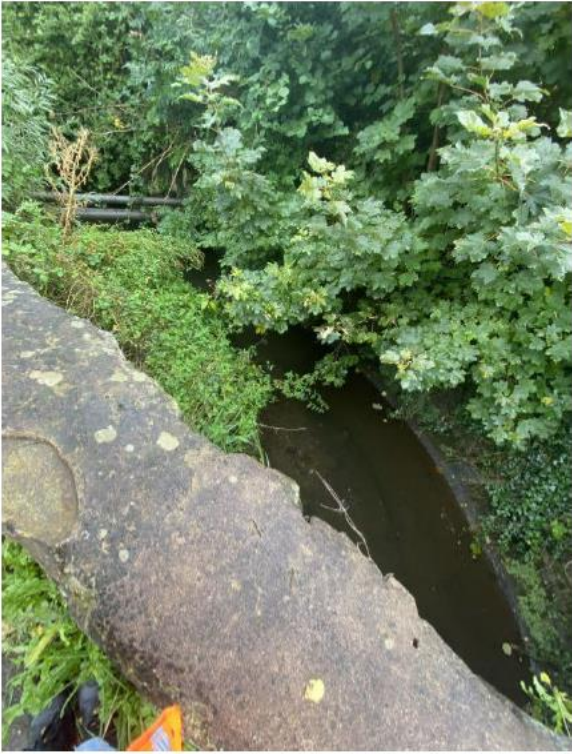
| Photo No. 7 | |

| Description: View of clear channel in watercourse off Tir y Fron Lane. | |

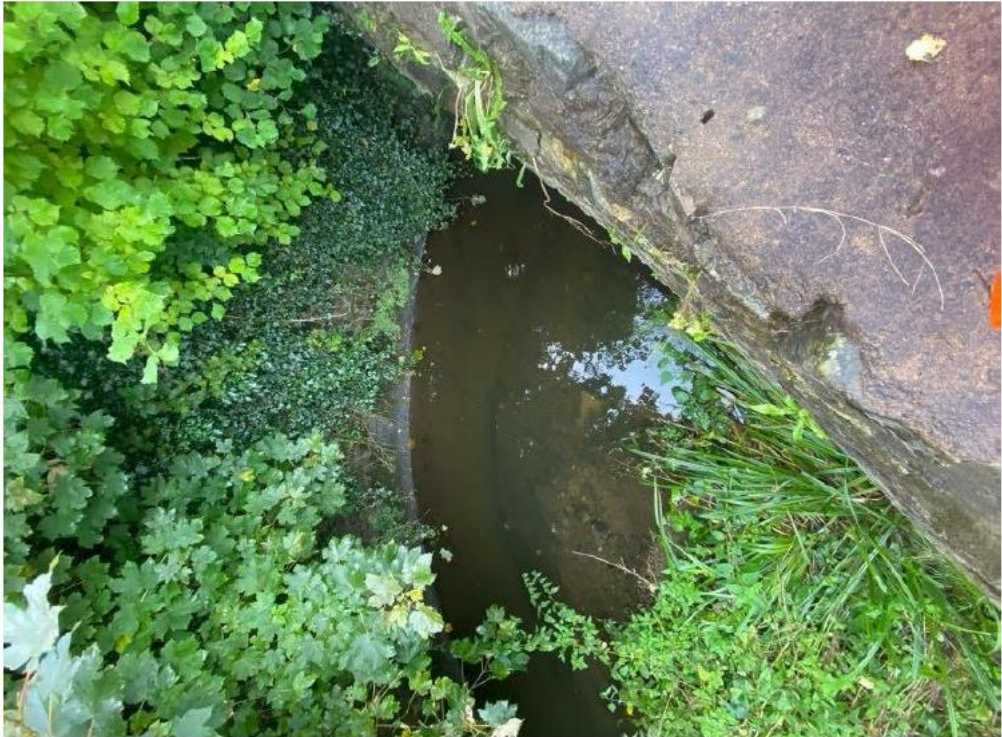
| Photo No. 8 | |

| Description: View of clear culvert inlet of watercourse off Tir y Fron Lane. | |
