# Flood & Water Management Act 2010

## Section 19 Flood Investigation Report FI0096

Location: Sandycroft, Flintshire

Incident Date: October 2023

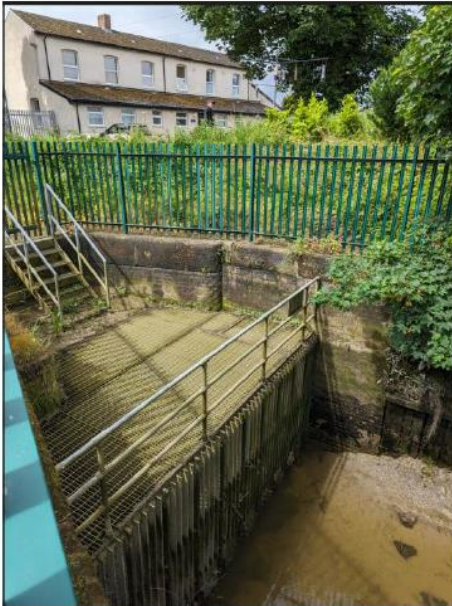
| Photo No.1 | |

| Description:<br>NRW Tidal Gate | |

| Ref | Stakeholder | Action |
|---|---|---|
| 06 | NRW | Consider a capital scheme to improve the tidal outfall and flap valves. |

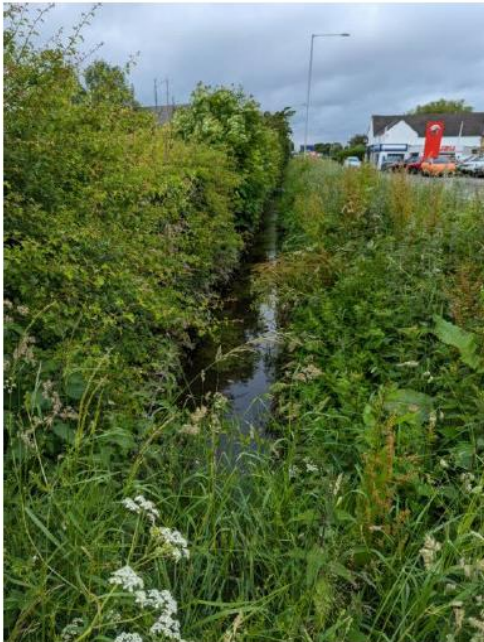
| Photo No. 2 | |

| Description:<br>Pentre Drain South | |

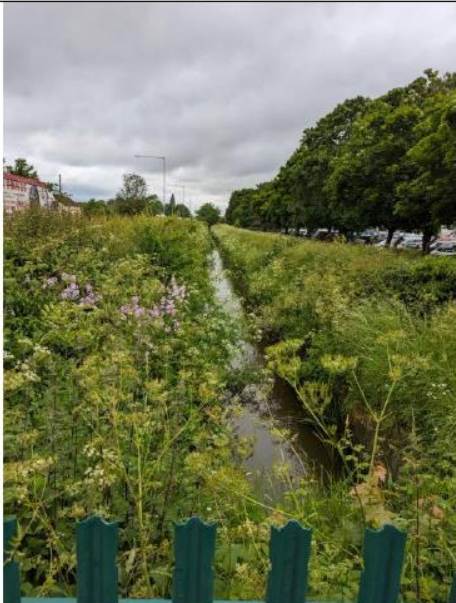
| Photo No.3 | |

| Description:<br><br>Pentre Drain North | |

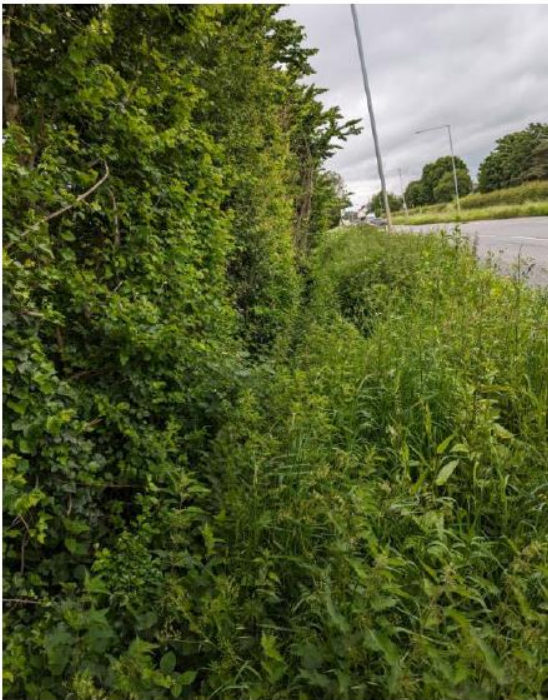
| Photo No. 4 | |

| Description:<br><br>Confluence of the unnamed watercourse from field to Pentre Drain South (overgrown) | |

| Ref | Stakeholder | Action |
|---|---|---|
| 05 | NRW | Continue to survey and maintain the Main Rivers in the area (Pentre Drain North, Pentre Drain South and Broughton Brook) to ensure they are free flowing. |

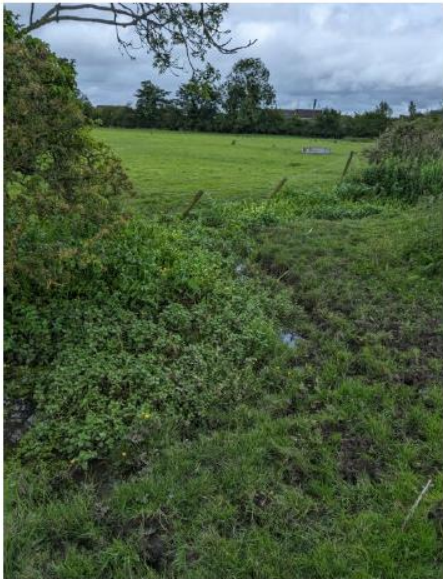
| Photo No.5 | |

| <b>Date: 28/05/2024</b><br><b>Description:</b><br>Unnamed watercourse in fields south of Chester Road | |

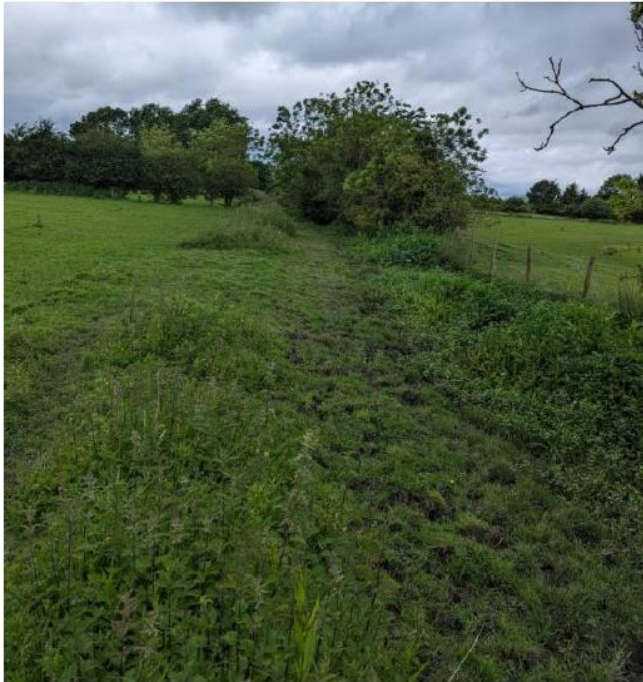
| Photo No. 6 | |

| <b>Date: 28/05/2024</b><br><b>Description:</b><br>Unnamed watercourse in fields south of Chester Road | |

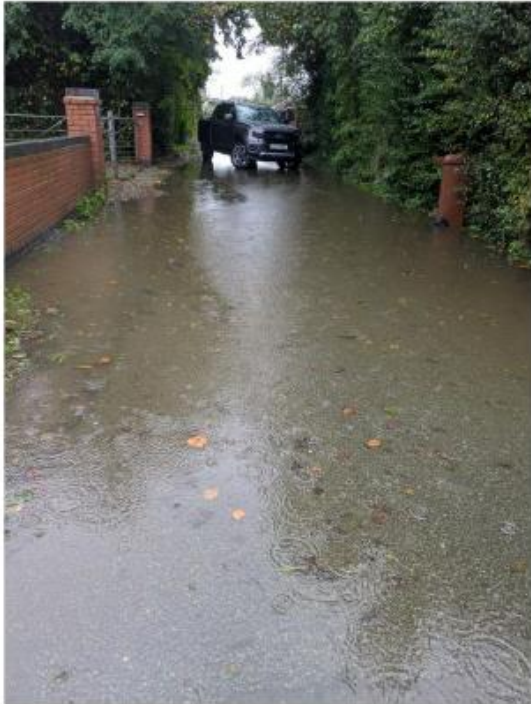
| Photo No. 4 | |

| Description:<br><br>Flooding along Wood Street | |

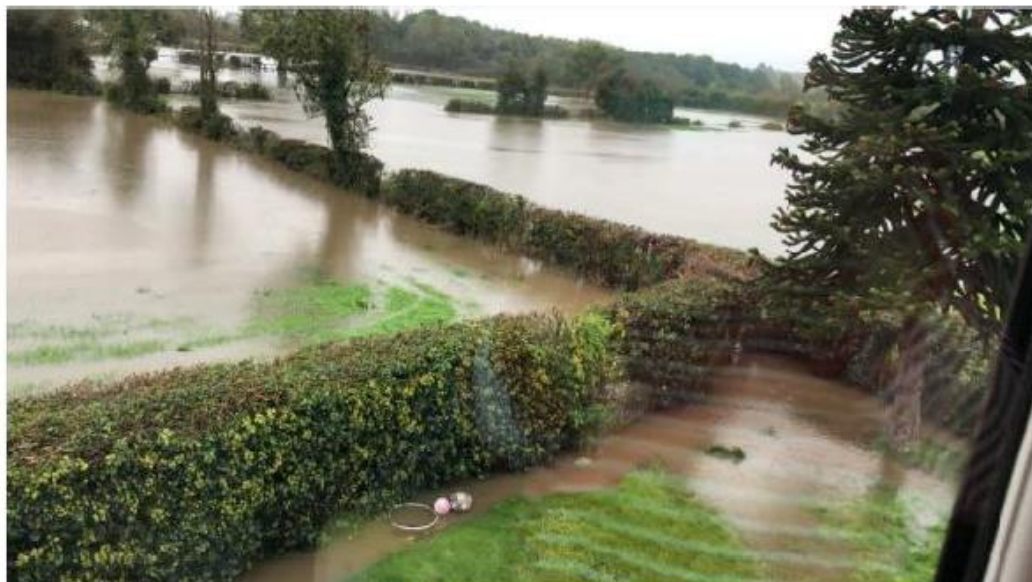
**Photo No.5**

Flooding to fields south  
of Rosslyn Close.
