Flood & Water Management Act 2010

Section 19 Flood Investigation Report FI0118

Location: Ffordd Dewi, Oakenholt
Incident Date: 5th – 6th January 2025

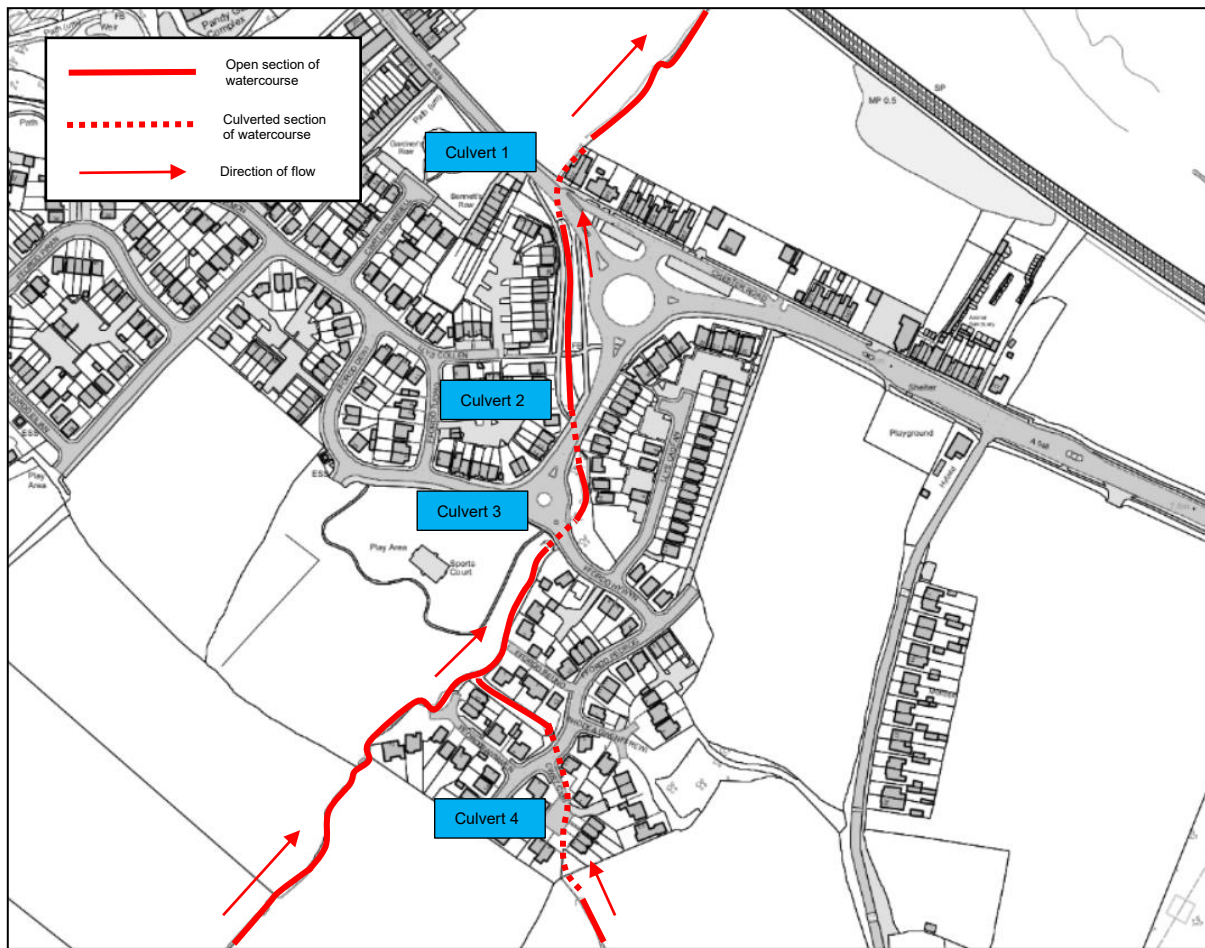
Figure 4 – Open and culverted sections of the Croes Onn stream watercourse

2.6 Parts of the open watercourse in the study area have been culverted as part of the development and the approximate routes are plotted below. A culvert is a structure, typically a pipe or box, that allows water to pass underneath an obstacle like a road or railway, (See photos in Appendix D for further route details).

- 4.17** On the 6th of January, contractors employed by Streetscene arrived and began using a high-volume jet to clear debris and silt in 'Culvert 2' which is indicated on Figure 4, starting from the downstream headwall and working upstream through the culvert. This was reported to have achieved a small increase in flow through the culvert which allowed the upstream section of the Croes Onn watercourse to partly drain. This partial drain allowed contractors to begin clearing around headwall and in-let of 'Culvert 2' where a wooden board and other debris such as foliage were removed; confirming North Wales Fire and Rescue Services previous observations. Upon removing these blockages, witnesses reported seeing a sudden release of water through 'Culvert 2'.

Ref	Stakeholder	Recommended action	Current Progress
01	Lead Local Flood Authority	Identify the parties responsible for the ongoing maintenance of the culverts 1-4 identified on Figure 4 and communicate this with all interested parties to allow future issues to be reported and resolved.	Culvert 1: FCC (as Highways Authority) Culvert 2: Anwyl Homes Culvert 3: Anwyl Homes Culvert 4: Anwyl Homes To be communicated formally on publication
02	Riparian Owner(s)	Review the maintenance regimes of the ordinary watercourse systems on site (<i>both open watercourse and culverts</i>). (www.naturalresources.wales/flooding/owning-a-watercourse)	Ongoing
03	Lead Local Flood Authority	Contact landowners downstream to desilt open watercourse downstream of 'Culvert 1' outfall.	Completed on 05.03.25 [See photograph log]
04	Anwyl Homes (Riparian Owner)	Continue working collaboratively on the land drainage and future SuDs for any further development of estate and undertake early engagement exercises for any new planning applications.	Ongoing

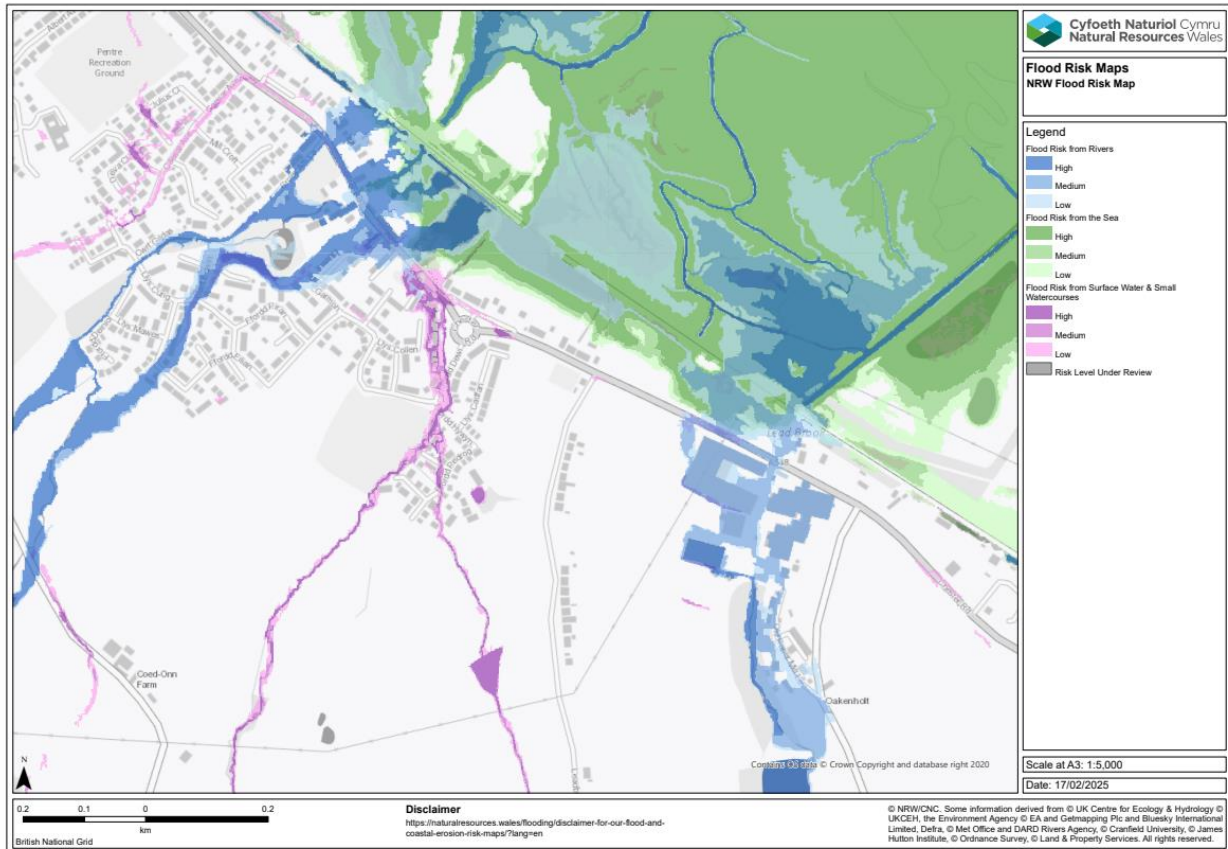
Figure 5 – NRW Flood and Coastal Erosion Risk Map

- 2.9** The flood risk shown on the NRW 'Flood Risk from Surface Water and Small Watercourses' map (Figure 5) is derived from a modelling study using inputs such as rainfall and LiDAR data. The mapping identifies areas where surface water may flow or pool during heavy rainfall. The NRW map does not consider factors such as drainage systems, culverts, blockages and recent changes in land levels by developments.
- 2.10** NRW mapping suggests that once flood flows exceed the capacity of the channels, they would continue flowing north along the western edge of the channel and over Ffordd Dewi Road.

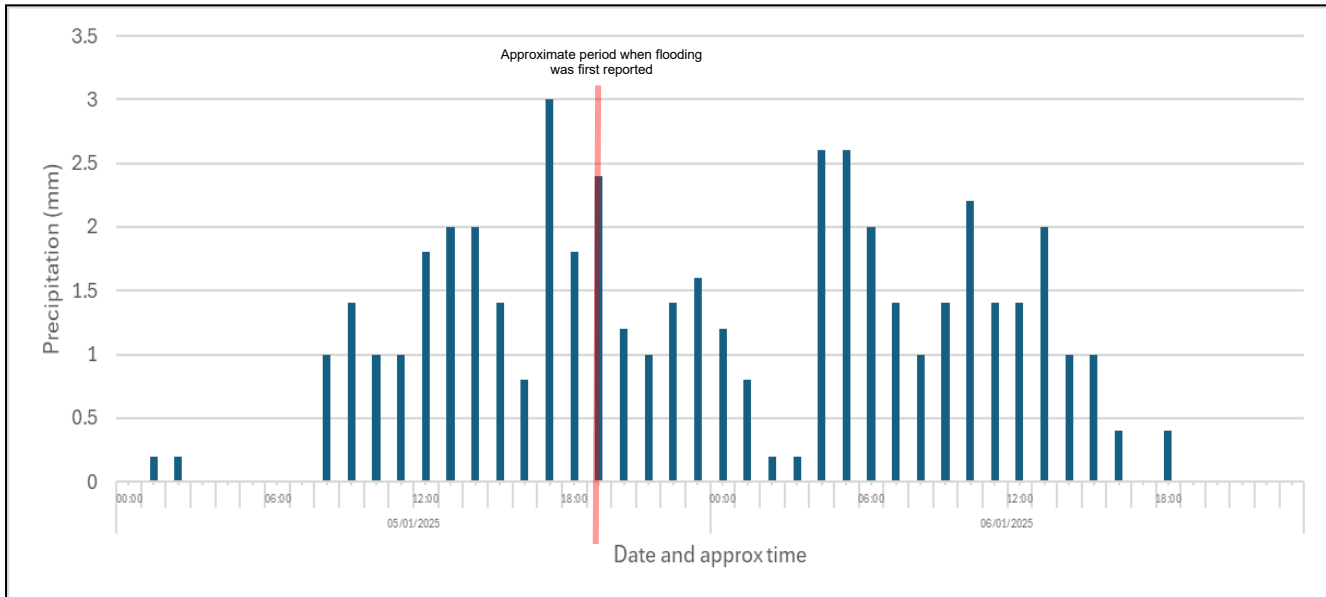
Figure 8 - Hourly rainfall between the 5th and 6th January 2025

3.5 Figure 8 shows that approximately 47.2mm of rainfall fell over 32 hours when the flooding event occurred, peaking at 3mm between 17:00 and 18:00 on the 5th January.

3.6 Flood Estimation Handbook (FEH) analysis suggests that this rainfall is equivalent to an Annual Exceedance Probability (AEP) of approximately 25%. This means the rainfall experienced had a probability of approximately 25% of occurring in any given year.

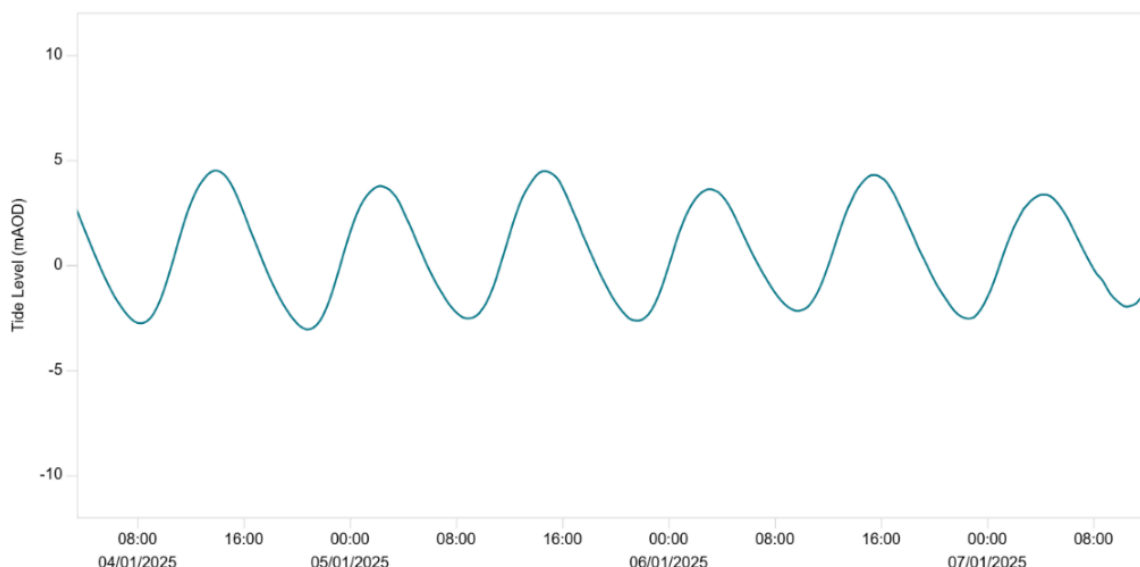
Figure 9 – Liverpool Tidal Gauge data

3.7 Tide data has been obtained from the Liverpool Tidal Gauge⁷ (Closest to Oakenholt). Rainfall during this flooding event was highest between 5pm and 6pm on the 5th January whilst high tide was just before 4pm as indicated by Figure 9. Waters levels in this watercourse may become elevated during periods of high tides, as flows may be restricted by high water levels in the River Dee.

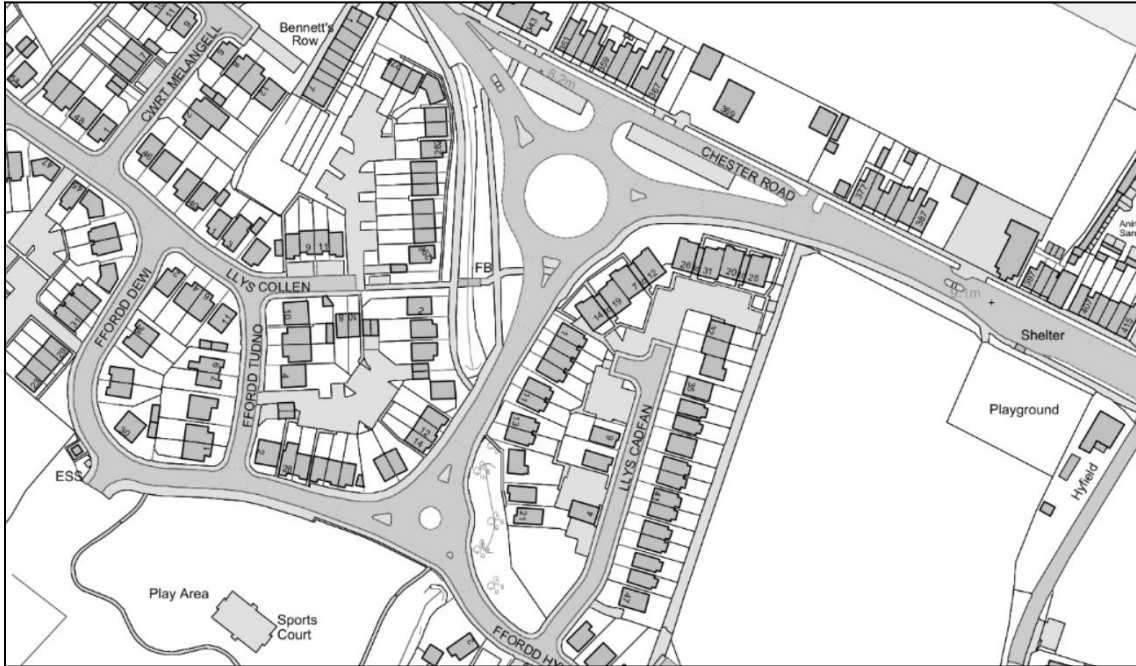
Reported Flood Areas

- 4.5 Floodwater followed local topography along Ffordd Dewi road, flooding the adjacent properties rather than going back into the open section of watercourse as suggested by NRW's Flood Risk Map. This is likely due to one of the variables not considered by NRW's map. The general flood location is identified in Appendix C.

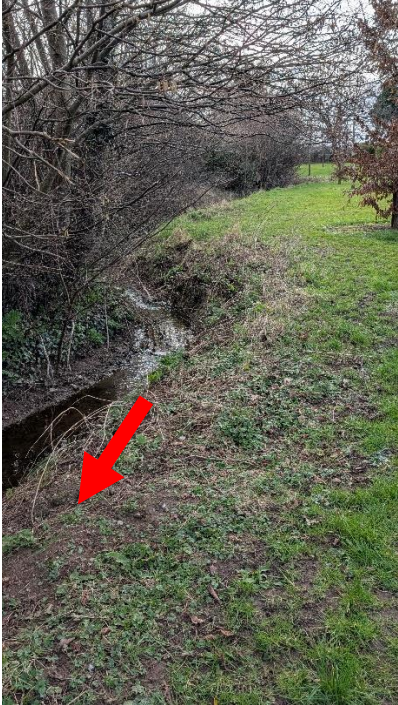
<p>Photograph no. 2</p>

<p>Date: 11/03/2025</p>	
<p>Description: A picture looking upstream of the Croes Onn watercourse opposite the playground.</p> <p>Source: Author</p>

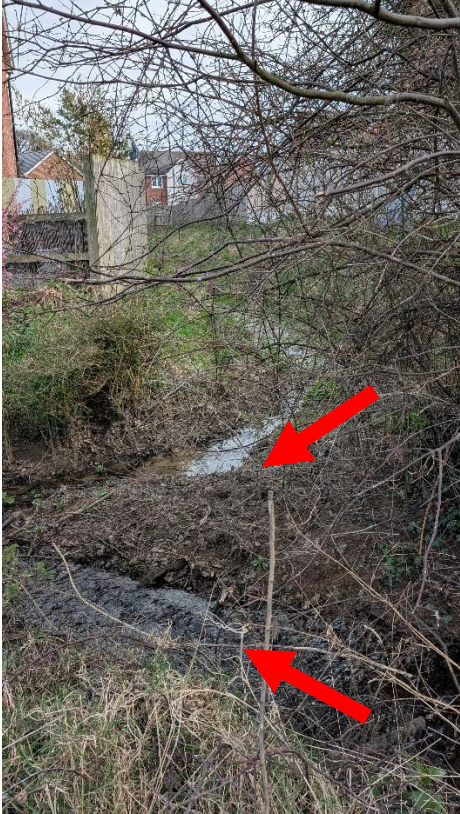
<p>Photograph no. 3</p>

<p>Date: 11/03/2025</p>	
<p>Description: A picture looking at the tributary which joins the main Croes Onn stream after going through 'Culvert 4'.</p> <p>Source: Author</p>

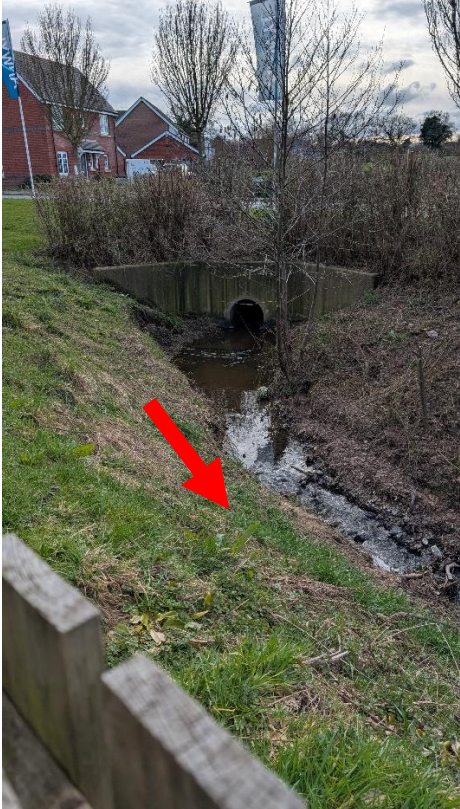
<p>Photograph no. 6</p>

<p>Date: 11/03/2025</p>	
<p>Description: The outfall and headwall of 'Culvert 3'.</p> <p>Source: Author</p>

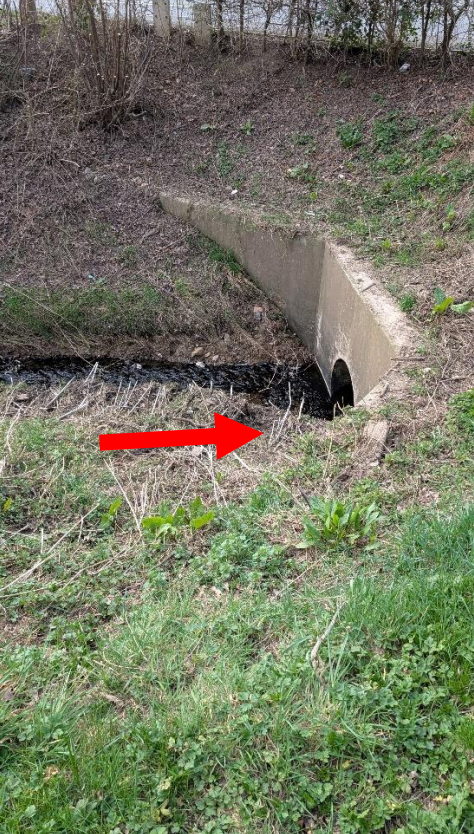
<p>Photograph no. 7</p>

<p>Date: 11/03/2025</p>	
<p>Description: The in-let and headwall of 'Culvert 2'.</p> <p>Source: Author</p>

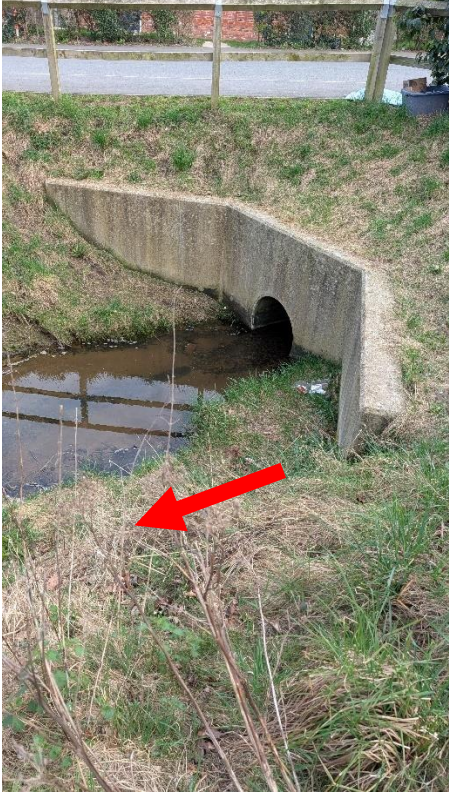
<p>Photograph no. 8</p>

<p>Date: 11/03/2025</p>	
<p>Description: The outfall and headwall of 'Culvert 2'.</p> <p>Source: Author</p>

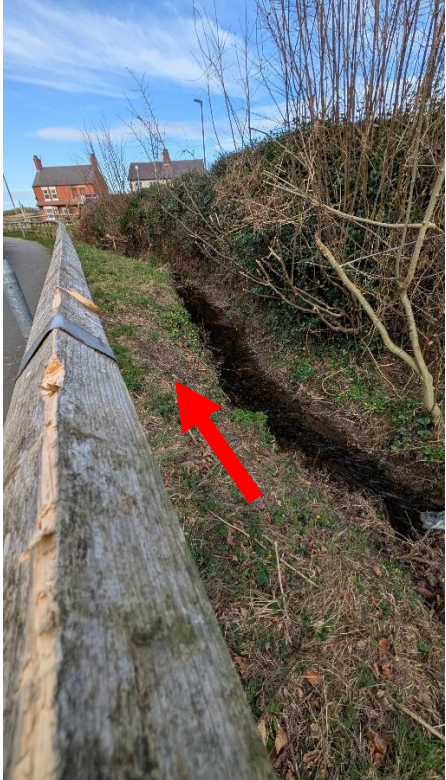
<p>Photograph no. 9</p>

<p>Date: 11/03/2025</p>	
<p>Description: A picture looking downstream at the open section of watercourse between 'Culvert 2' and 'Culvert 1'.</p> <p>Source: Author</p>

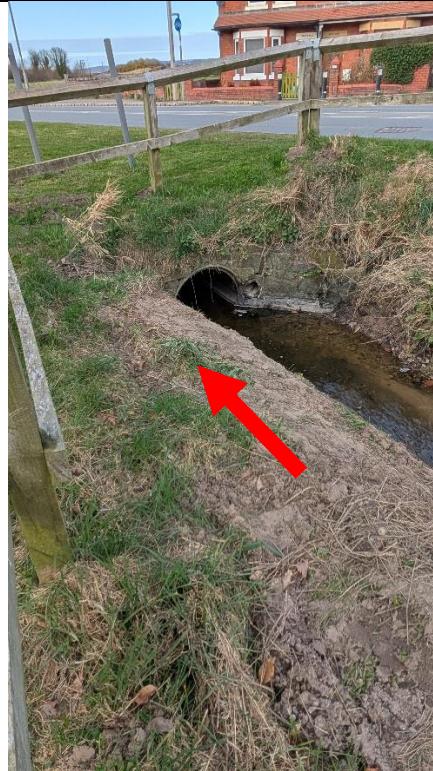
Photograph no. 10

Description:
The in-let and headwall of 'Culvert 1' which flows under the A548.

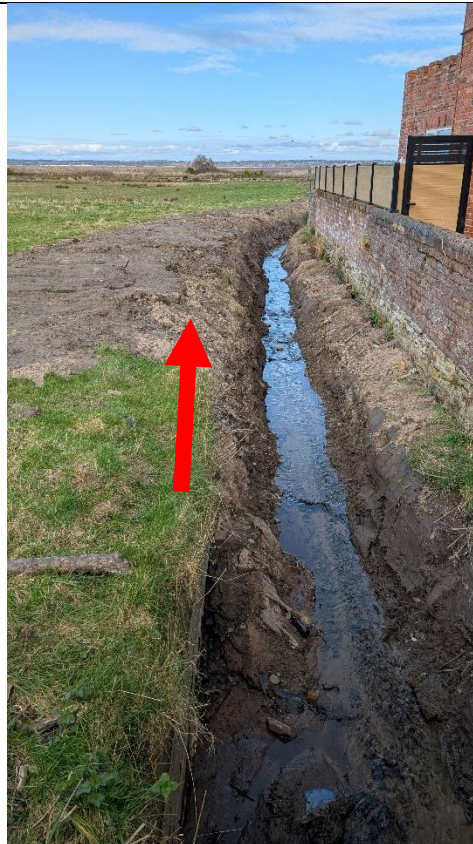
Photograph no. 11

Description: A picture looking downstream of the 'Culvert 1' outfall at the desilted watercourse.

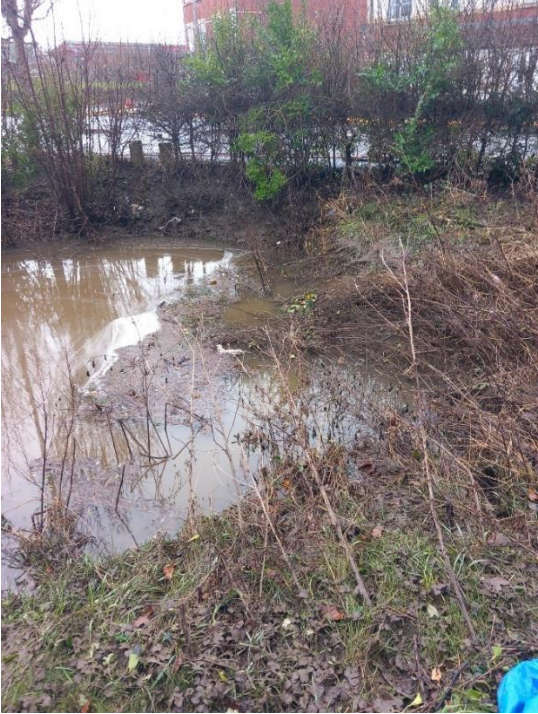
<p>Photograph no. 12</p>

- 4.11 During the stakeholder engagement exercise, multiple sources reported that a blockage in the form of a wooden plank and debris/foilage had formed in the high flood risk fluvial system known as the Croes Onn stream at the in-let of 'Culvert 2', blockage of any culvert reduces its capacity to pass forward flows and could have exacerbated upstream water levels.

<p>Date: 06/01/2025</p>	
<p>Description: The in-let and headwall of 'Culvert 2' after pumping but prior to being unblocked.</p> <p>Source: Streetscene</p>

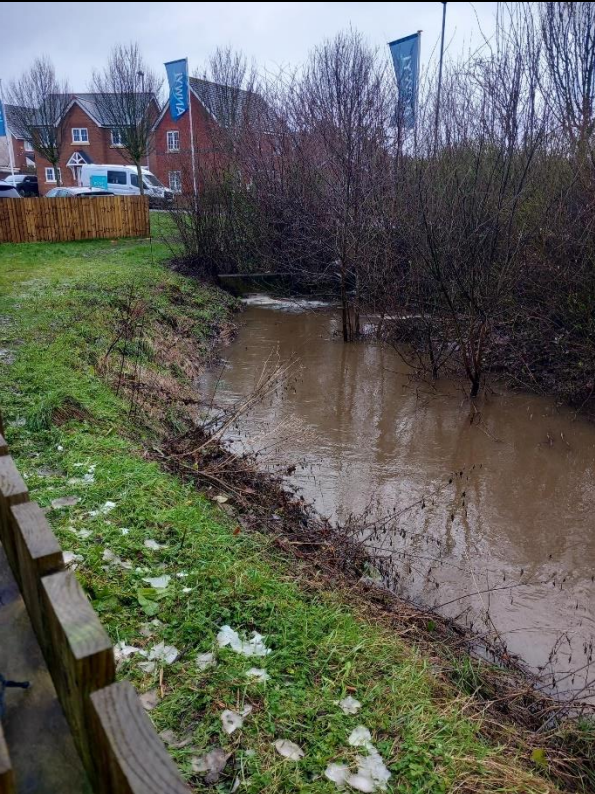
<p>Photograph no. 13</p>

<p>Date: 06/01/2025</p>	
<p>Description: A picture looking upstream at the outfall of 'Culvert 3' demonstrating the water level of the open brook prior to being unblocked.</p> <p>Source: Streetscene</p>

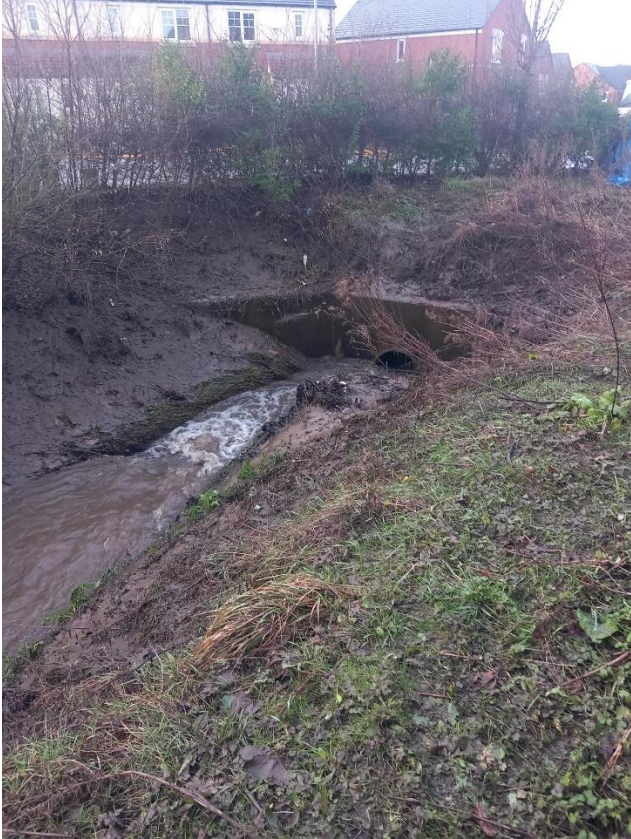
<p>Photograph no. 14</p>

<p>Date: 06/01/2025</p>	
<p>Description: The in-let and headwall of 'Culvert 2' a few minutes after the blockage was removed.</p> <p>Source: Streetscene</p>
