ENVIRONMENTAL PROTECTION ACT 1990, SECTION 78H(9)

REMEDIATION STATEMENT

Contaminated land caused by communal oil tank, at Wirral View, Connahs Quay, Flintshire. The site is illustrated on the attached map.

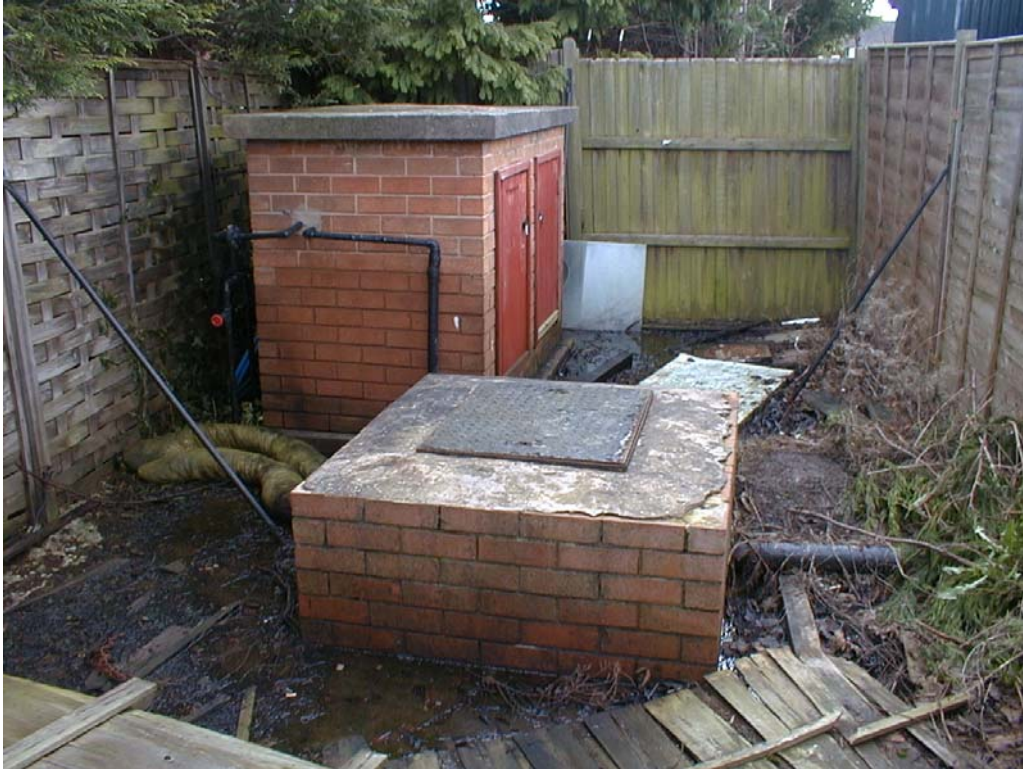
PHOTOGRAPH 1

- A trench, approximately a metre deep, was dug along the length of the supply pipe running along the edge of the communal tank and its concrete bund surrounding the tank and then a visual search was made for any leaks. The trench was dug here on the basis that the oil was found pooled in the tank compound (see photograph 1 attached) and was therefore emanating from somewhere in this area.
- The depth of the communal oil tank was measured.
- The sheath of the supply pipe had been removed in a couple of places to check for any seepage of oil within the sheath.

OIL ON SURFACE OF WATER POOLED WITHIN COMPOUND

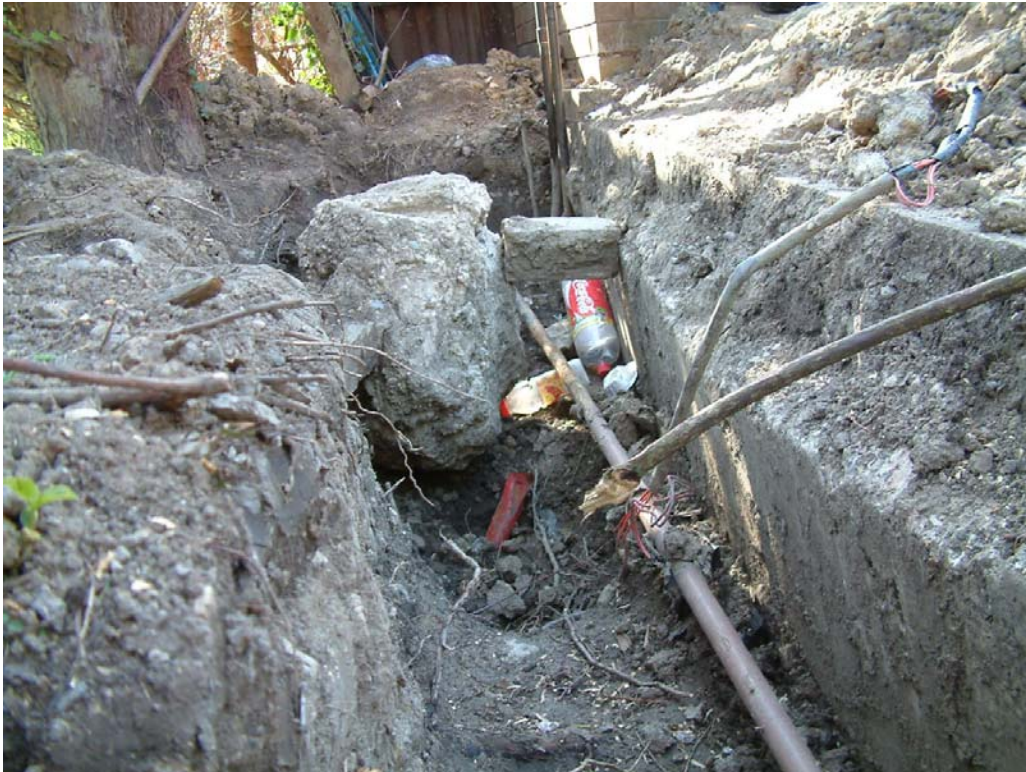
PHOTOGRAPH 2

No holes or damage were found in the supply pipe below ground level and no oil was found within the sheath surrounding the pipe. There was no sign of oil seepage through the concrete bund surrounding the communal oil tank (see photograph 2 attached). The tank was found to be approximately 3.3m deep. The engineer advised that due to the depth of the tank the pressure head would have caused a noticeable amount of oil to leak from the bund either through the bund itself or overflow from the pump well. There was no oil in the pump well.

CONCRETE BUND OF OIL TANK SHOWING NO SEEPAGE OF OIL

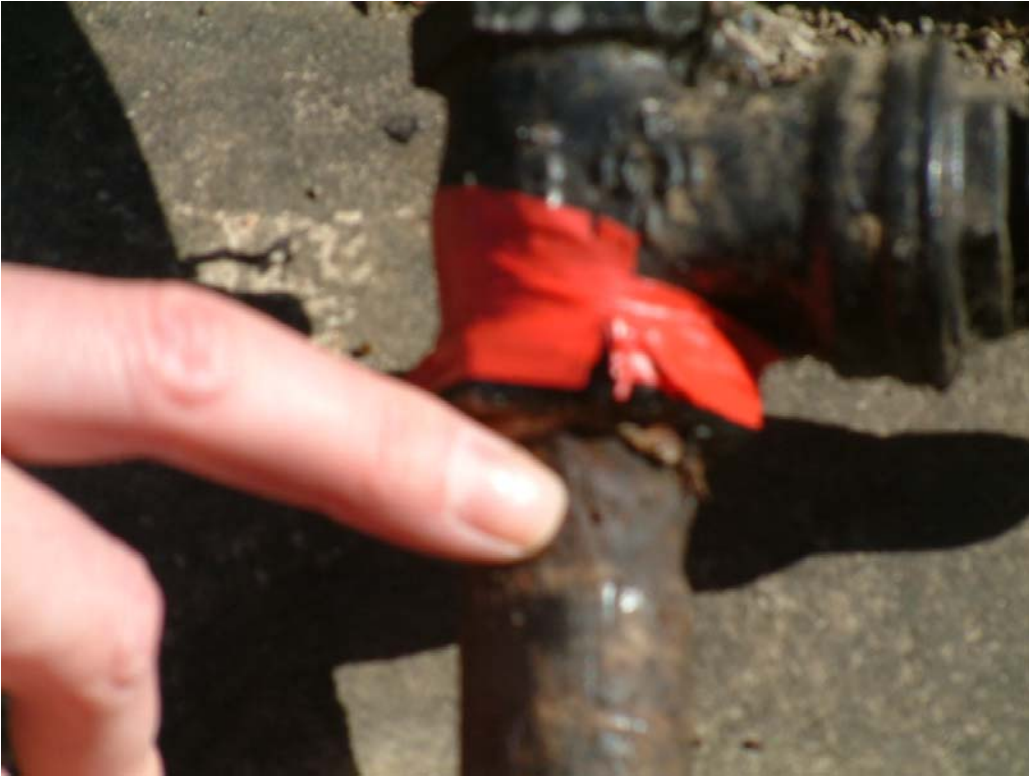
A very small hole about 1 to 2mm in diameter was found on one of the supply pipes under an area covered by denso tape (see photograph 3 attached). This was in a position above ground.

PHOTOGRAPH 3
HOLE IN SUPPLY PIPE

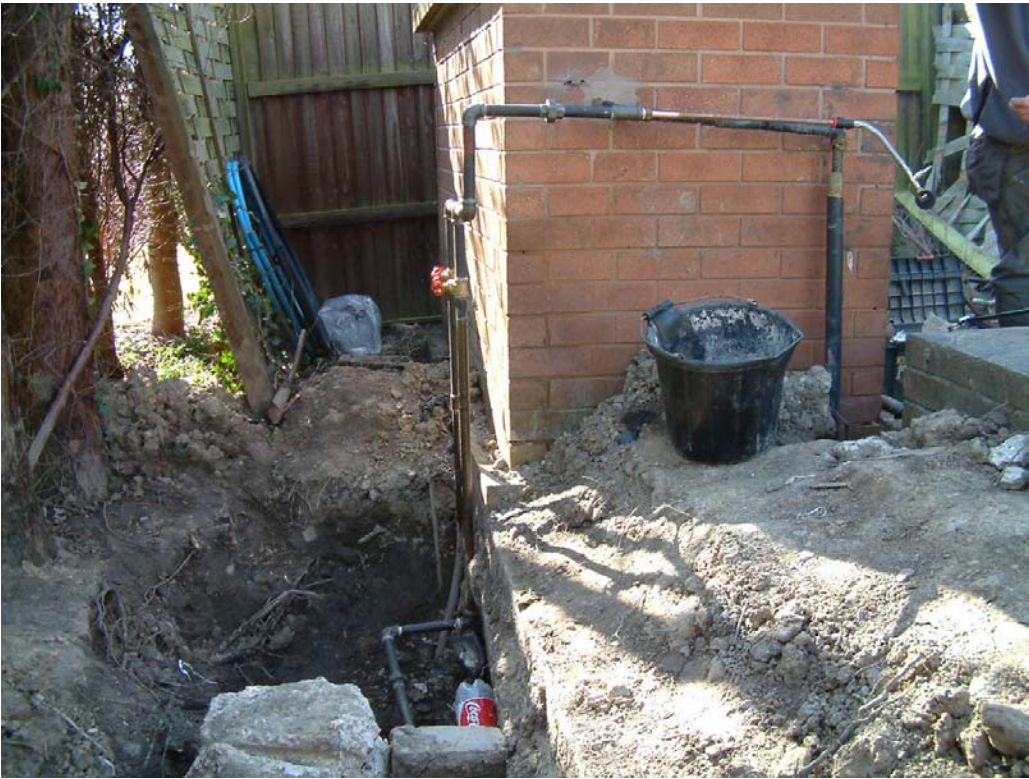
PHOTOGRAPH 4
NEW SUPPLY PIPE WITH PRESSURE METER ATTACHED

The section of pipe with the hole in was replaced by a new piece of pipe (see photograph 4 attached).

- Blocking off the oil supply to those dwellings still utilising the fuel;
- Disconnecting the two pipes from the tank (see photograph 5 attached), which run in a circuit;
- Draining down the oil from the supply pipes;
- Applying a pressure meter to the circuit (see photograph 4 attached).

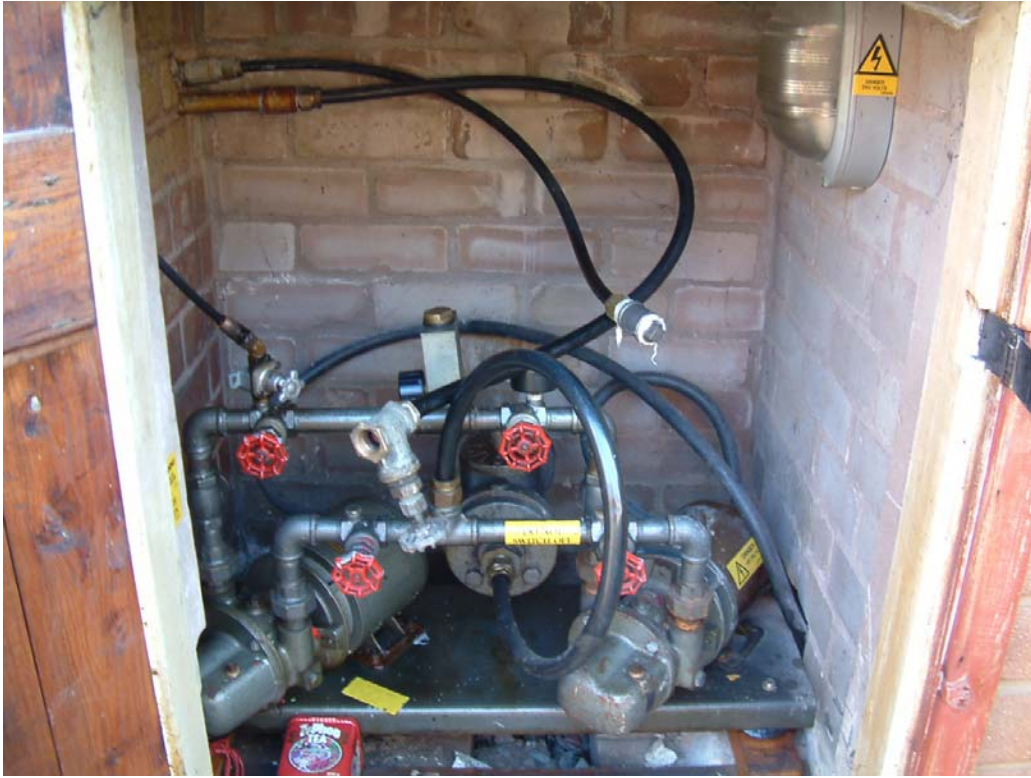
PHOTOGRAPH 5

TWO SUPPLY PIPES DISCONNECTED FROM THE TANK
