Re: Letter Ref: RAJ/003105, dated 7 March 2003 regarding the 'Environmental Protection Act' 1990, section 78B on contaminated land arising from a kerosene oil leak at 'Bilberry', Mold Road, Altami.

Remediation Statement

Item 6.4 Details of Remediation Scheme and specification of the Remediation Method

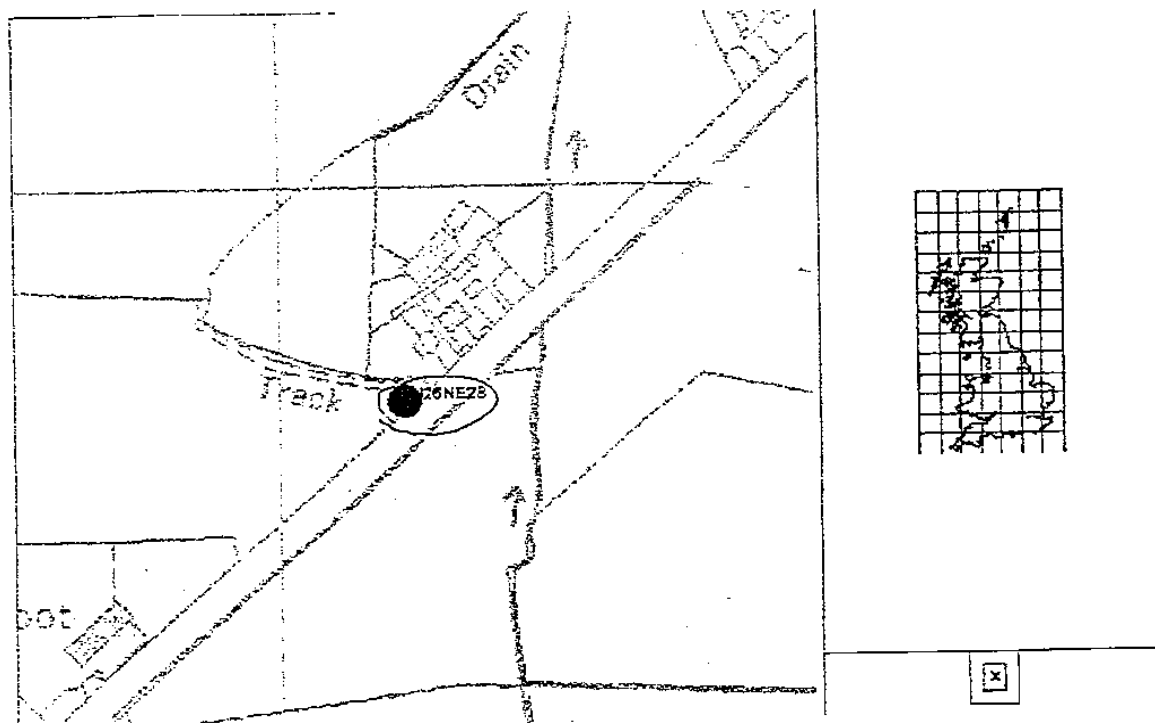
ALTAMI SITE (ABOVE CENTRE) WITH BOREHOLE RECORD SJ26NE28 INDICATED

Herewith a fax copy of a borehole log (our ref SJ26NE28) from the database we subscribe to. From the attached plan you can see that it is located just a few tens of metres to the south west of the 4 Altami properties in question. No geological discontinuities exist between the borehole and the residences and therefore it is suggested we can extrapolate the date to the contaminated land.

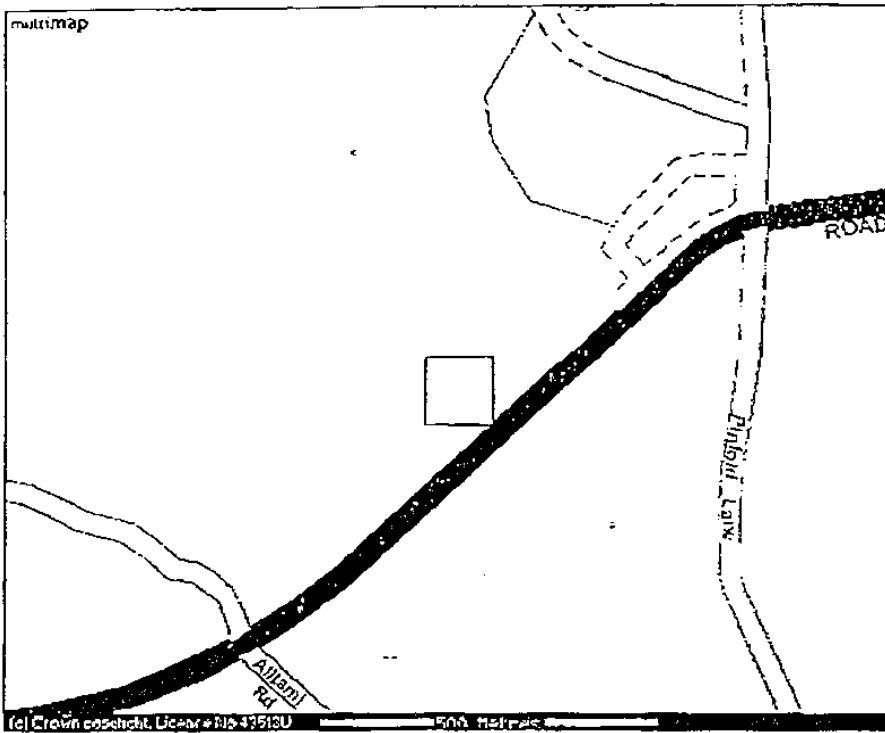
LARGE SCALE PLAN OF CONTAMINATED LOCATION AT ALLTAMI, MOLD
PLAN NOT TO SCALE

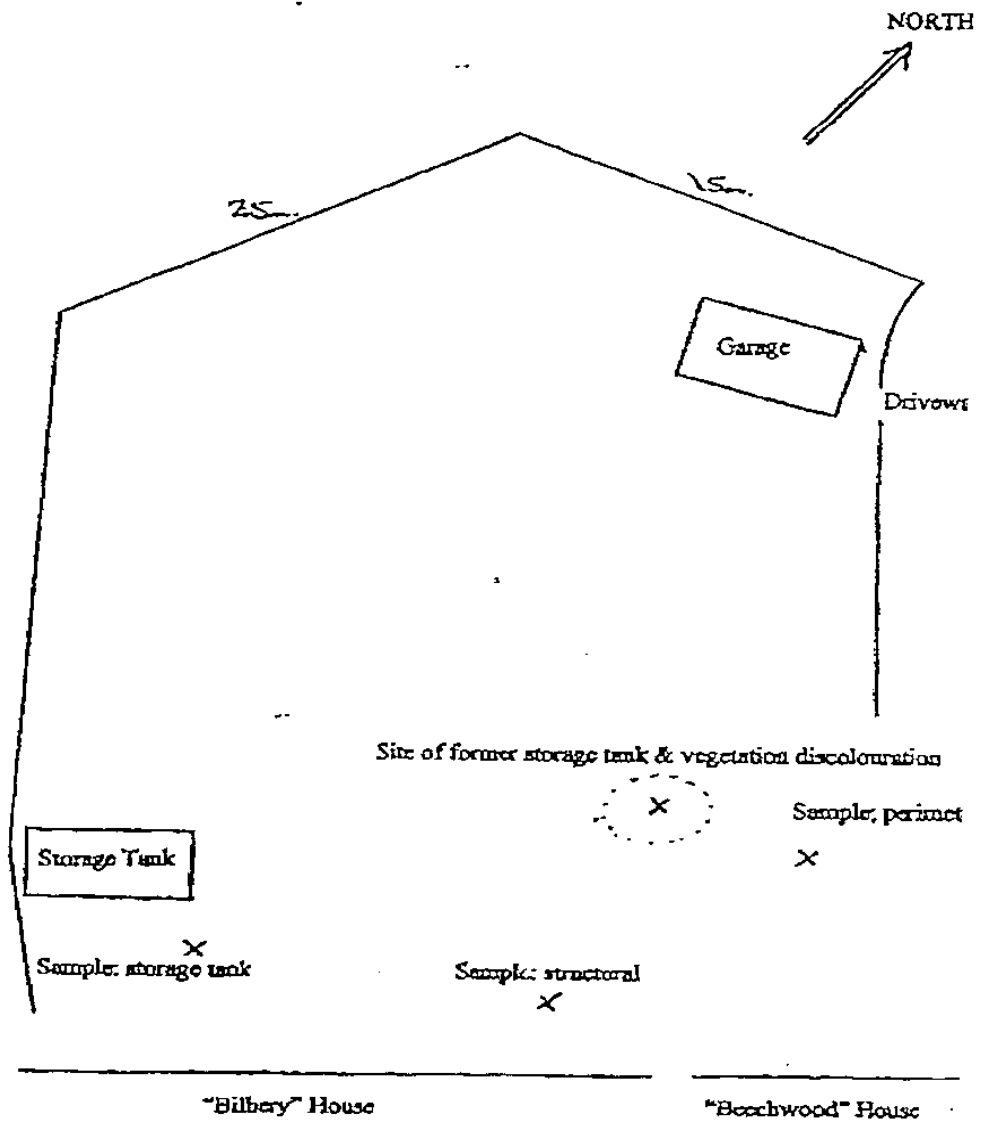
SOIL SAMPLING LOCATIONS AT ALLTAMI, MOLD
PLAN NOT TO SCALE

PID readings were taken at 1 metre and 3 metre intervals from the existing diesel storage container in a northerly direction at surface and 0.5 metre depths.

At North, East, South and Westerly directions from the centre of the former location of the diesel storage tank also at surface and 0.5 metre depths.
