## **Tree Survey**

**Axis P.E.D. Ltd**

**Waste Transfer Station**

**Buckley**

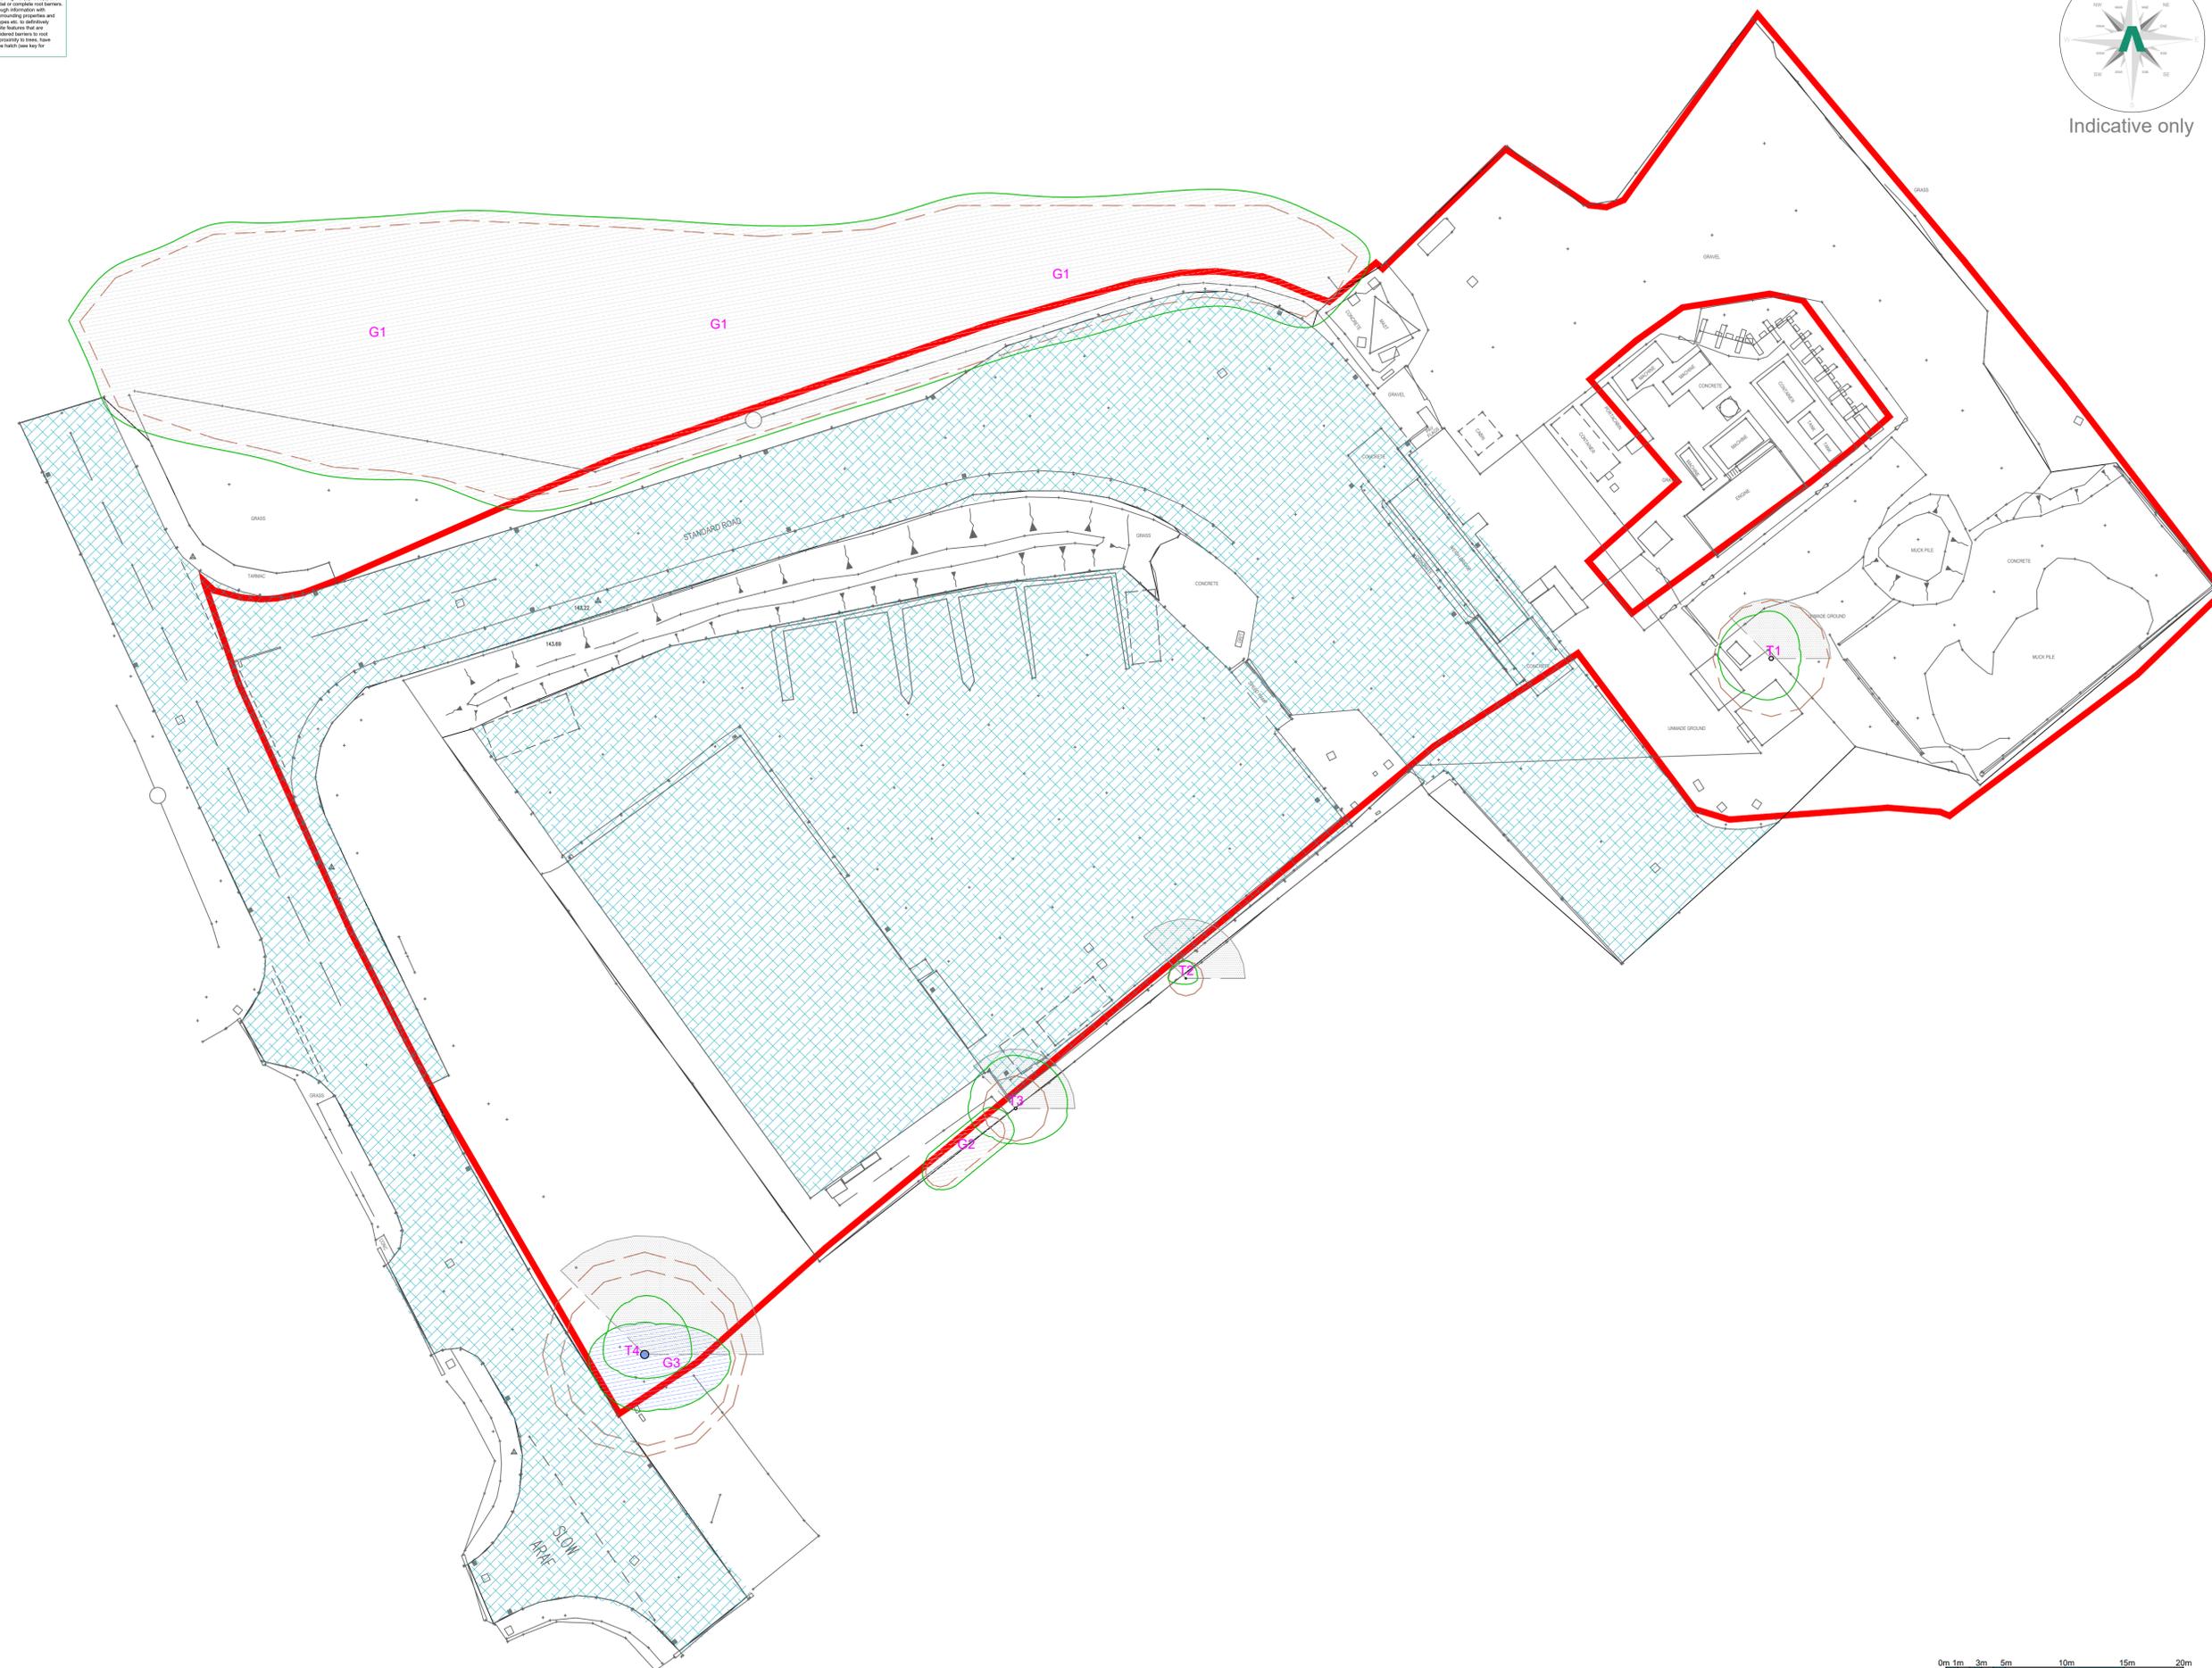
Drawing: **Tree Constraints Plan**

Note: Existing buildings, retaining walls, roads and structures are likely to be partial or complete root barriers. This drawing is not based on thorough observation with regard to the existing and surrounding properties and structures, foundations, soil types etc. to definitively determine the root barriers. Site features that are significant enough to be considered barriers to root development, irrespective of proximity to trees, have been identified with a light blue hatch (see key for details).

In order to avoid damage to the roots or rooting environment of retained trees, the Root Protection Areas (RPAs) should be plotted around each of the category 'A', 'B' and 'C' trees. This is a minimum area in m<sup>2</sup> which should be left undisturbed around each retained tree.

The calculated RPA is capped to 707m<sup>2</sup>, which is the equivalent to a circle with a radius of 15m. Where there appears to be restrictions to root growth the root protection area is reshaped to more accurately reflect the likely distribution of the roots.

We make the following recommendation to ensure that no conditions relating to arboriculture are attached to any planning consent secured: obtain an arboricultural report to include:

- An arboricultural impact assessment (AIA);
- An arboricultural method statement (AMS); and
- A tree protection plan (TPP).
