# Flood & Water Management Act 2010

## Section 19 Flood Investigation Report FI0087

Location: Bretton, Flintshire  
Incident Date: October 2023

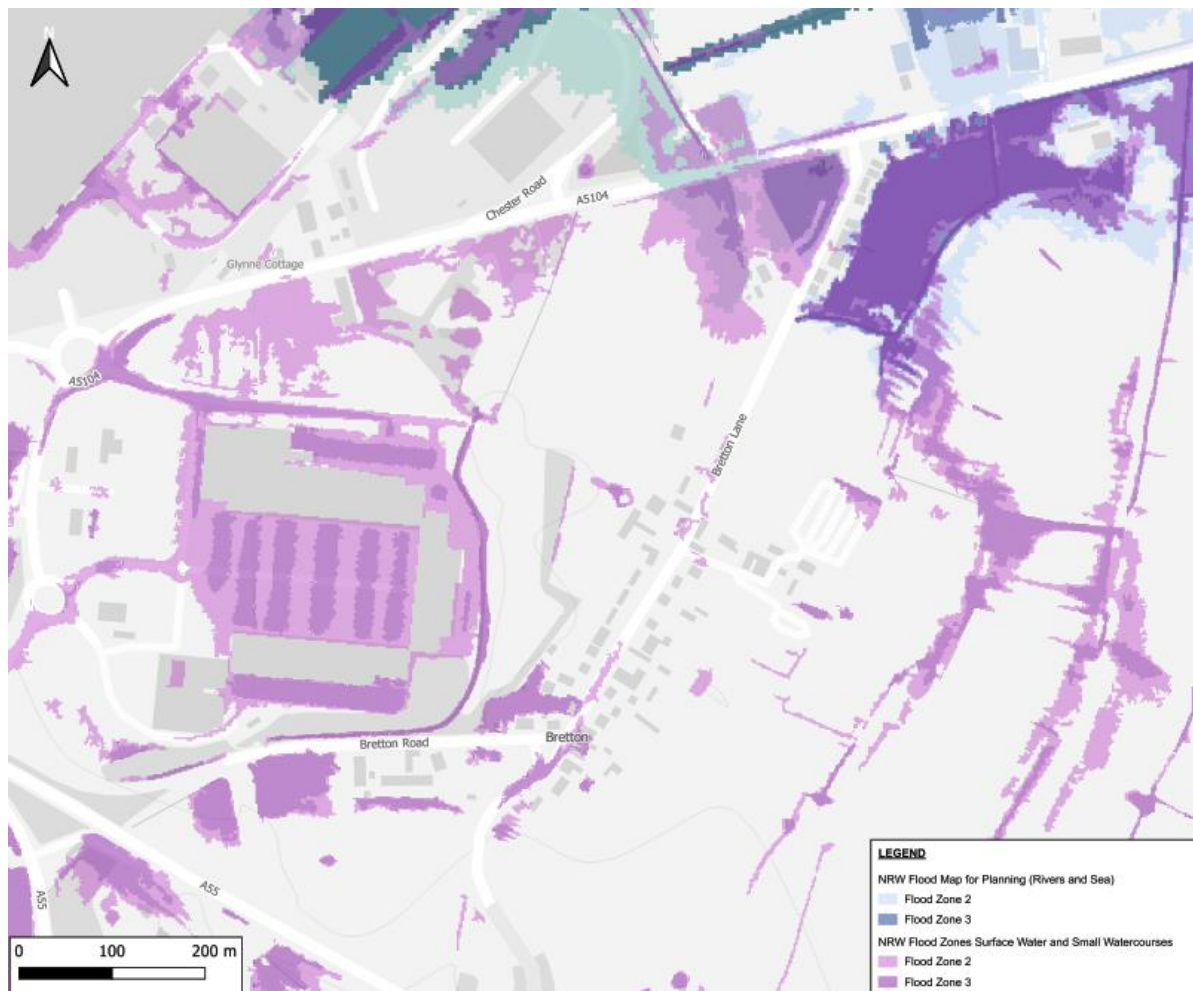
**Figure 6 - NRW Flood Map for Planning – Rivers, Sea, Surface Water and Small Watercourses Map**

- 3.7 The NRW 'Flood Map for Planning – Rivers and Sea' (shown in Figure 6) shows that a number of the properties in Bretton are located in Flood Zone 3 – defined as having a 1% or greater annual probability of flooding, including the effects of climate change.
- 3.8 The NRW 'Flood Map for Planning – Surface Water and Small Watercourses' identifies areas where surface water may flow or pool during heavy rainfall. The NRW map (shown in Figure 6) shows that a number of properties in Bretton are located in Flood Zone 3. Further maps are contained within Appendix F.

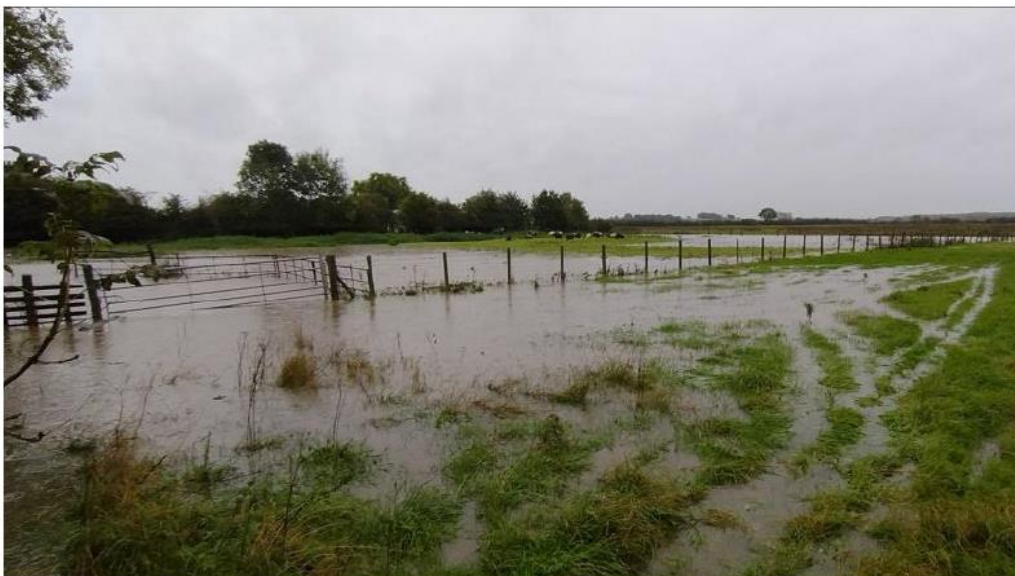
| Photo No.1 | |

| Description:<br>Flooding to fields<br>adjacent to Bretton<br>Lane<br><br>Source: Local Resident | |

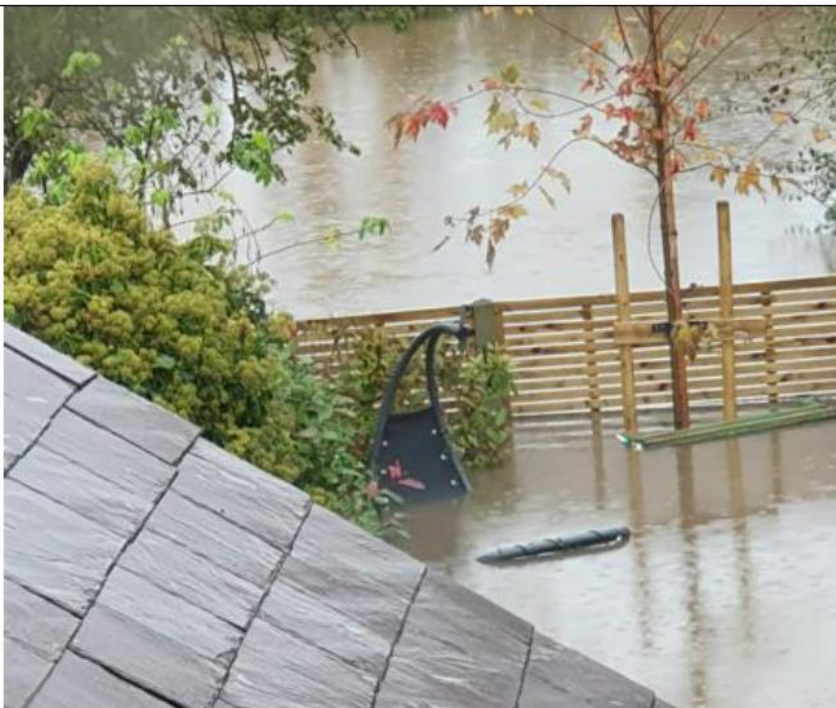
| Photo No. 2 | |

| Description:<br>External Flooding to a<br>property along Chester<br>Road<br><br>Source: Local Resident | |

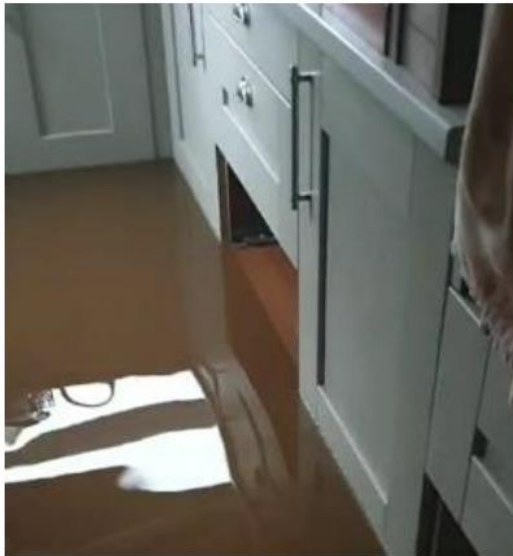
| Photo No.3 | |

| <p>Date: 20<sup>st</sup> October 2023</p> <p>Description:<br/>Internal Flooding to a property along Chester Road</p> <p>Source: Local Resident</p> | |

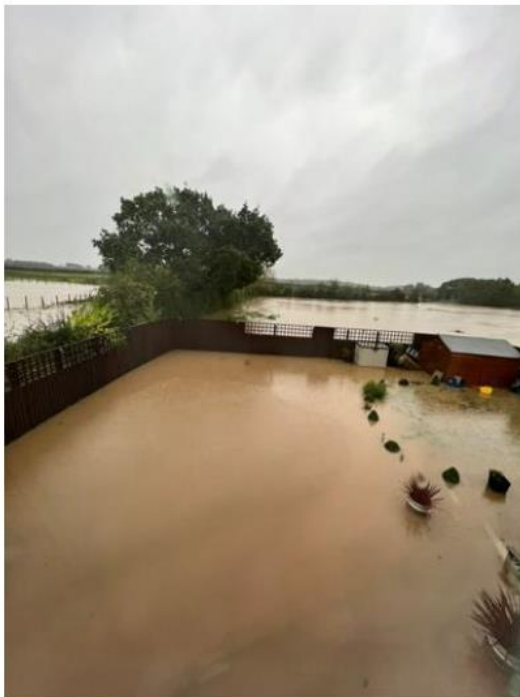
| Photo No. 4 | |

| <p>Date: 20<sup>st</sup> October 2023</p> <p>Description:<br/>External flooding to a property along Chester Road</p> <p>Source: Local Resident</p> | |

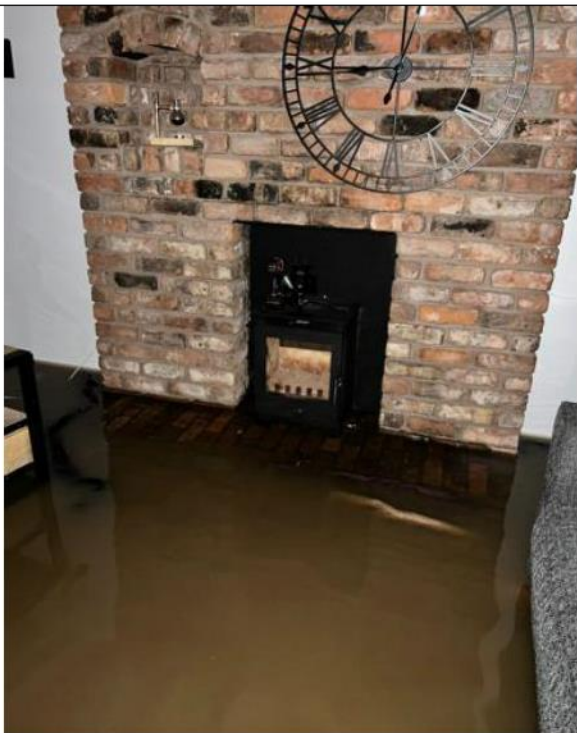
| Photo No. 5 | |

| <p>Description:<br/>Internal flooding at a property along Chester Road</p> <p>Source: Local Resident</p> | |

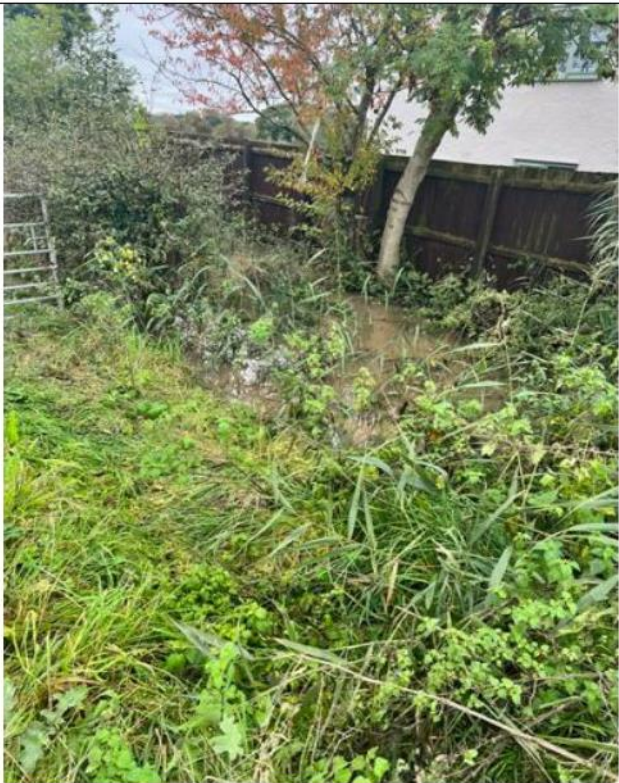
| Photo No. 6 | |

- 4.3 It was reported by local residents that flooding also came from the watercourse (designated Main River) located immediately east and south-east of properties south of Chester Road. This report is anecdotal and there is no other evidence that this is the case, and it is not obvious that this is the source of flooding on inspection. Although vegetation clearance has now taken place, it was reported that at the time of Storm Babet, the watercourse channel was overgrown and was therefore unable to cope with the increased volume of water.

| <p>Description:<br/>Overgrown vegetation along the watercourse adjacent to properties on Chester Road.</p> <p>Source: Local Resident</p> | |

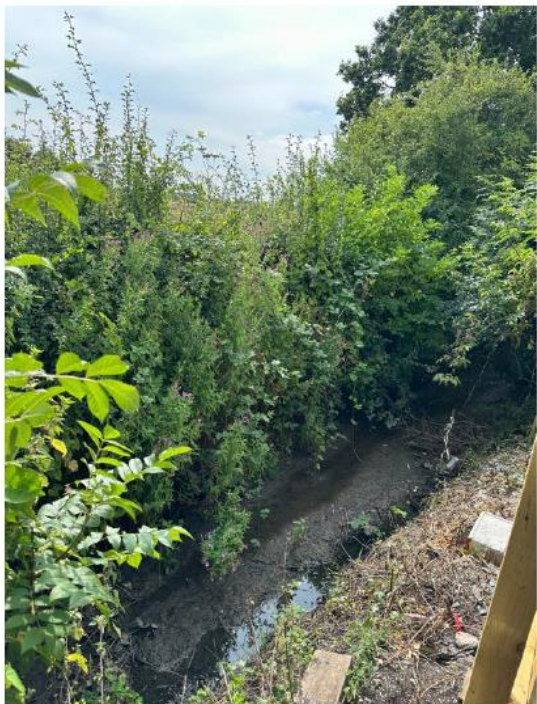
| Photo No. 7 | |

| <p><b>Description:</b><br/>The same watercourse as Photo 6, but after channel clearance had taken place.</p> <p><b>Source:</b> Waterco Site Visit</p> | |

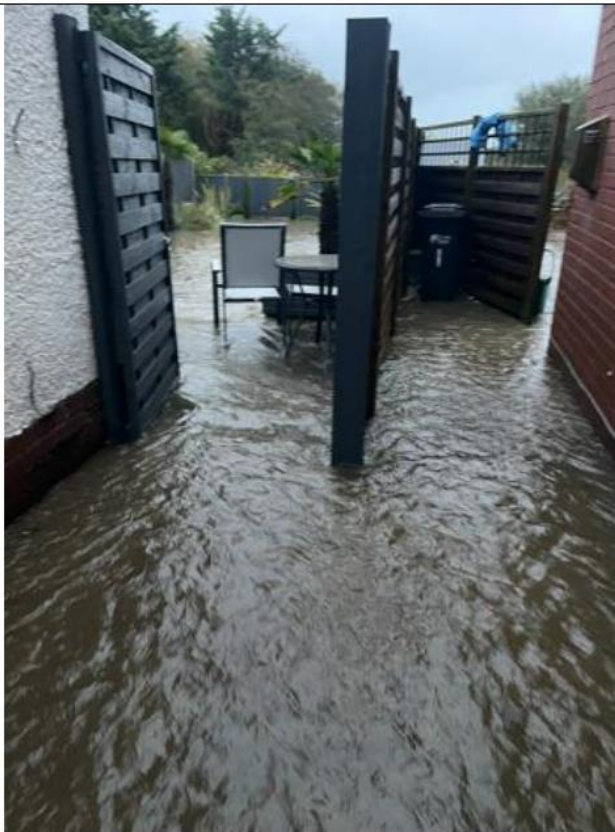
| Photo No. 8 | |

| <p><b>Description:</b><br/>Flood water flowing from Bretton Lane to the rear gardens of multiple properties during Storm Babet.</p> <p><b>Source:</b> Local resident</p> | |

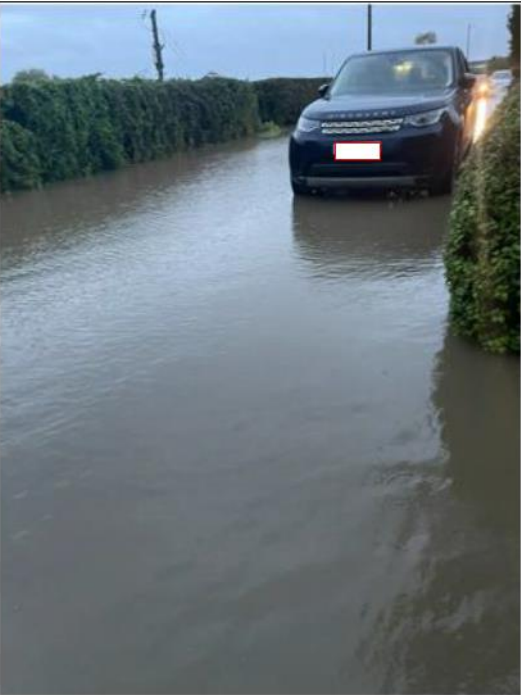
| Photo No. 9 | |

| <p>Description:</p> <p>Surface water build up along Bretton Lane during Storm Babet.</p> <p>Source: Local resident</p> | |
