# Flood & Water Management Act 2010

## Section 19 Flood Investigation Report FI0086

Location: Broughton, Flintshire

Incident Date: October 2023

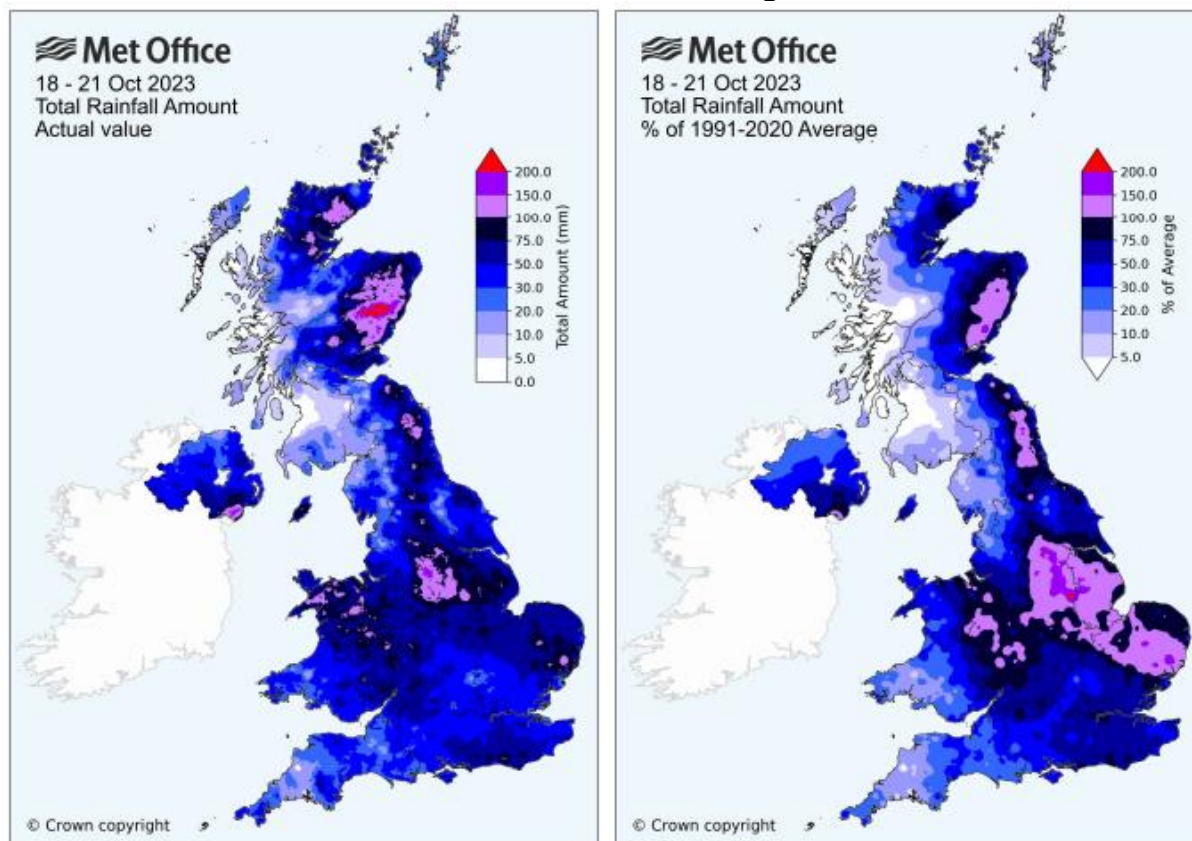
**Figure 1 - Met Office Accumulated Daily Rainfall 18th-21st of October 2023**

- 2.1 Storm Babet brought heavy and persistent rainfall across much of the UK and 'was the third-wettest independent 3-day period for England and Wales in a series from 1891' according to the Met Office<sup>2</sup>. As shown in Figure 1, many parts of the UK received over 50mm of rain, with 75-100mm of rain recorded across areas of North Wales. Several areas across the UK received over 100% of the average rainfall amount for October.

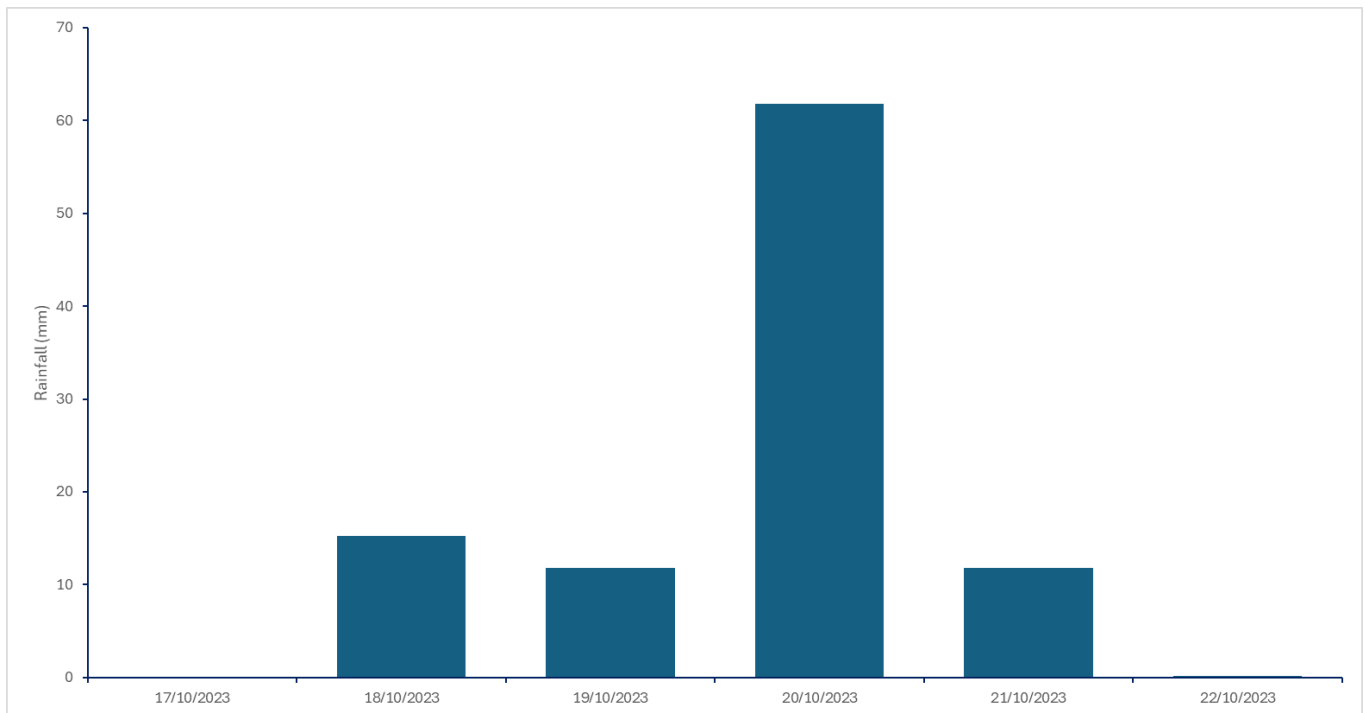
**Figure 2 - NRW Mold Rain Gauge - Daily Rainfall From 18th-21<sup>st</sup> October**

- 2.5 Figure 2 shows the rainfall in the days leading up to the flooding on the 20<sup>th</sup> October. Flintshire experienced rainfall two days prior to the 20<sup>th</sup> October, with 15.2mm of rainfall on the 18<sup>th</sup> and 11.8mm on the 19<sup>th</sup>. On 20<sup>th</sup> October, Mold rain gauge recorded 61.8mm of rainfall.

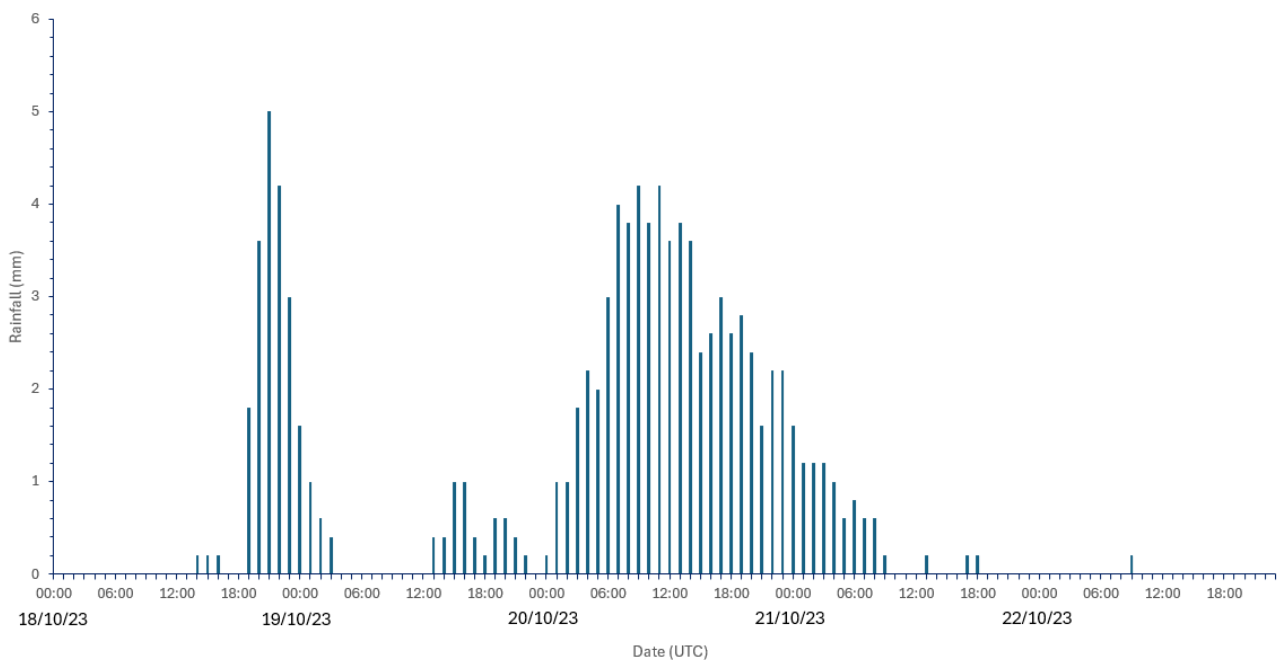
**Figure 3 - Hourly rainfall between the 18th and 22nd of October**

- 2.6 Figure 3 shows that there was a period of intense rainfall on Wednesday the 18<sup>th</sup> October which began at 19:00pm and peaked between 21:00-22:00 with 5mm of rainfall per hour. There was some additional rainfall on Thursday the 19<sup>th</sup> October peaking at approximately 1mm per hour. During 20<sup>th</sup> October, rainfall was prolonged with peak rainfall intensities at approximately 4.2mm per hour.

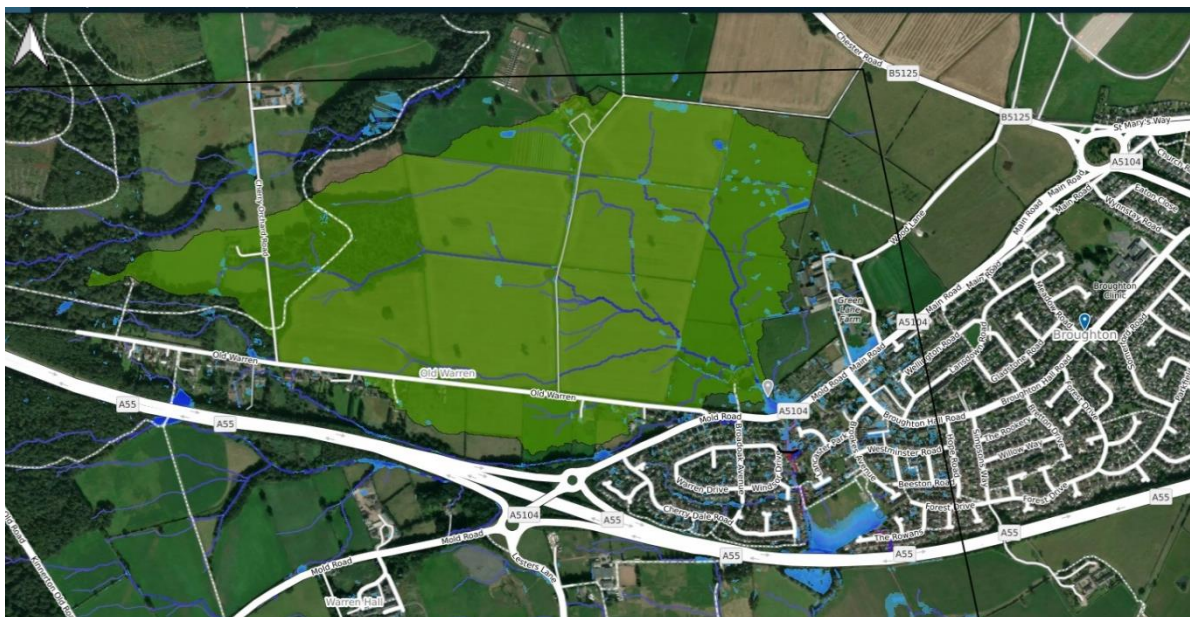
**Figure 5 – Contributing Watercourse Catchment**  
(source: SCALGO)

- 3.5 The catchment area of the unnamed watercourse covers approximately 0.9km<sup>2</sup>. Figure 5 shows the approximate catchment area generated using Scalgo software<sup>5</sup>. The catchment area may be larger than that shown in Figure 5 should highway runoff from the A55 be drained towards the Mold Road culvert. A review of detailed Ordnance Survey mapping suggests that there are drains (watercourses) orientating from the A55 west of Broughton, towards the Broughton area and the Mold Road culvert. Detailed survey, including a review of the drainage system serving the A55, would be required to establish the exact catchment area.

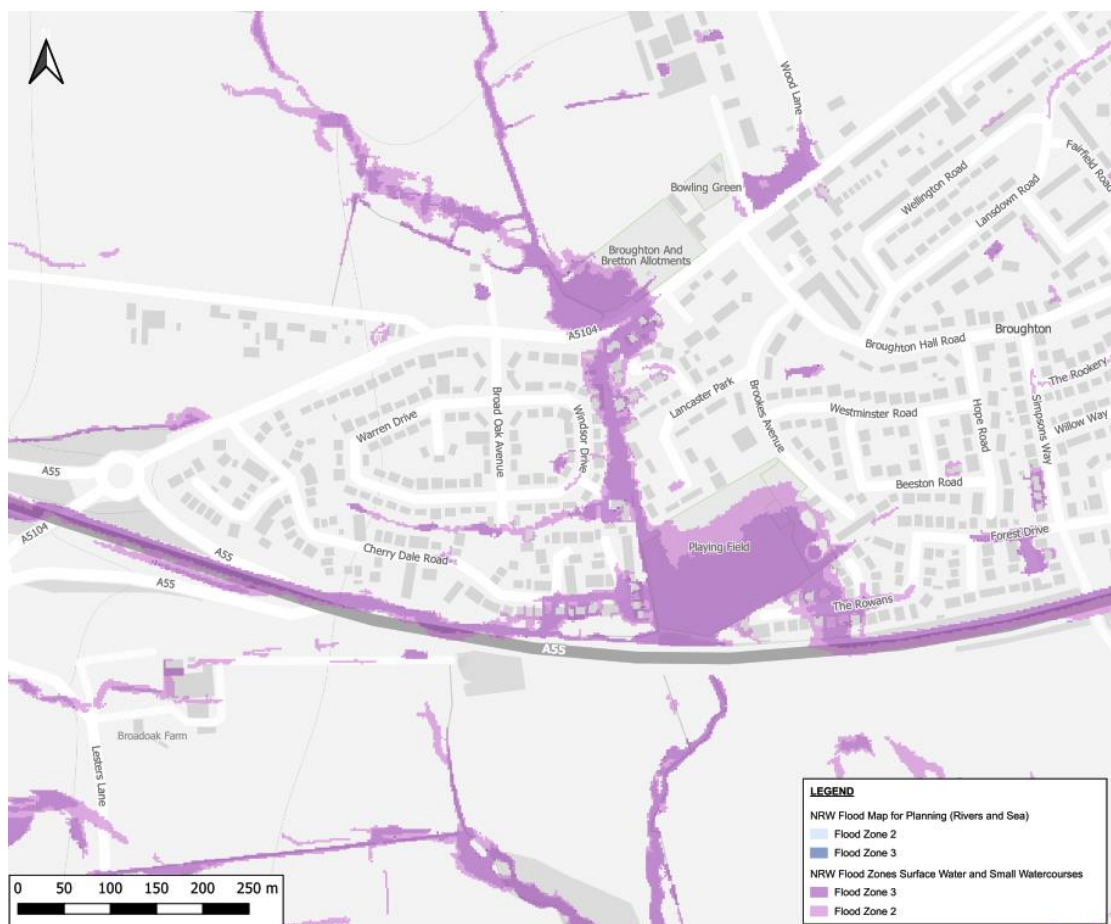
**Figure 6 - NRW Flood Map for Planning, Rivers and Sea, Surface Water and Small Watercourses Map**

- 3.8 The NRW 'Flood Map for Planning – Rivers, Surface Water and Small Watercourses' map (shown in Figure 6 and Appendix D) identifies the flood risk associated with small watercourses such as the unnamed watercourse which flows south through Broughton. The NRW map shows that a number of the properties / streets in Broughton are located in Flood Zones 2 and 3. Flood Zone 2 is defined as an area with between a 0.1% and 1% chance of flooding from surface water and / or small watercourses in any given year, including the effects of climate change. Flood Zone 3 is defined as an area with a greater than 1% chance of flooding from surface water and / or small watercourses in any given year, including the effects of climate change.

- 3.10 NRW mapping shows that once the Mold Road culvert exceeds its capacity, flood flows are stored upstream of the culvert inlet before reaching a sufficient height to spill onto Mold Road. Flooding disperses south of Mold Road. The NRW mapping also shows that flooding could occur upstream of the A55 culvert should the culvert exceed its capacity.
