# Flood and Water Management Act 2010

## Section 19 Flood Investigation Report FI0084/A

Location: Mold, Flintshire  
Incident Date: October 2023

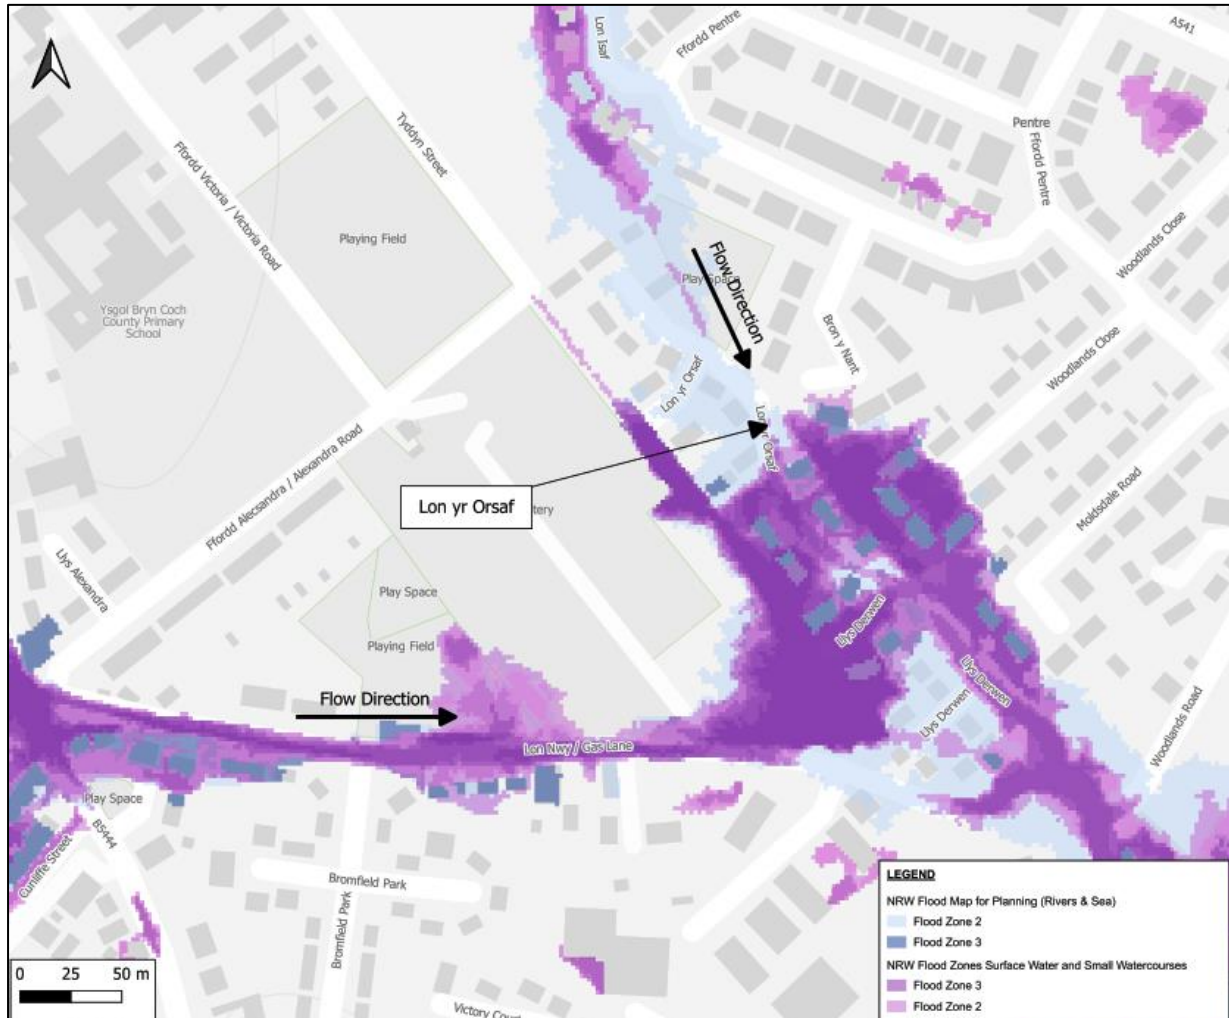
**Figure 26 - NRW Flood Map for Planning – Rivers, Sea, Surface Water and Small Watercourses Map at Lon yr Orsaf**

- 3.28 NRW Mapping shown in Figure 26 shows a large area of flooding across and surrounding Lon yr Orsaf, with the sources being from rivers, small watercourses and surface water. Flooding appears to occur along the route of the culverted watercourse which runs directly through Lon yr Orsaf, as well as surface water and small watercourse flooding which pools in the land to the east and west of the area.

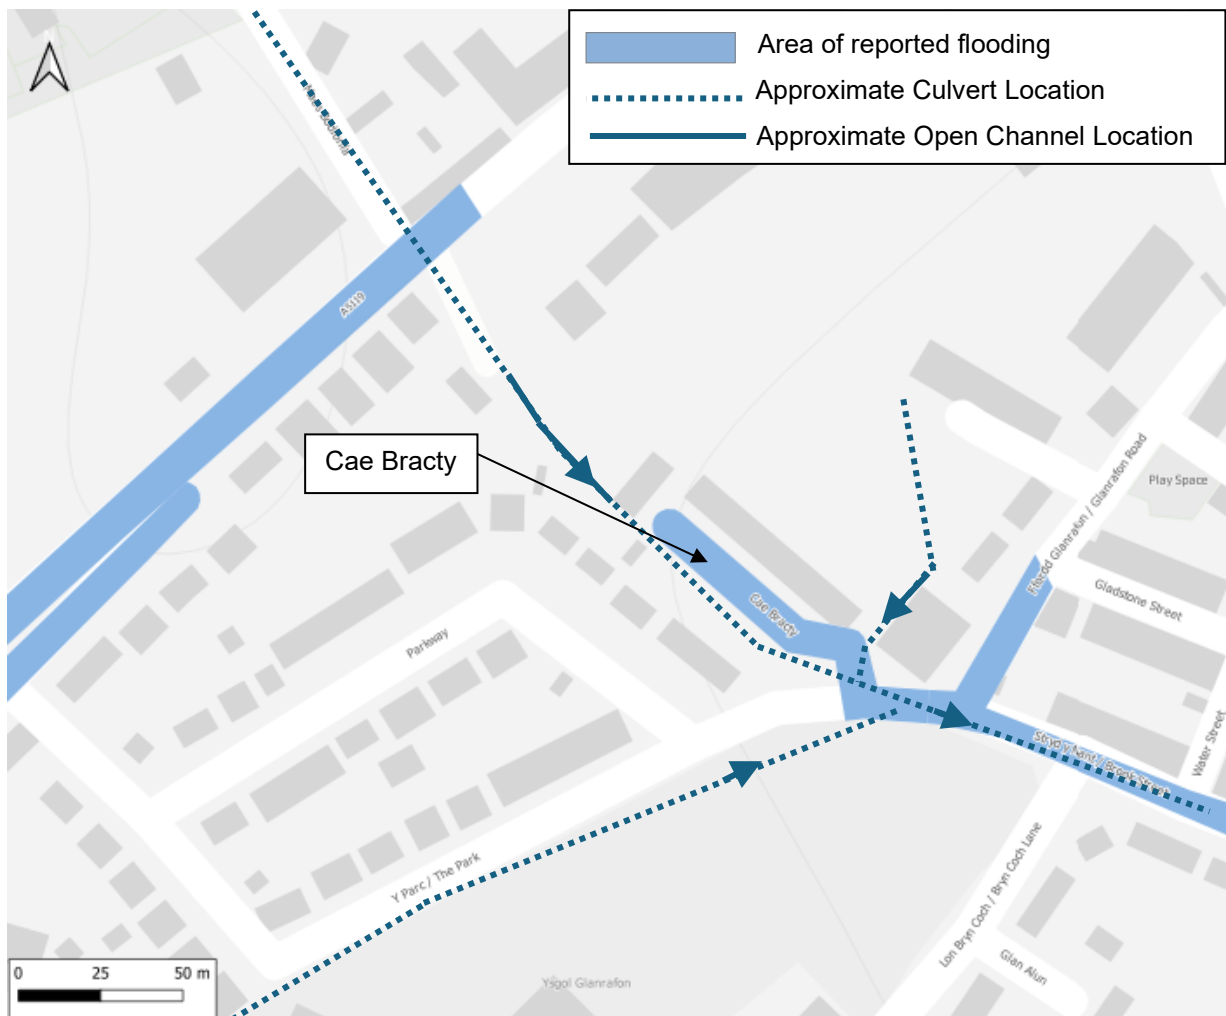
**Figure 30 - Cae Bracty**  
Contains OS Data © Crown Copyright (2024)

- 4.15 Based on the findings of the community engagement exercise and stakeholder engagement, the reported source of flooding was from an exceedance of the culverted watercourse which flows directly through Cae Bracty. Surcharging of surface water from a chamber on the culverted watercourse was reported on Brook Street where 3no. culverted watercourses combine, as well as surface water which is unable to drain into the culvert. Surface water flooding is also reported to flow into Cae Bracty from the car park to the north-east of Cae Bracty.
- 4.16 There were reports that all ground floor properties were flooded, however residents were relocated following a previous flooding event in 2021. Figure 30 provides a summary of the reported flooding.

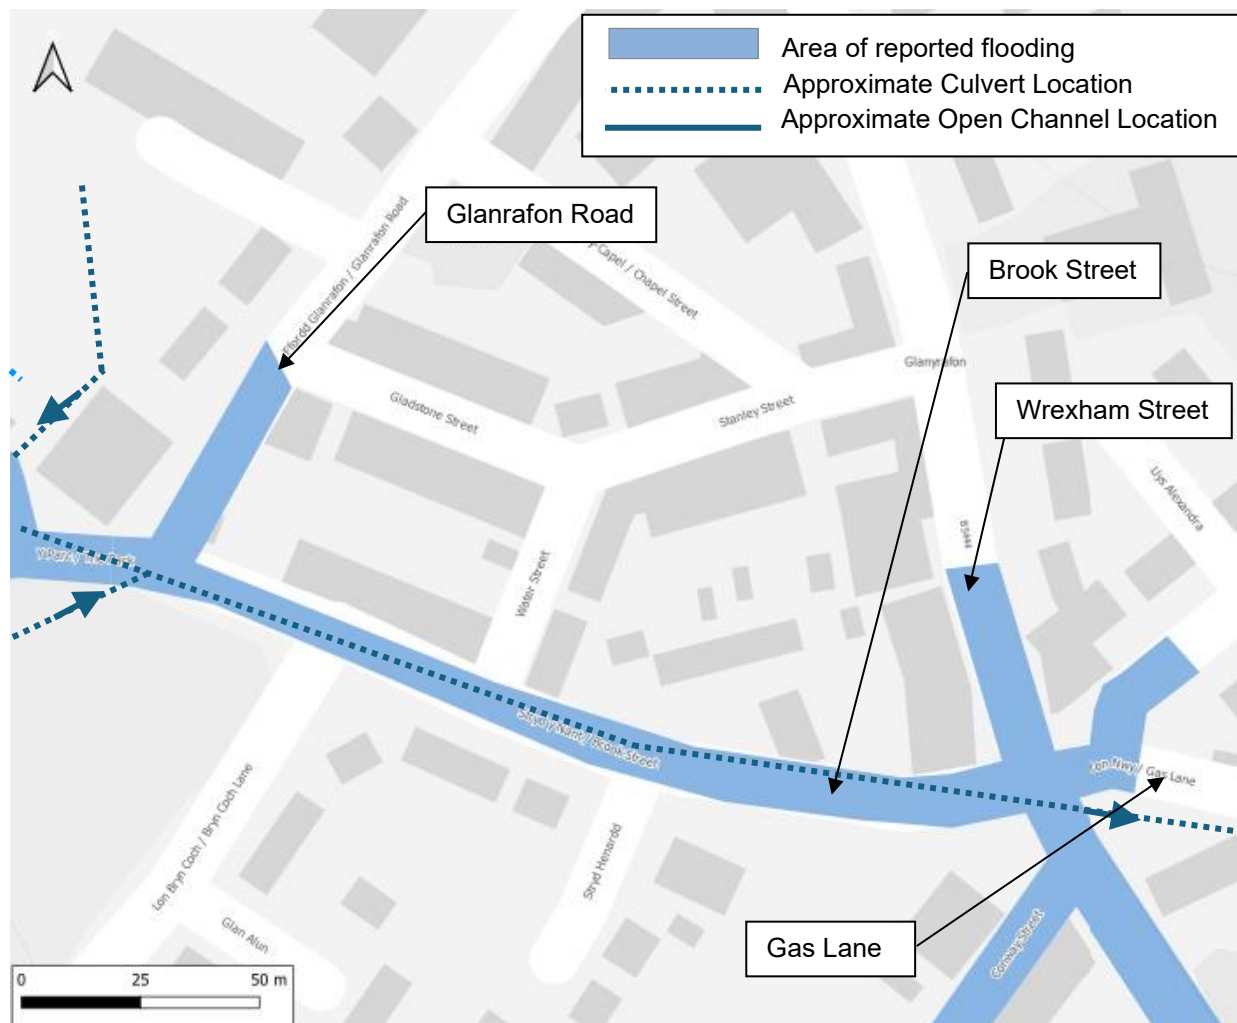
**Figure 31 - Brook Street and Wrexham Street**

- 4.19 There were reports of water flowing out of the culvert manhole cover at the junction of Brook Street and Glanrafon Road.
- 4.20 Properties on Wrexham Street were reportedly affected by flood flows which entered basements to a depth of around 1200mm.

| Ref | Stakeholder | Action |
|---|---|---|
| 02 | FCC Highways Authority | Post event undertake a CCTV condition survey of the Brook Street culvert confluence to ensure the culvert is free of blockage and any significant siltation. Take remedial action as required. |

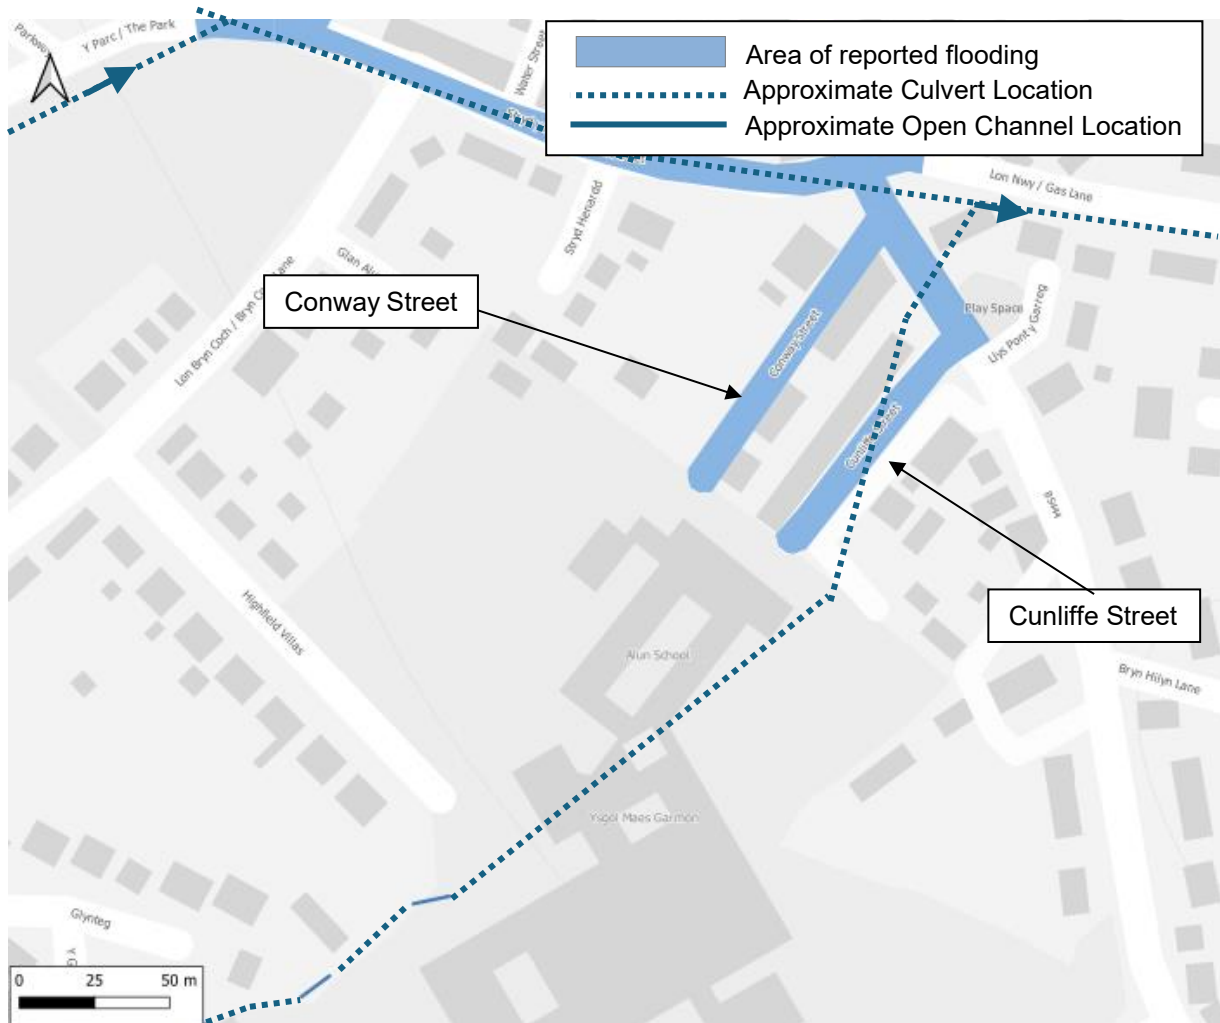
**Figure 32 - Conway Street and Cunliffe Street**  
Contains OS Data © Crown Copyright (2024)

- 4.22 Based on the findings of the community engagement exercise and stakeholder engagement, the reported source of flooding was from an exceedance of the culverted watercourse beneath Cunliffe Street (linked with the flooding on Brook Street and Wrexham Road). It is anticipated that flows overtop a culvert to the southwest of Cunliffe Street within the grounds of Ysgol Maes Garmon and Alyn School.
- 4.23 There were reports that basements were flooded on both Conway Street and Cunliffe Street.
- 4.24 Figure 32 provides a summary of the reported flooding.

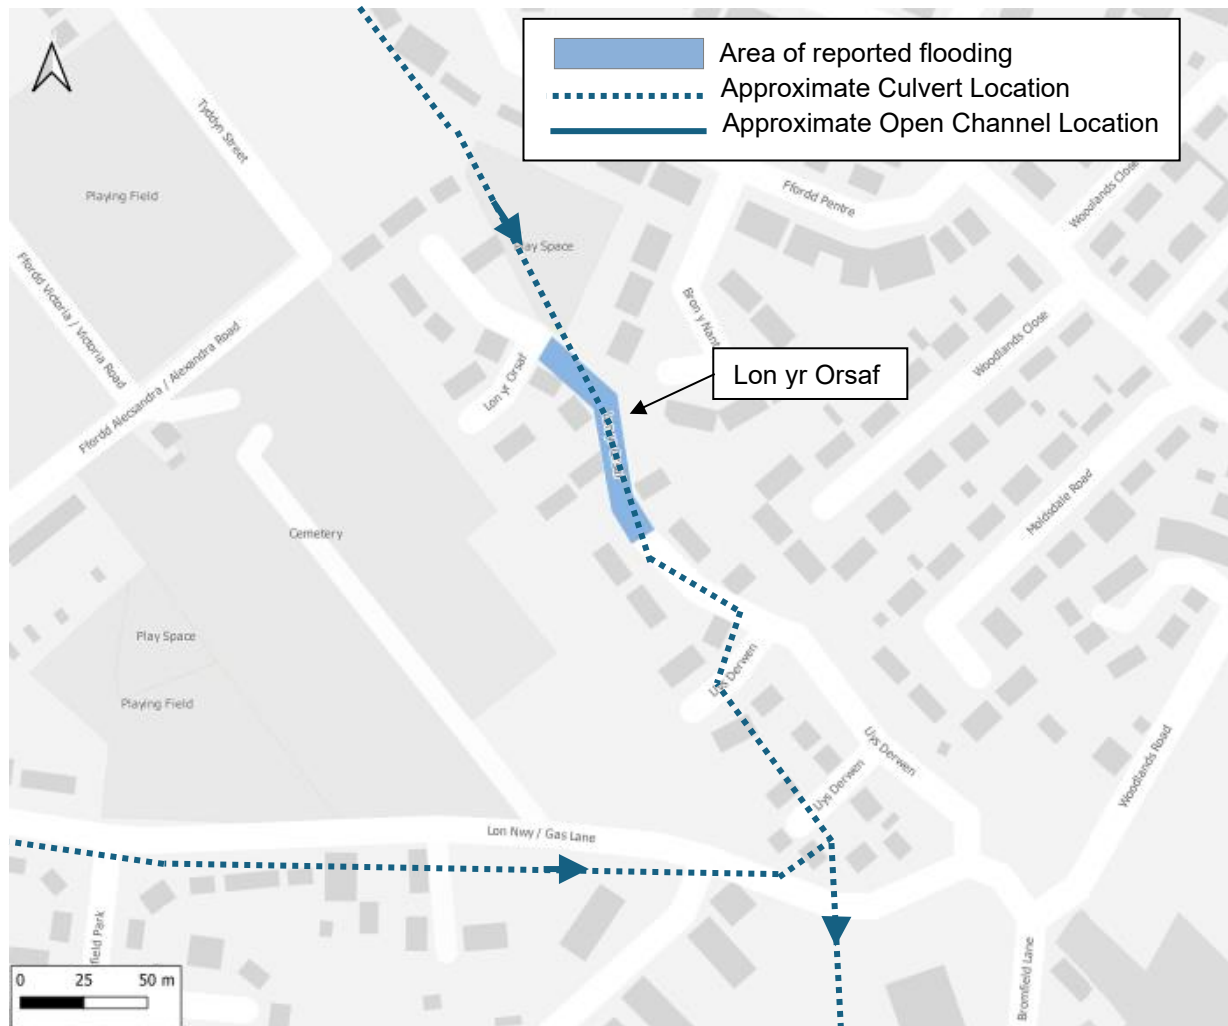
**Figure 33 - Lon yr Orsaf**  
Contains OS Data © Crown Copyright (2024)

4.25 Based on the findings of the community engagement exercise and stakeholder engagement, the reported source of flooding was from an exceedance of the culverted watercourse which flows east beneath Gas Lane. Flood flows are reported to pool in an area of public open space north of Gas Lane and west of Lon yr Orsaf. Flooding in the area of open space reached a sufficient level to flood Lon yr Orsaf.

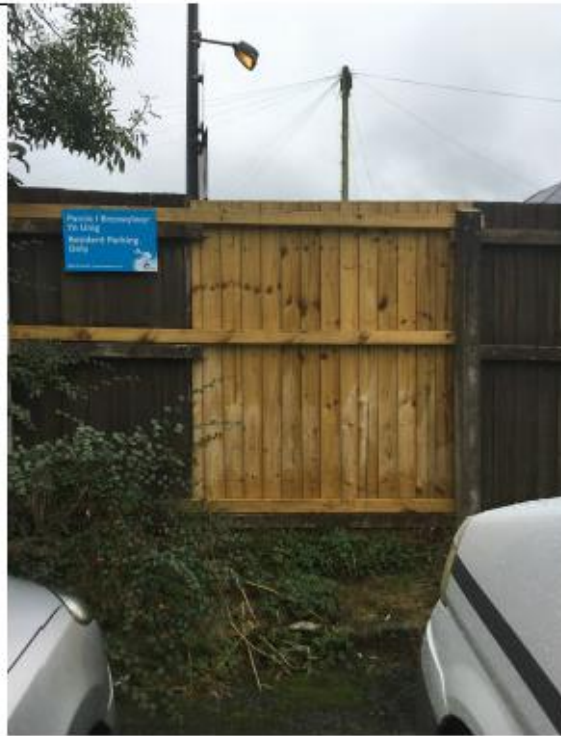
Photo No. 11

Description: Fence that was reported to have been replaced on Maes y March following reported destruction by flood flows during Storm Babet
