# Flood & Water Management Act 2010

## Section 19 Flood Investigation Report FI0089

Location: Pontblyddyn, Mold

Incident Date: October 2023

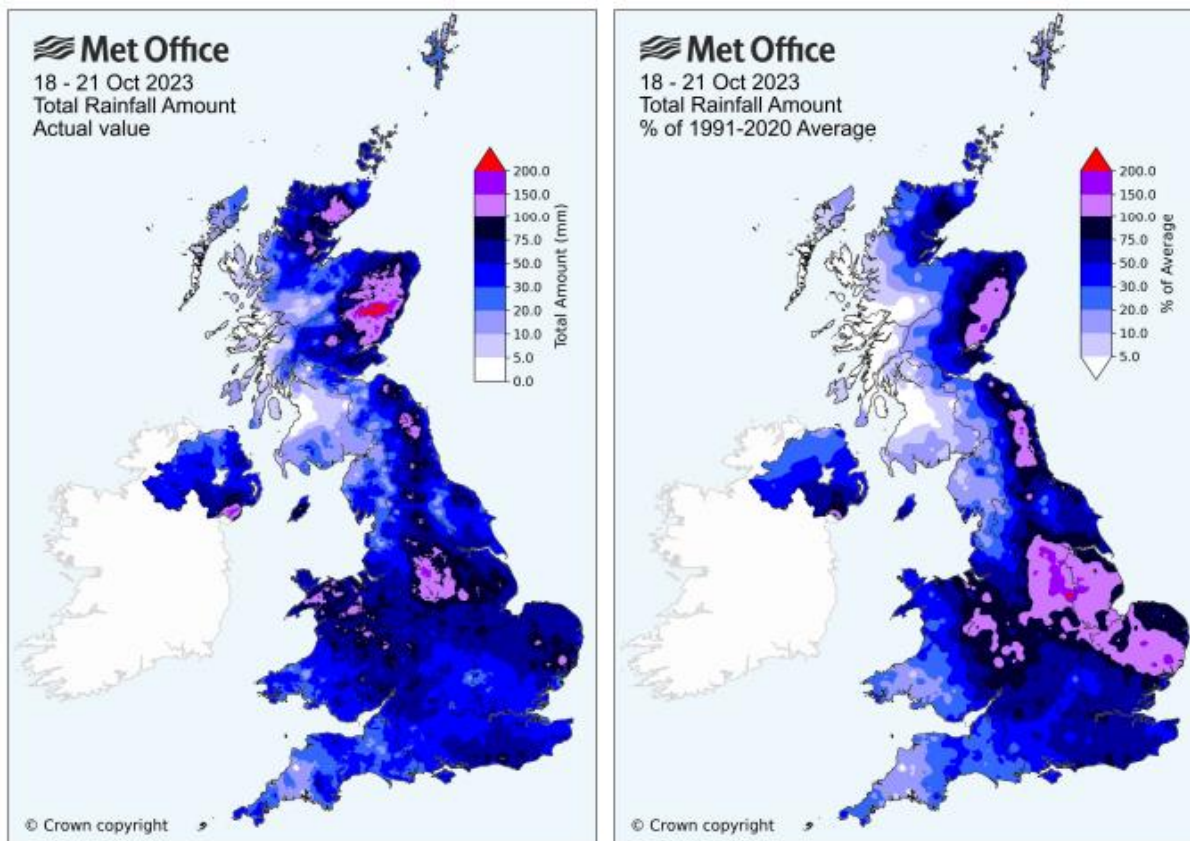
**Figure 1 - Met Office Accumulated Daily Rainfall 18th-21st of October 2023**

- 2.1 Storm Babet brought heavy and persistent rainfall across much of the UK and 'was the third-wettest independent 3-day period for England and Wales in a series from 1891' according to the Met Office<sup>2</sup>. As shown in Figure 1, many parts of the UK received over 50mm of rain, with 75-100mm of rain recorded across areas of North Wales. Several areas across the UK received over 100% of the average rainfall amount for October.

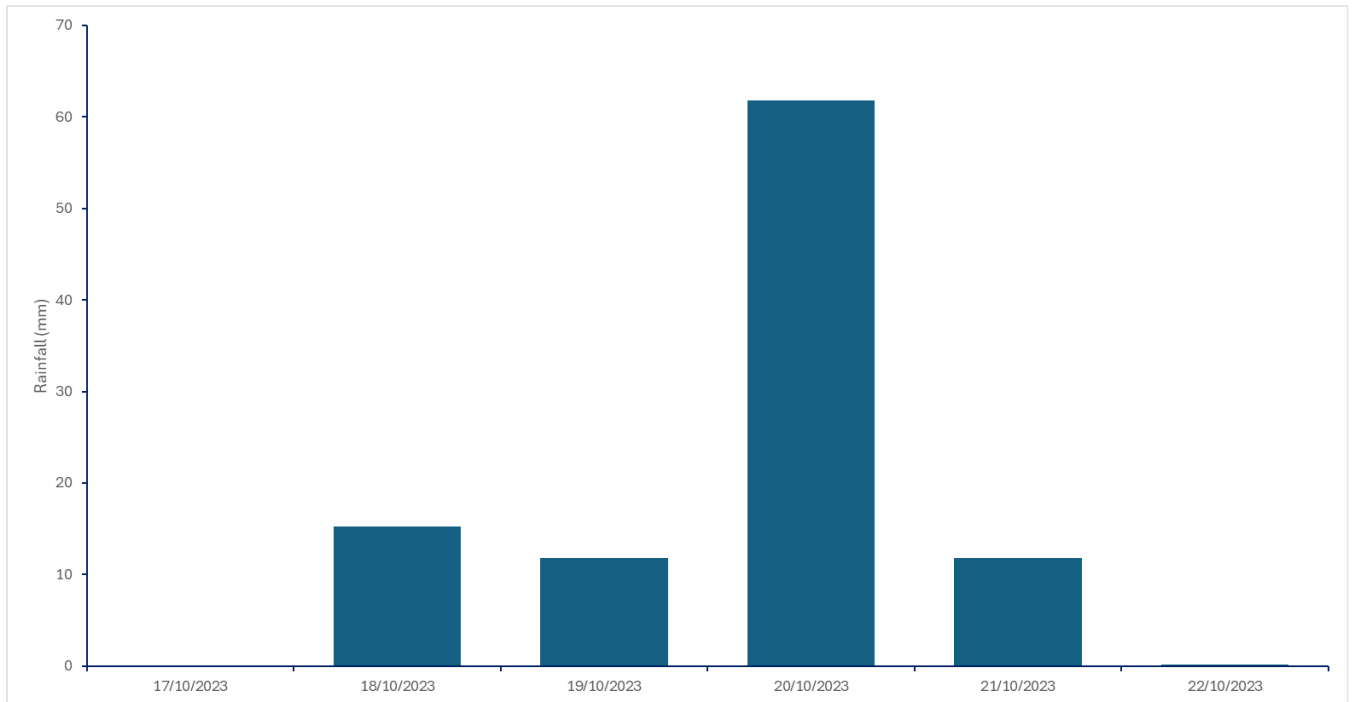
**Figure 2 - NRW Mold Rain Gauge - Daily Rainfall From 18th-21<sup>st</sup> October**

- 2.2 Unlike most storms, Storm Babet did not pass over rapidly. This allowed multiple fronts to add more rainfall over a prolonged period of time. The evapotranspiration rate in October was low and rainfalls were frequent throughout the month, with high levels of antecedent rainfall on October 13<sup>th</sup> / 14<sup>th</sup> (27mm in Mold) leading to soils being close to saturation.
- 2.3 Rainfall records have been obtained from NRW's Mold rain gauge<sup>3</sup>.
- 2.4 Figure 2 shows the rainfall in the days leading up to the flooding on the 20<sup>th</sup> of October. Flintshire experienced rainfall two days prior to the 20<sup>th</sup> of October, with 15.2mm of rainfall on the 18<sup>th</sup> and 11.8mm on the 19<sup>th</sup>. On the 20<sup>th</sup> of October, Mold rain gauge recorded 61.8mm of rainfall.

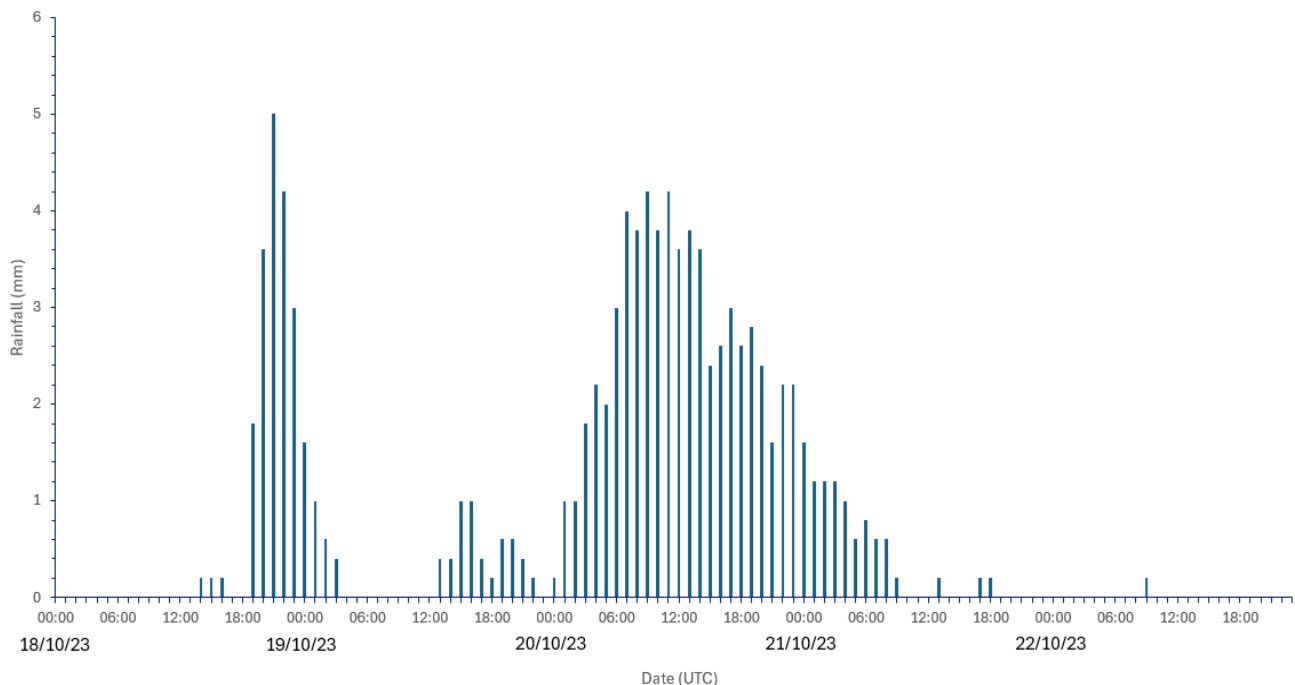
**Figure 3 - Hourly rainfall between the 18th and 22nd of October**

- 2.5 Figure 3 shows that there was a period of intense rainfall on Wednesday the 18<sup>th</sup> of October which began at 19:00pm and peaked between 21:00-22:00 with 5mm of rainfall per hour. There was some additional rainfall on Thursday the 19<sup>th</sup> of October peaking at approximately 1mm per hour. During 20<sup>th</sup> October, rainfall was prolonged with peak rainfall intensities at approximately 4.2mm per hour.

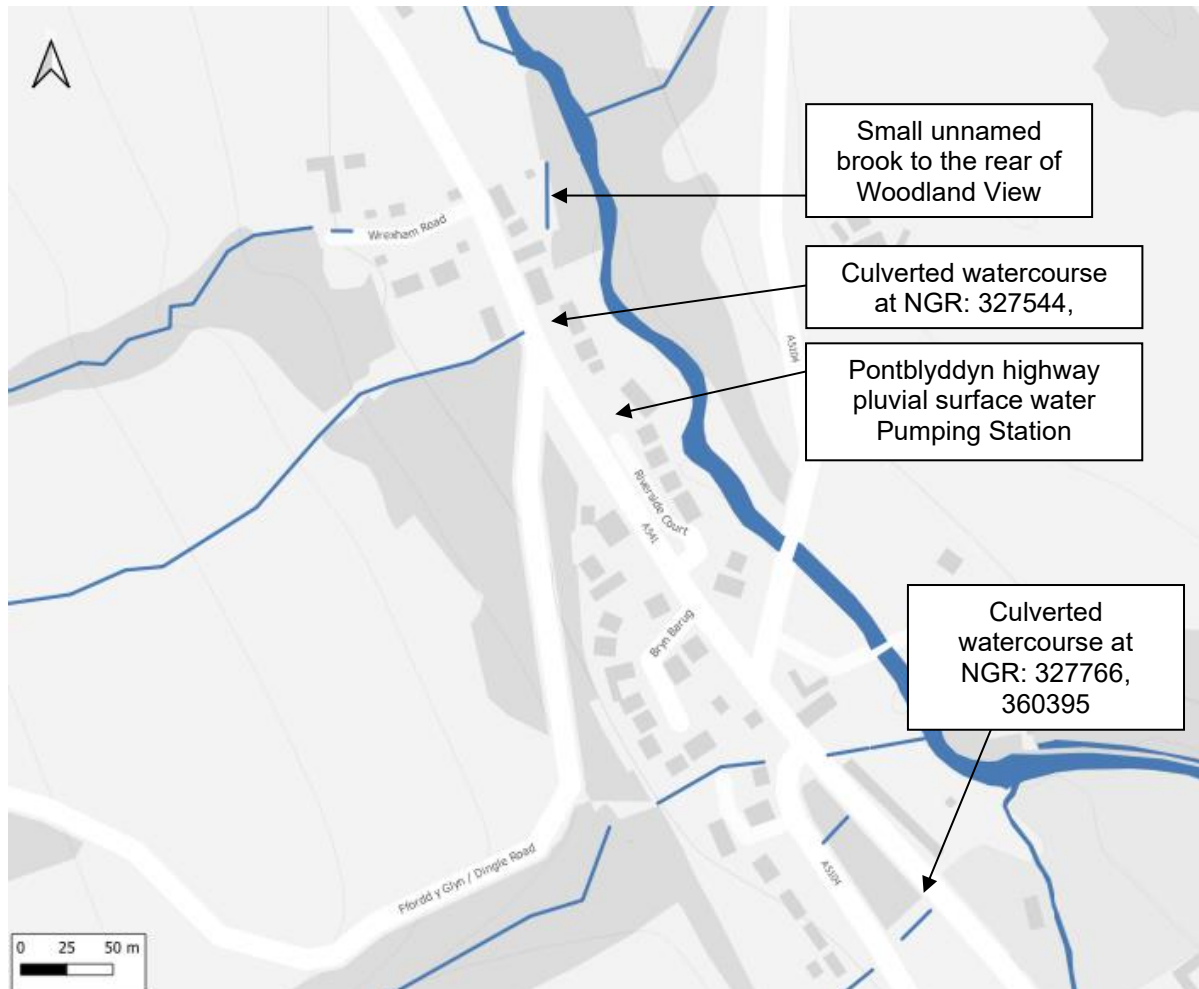
**Figure 5 – Watercourse Map**

There are a number of unnamed watercourses to the West of Pontblyddyn which flow into the River Alyn flowing Southeast. The relevant unnamed watercourses are culverted beneath the A541, Wrexham Road at National Grid Reference (NGR): 327544, 360696 and 327766, 360395. The watercourses and culverts mentioned are shown in Figure 5.

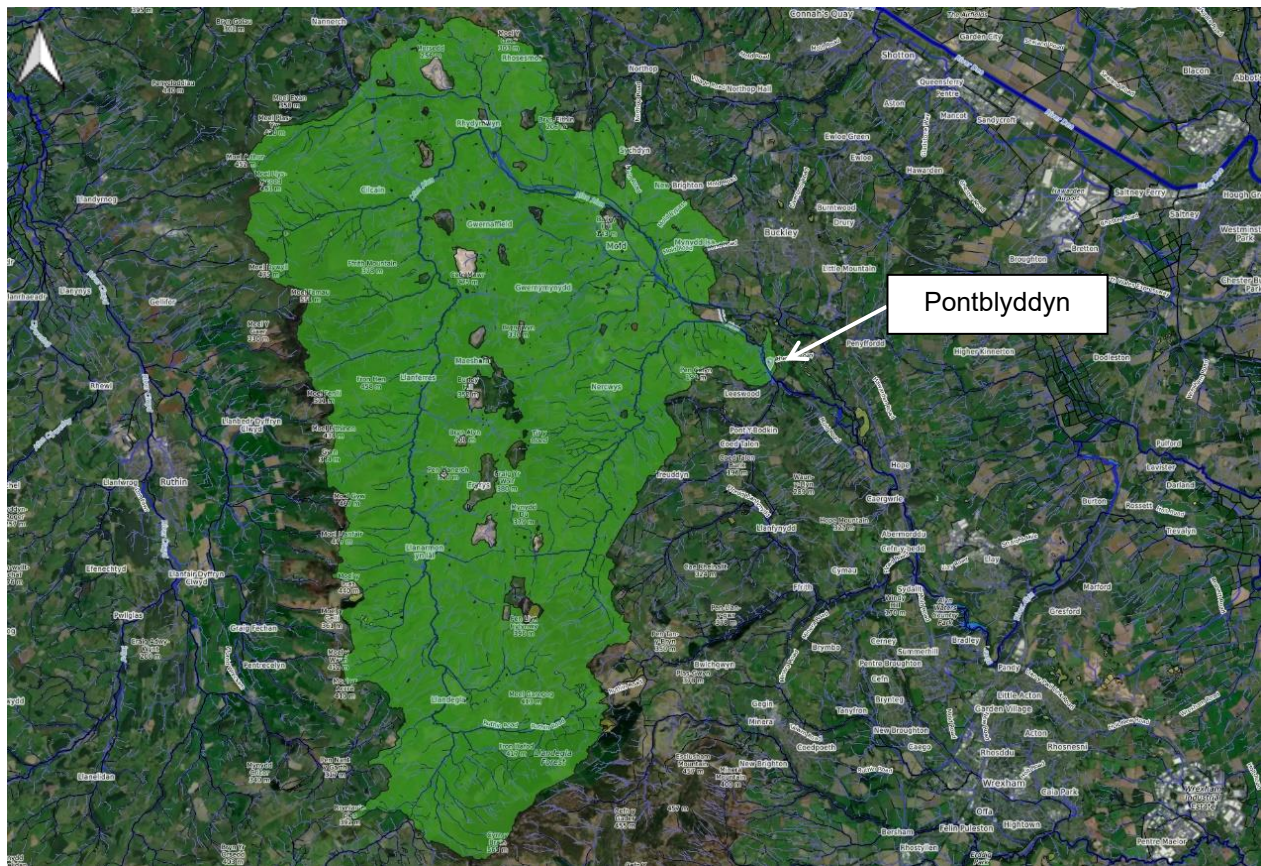
**Figure 6 – Contributing Watercourse Catchment**  
(source: SCALGO)

- 3.3 The catchment area of the River Alyn upstream from Pontblyddyn covers approximately 148.22km<sup>2</sup>. Figure 6 shows the approximate catchment area generated using Scalgo software<sup>5</sup>.
