# Flood & Water Management Act 2010

## Section 19 Flood Investigation Report FI0106

Location: Pontybodkin, Flintshire  
Incident Date: October 2023

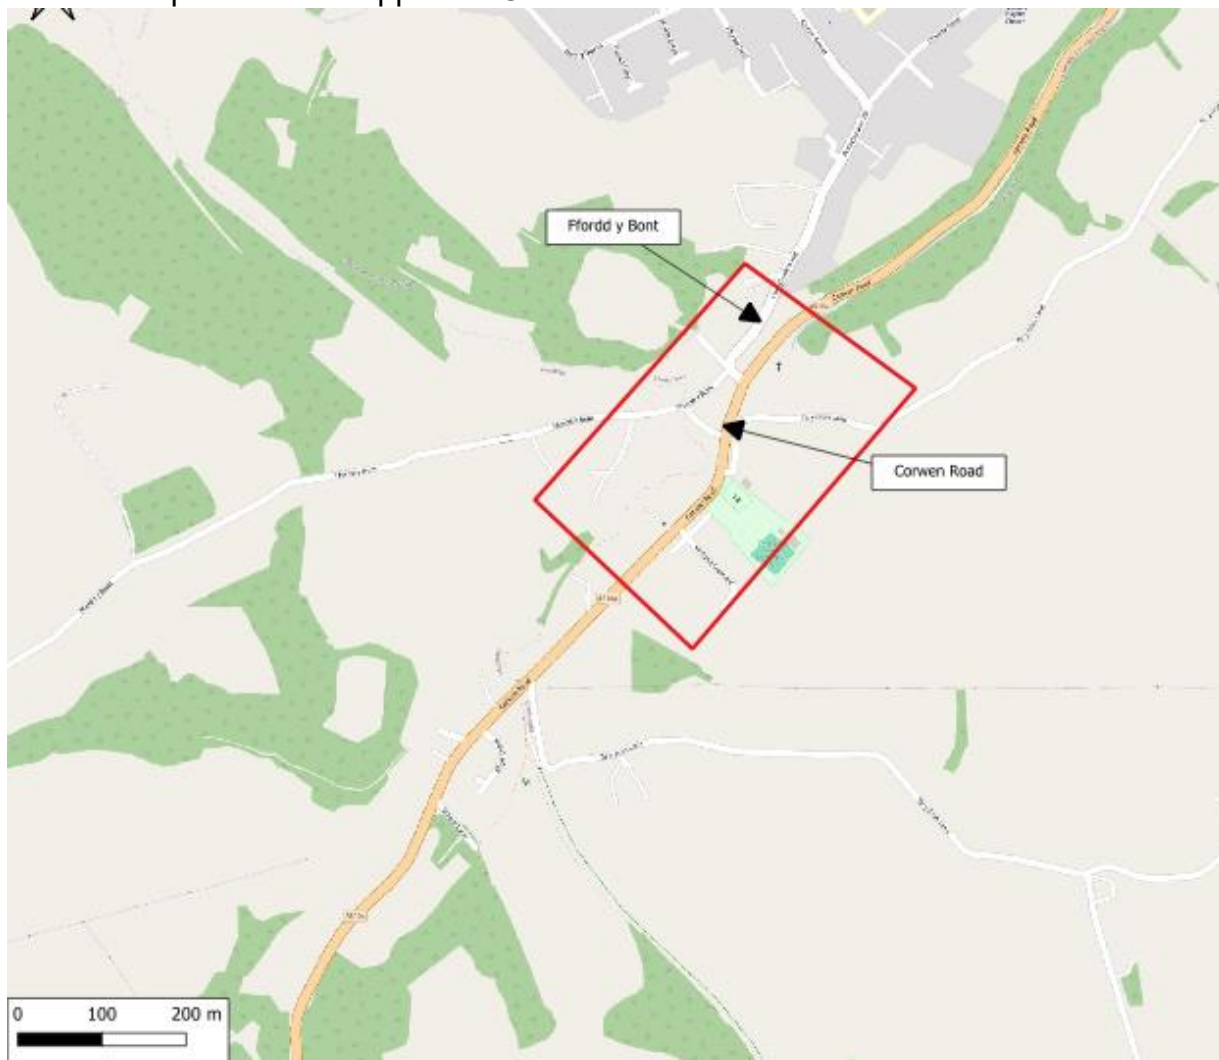
**Figure 4 - Plan of Reported Flooding Areas**  
Contains OS Data © Crown Copyright (2024)

- 3.1 Flooding in Pontybodkin was generally reported on or adjacent to Corwen Road. Figure 4 shows the approximate locations of internal property flooding in Pontybodkin. Figure 4 is also reproduced as Appendix C.

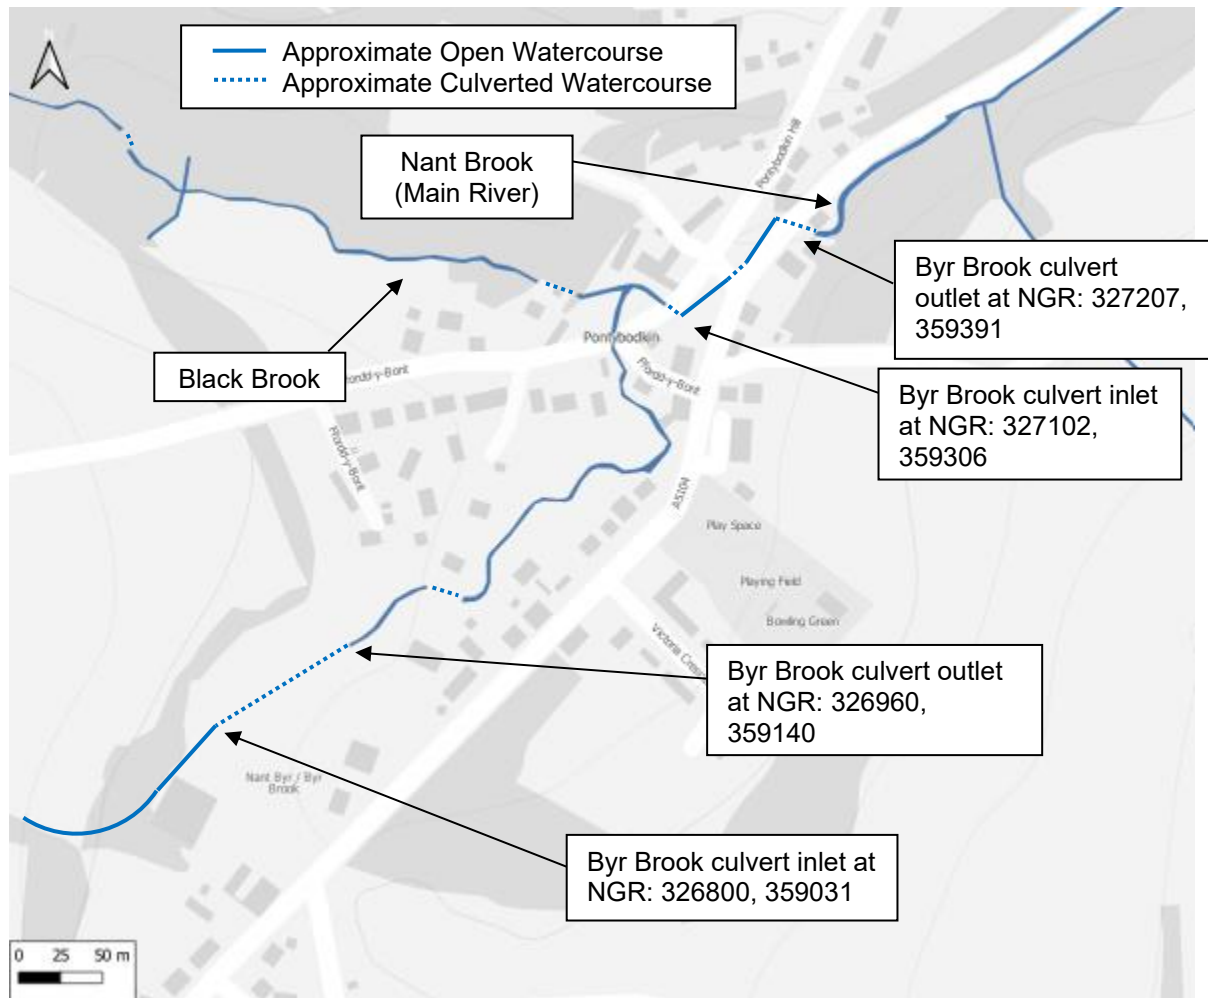
**Figure 5 – Watercourse Map**  
Contains OS Data © Crown Copyright (2024)

- 3.3 'Byr Brook' flows north through Pontybodkin and is culverted in multiple locations including beneath Ffordd y Bont at National Grid Reference (NGR): 327068, 359288. Byr Brook joins 'Black Brook' watercourse at National Grid Reference (NGR): 327173, 359355. Black Brook flows east through Pontybodkin. After joining Byr Brook, the watercourse is culverted beneath Corwen Road where it becomes Main River. Once this becomes Main River it is called the Nant Brook. The watercourses and culverts are shown in Figure 5.
