# Flood & Water Management Act 2010

## Section 19 Flood Investigation Report FI0096

Location: Sandycroft, Flintshire

Incident Date: October 2023

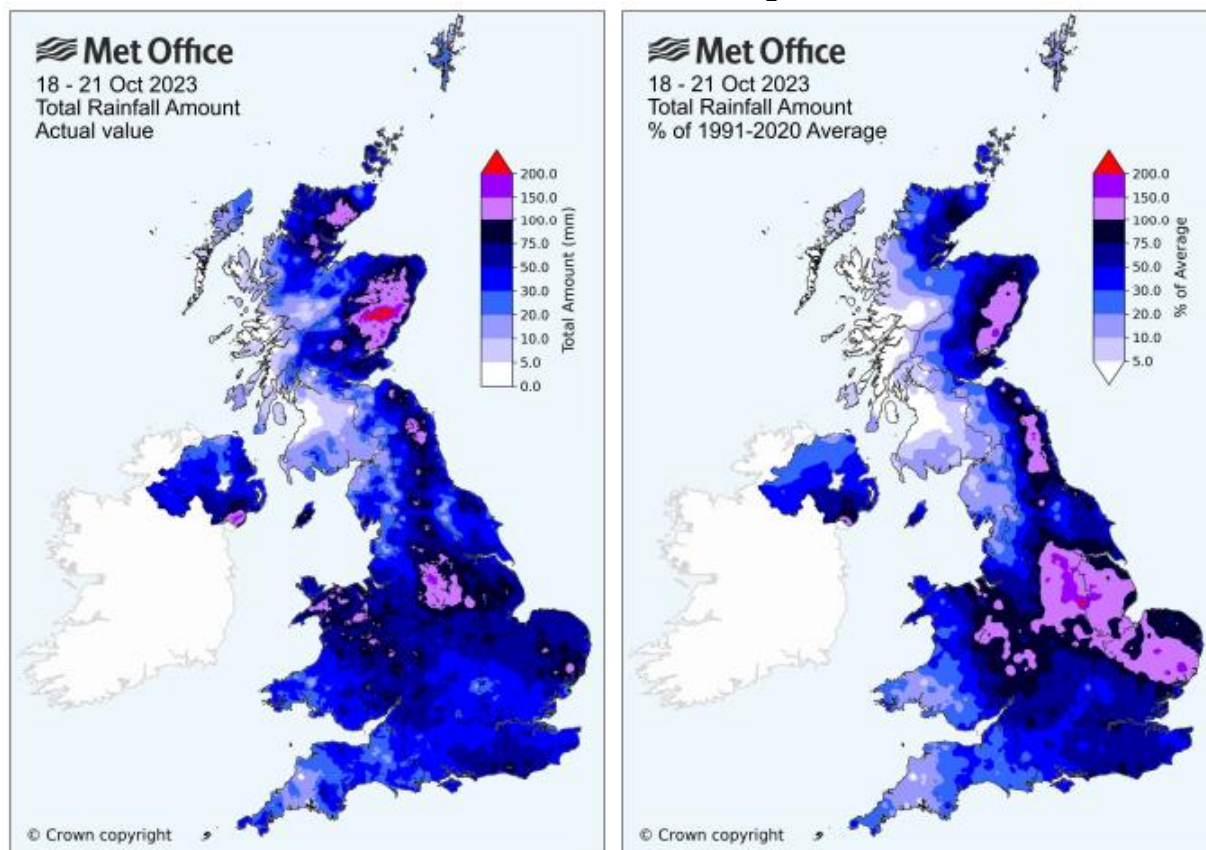
**Figure 1 - Met Office Accumulated Daily Rainfall 18th-21st of October 2023**

- 2.1 Storm Babet brought heavy and persistent rainfall across much of the UK and ‘*was the third-wettest independent 3-day period for England and Wales in a series from 1891*’ according to the Met Office<sup>2</sup>. As shown in Figure 1, many parts of the UK received over 50mm of rain, with 75-100mm of rain recorded across areas of North Wales. Several areas across the UK received over 100% of the average rainfall amount for October.

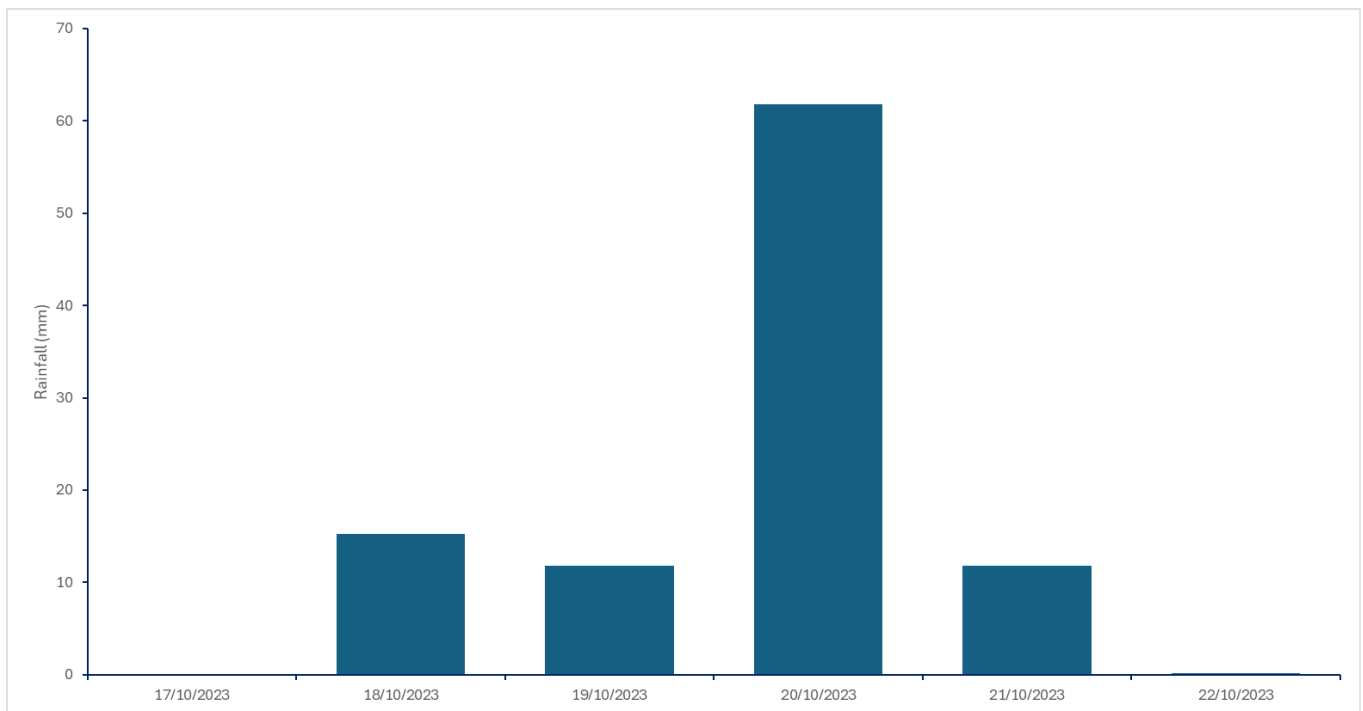
**Figure 2 - NRW Mold Rain Gauge- Daily Rainfall From 18<sup>th</sup>-21<sup>st</sup> October**

- 2.5 Figure 2 shows the rainfall in the days leading up to the flooding on the 20<sup>th</sup> October. Flintshire experienced rainfall two days prior to the 20<sup>th</sup> October, with 15.2mm of rainfall on the 18<sup>th</sup> and 11.8mm on the 19<sup>th</sup>. On 20<sup>th</sup> October, Mold rain gauge recorded 61.8mm of rainfall.

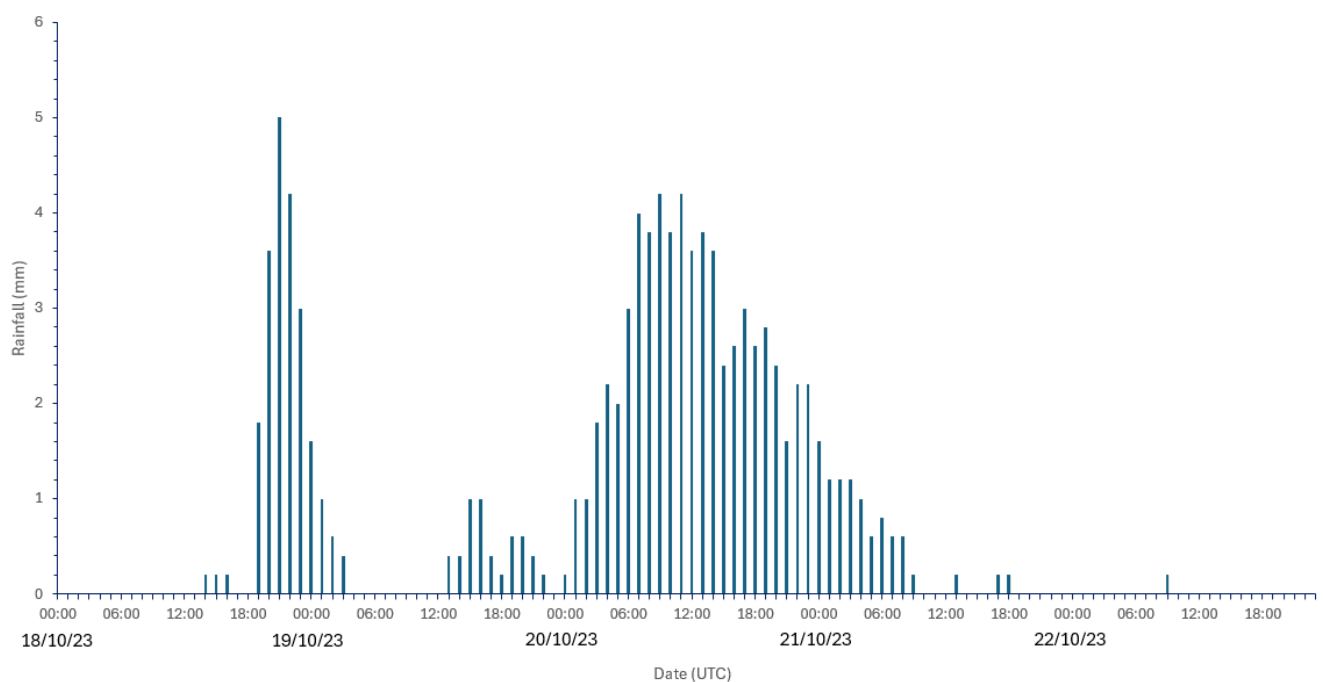
**Figure 3 - Hourly Rainfall Between the 18th and 22nd of October**

- 2.6 Figure 3 shows that there was a period of intense rainfall on Wednesday the 18<sup>th</sup> October which began at 19:00pm and peaked between 21:00-22:00 with 5mm of rainfall per hour. There was some additional rainfall on Thursday the 19<sup>th</sup> October peaking at approximately 1mm per hour. During 20<sup>th</sup> October, rainfall was prolonged with peak rainfall intensities at approximately 4.2mm per hour.

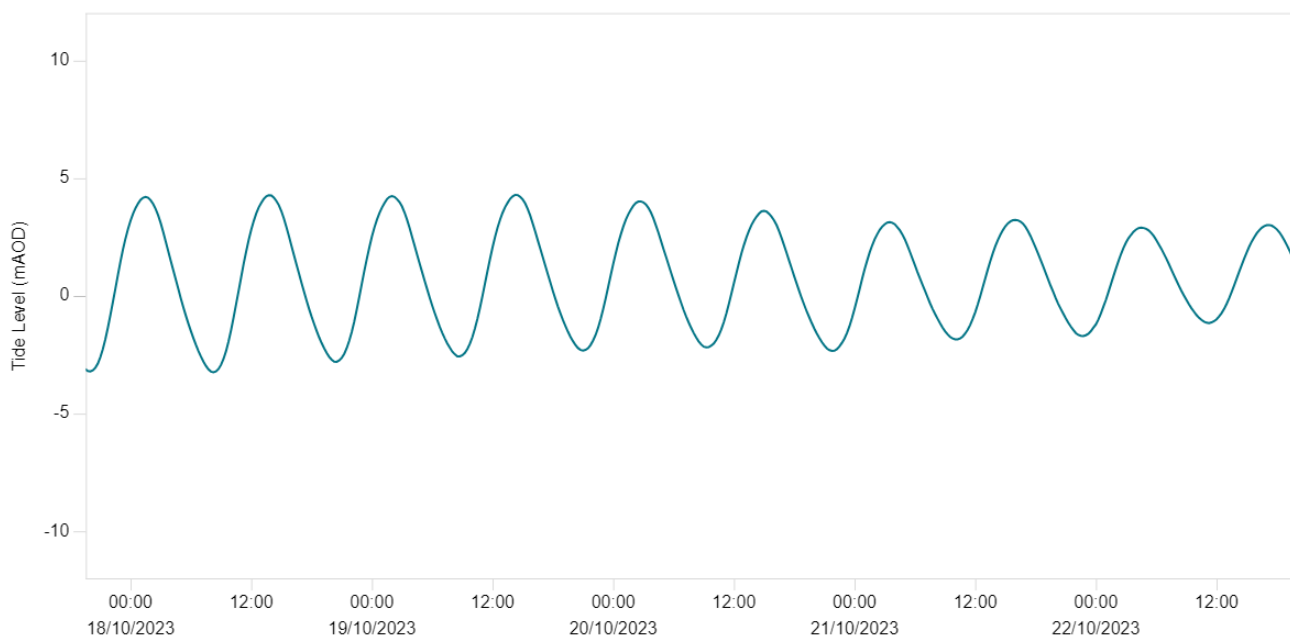
**Figure 4 - Tide Level (m AOD) between 18<sup>th</sup> and 22<sup>nd</sup> of October:  
Liverpool Tidal Gauge**

- 2.10 Tide levels have been obtained from the Liverpool tide gauge<sup>4</sup> (closest to Sandycroft). Rainfall during Storm Babet was at its heaviest between 10am and 2pm on the 20<sup>th</sup> of October, whilst high tide on the 20<sup>th</sup> of October was at 3pm. The high tide immediately following the heavy rainfall will have restricted water from the surrounding watercourses freely discharging into the Dee.

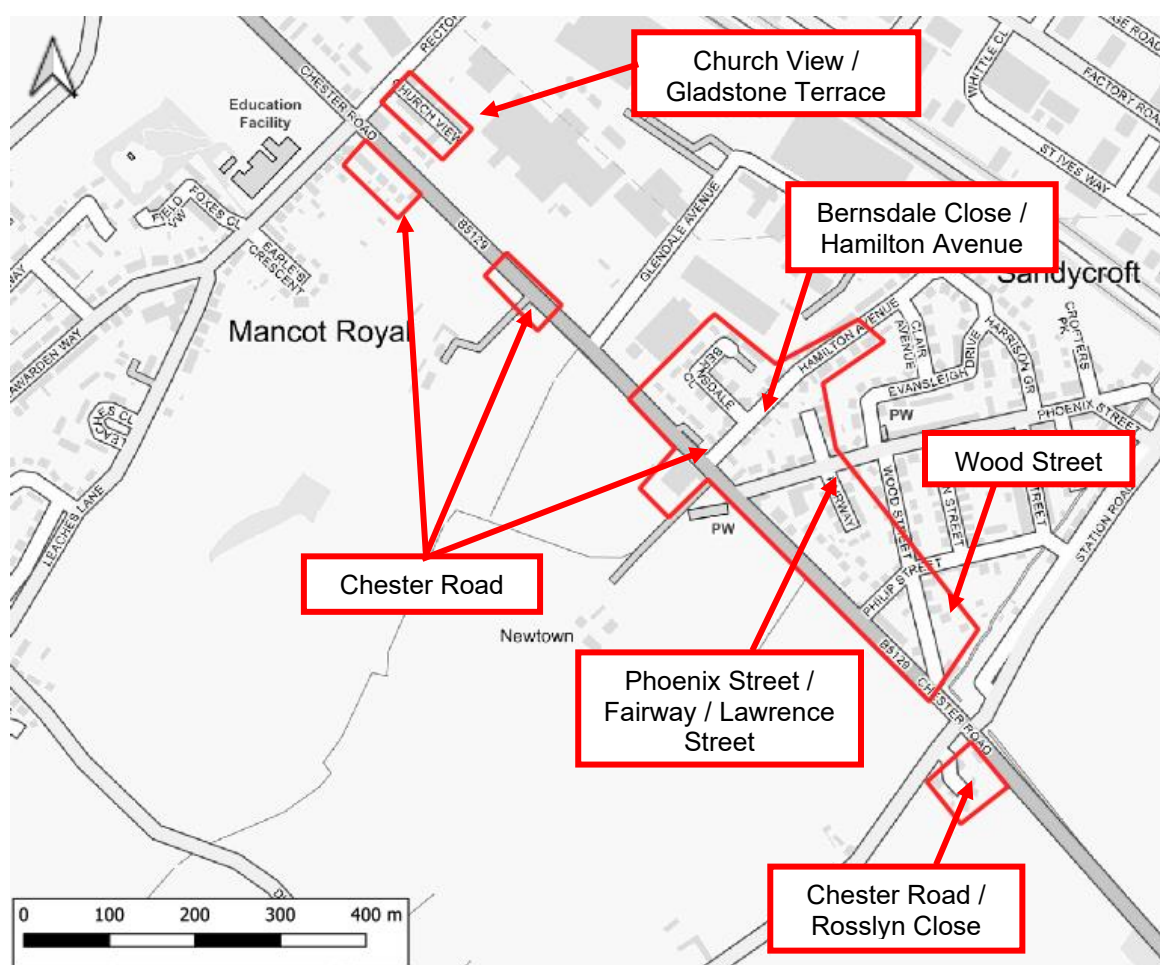
**Figure 5 - Location Plan of Reported Flooding Areas**  
Contains OS Data © Crown Copyright (2024)

- 3.1 The area affected by flooding during Storm Babet in Sandycroft covered in this report stretches from Rosslyn Close in the south-eastern corner of Sandycroft to Church View in the north-western corner towards Pentre and Mancot. Flooding to properties in Pentre and Mancot is subject of further investigation and will be detailed in a separate S19 Flood Investigation Report.
- 3.2 For the purposes of this report, the investigation focuses on the following streets where flooding was reported: Church View, Gladstone Terrace, Chester Road, Bernsdale Close, Hamilton Avenue, Phoenix Street, Fairway, Lawrence Street, Wood Street and Rosslyn Close. Figure 5 shows the approximate outline of areas impacted by flooding during Storm Babet. The approximate flooding locations are also shown on the Location Plan in Appendix B.

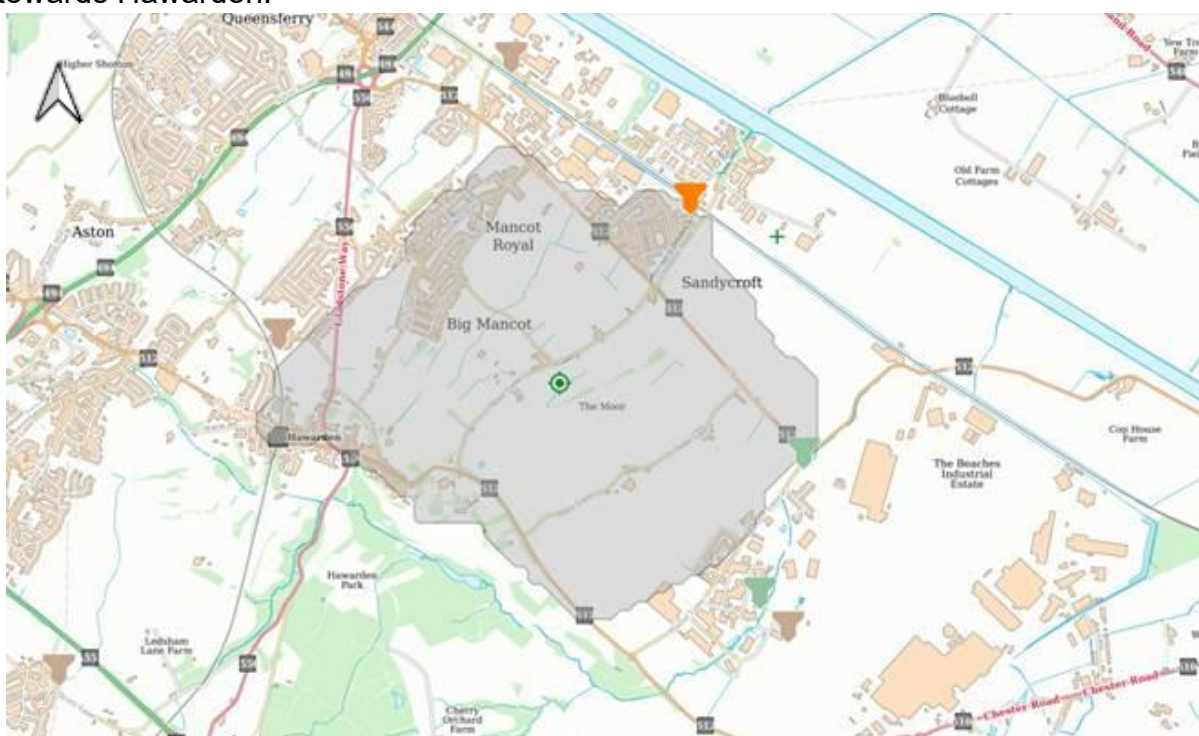
**Figure 6 – Pentre Drain South Catchment**

- 3.7 Figure 6, derived from the FEH web service<sup>6</sup>, shows that the catchment area for Pentre Drain South and the associated unnamed watercourse covers 5.5km<sup>2</sup> and extends towards Hawarden.

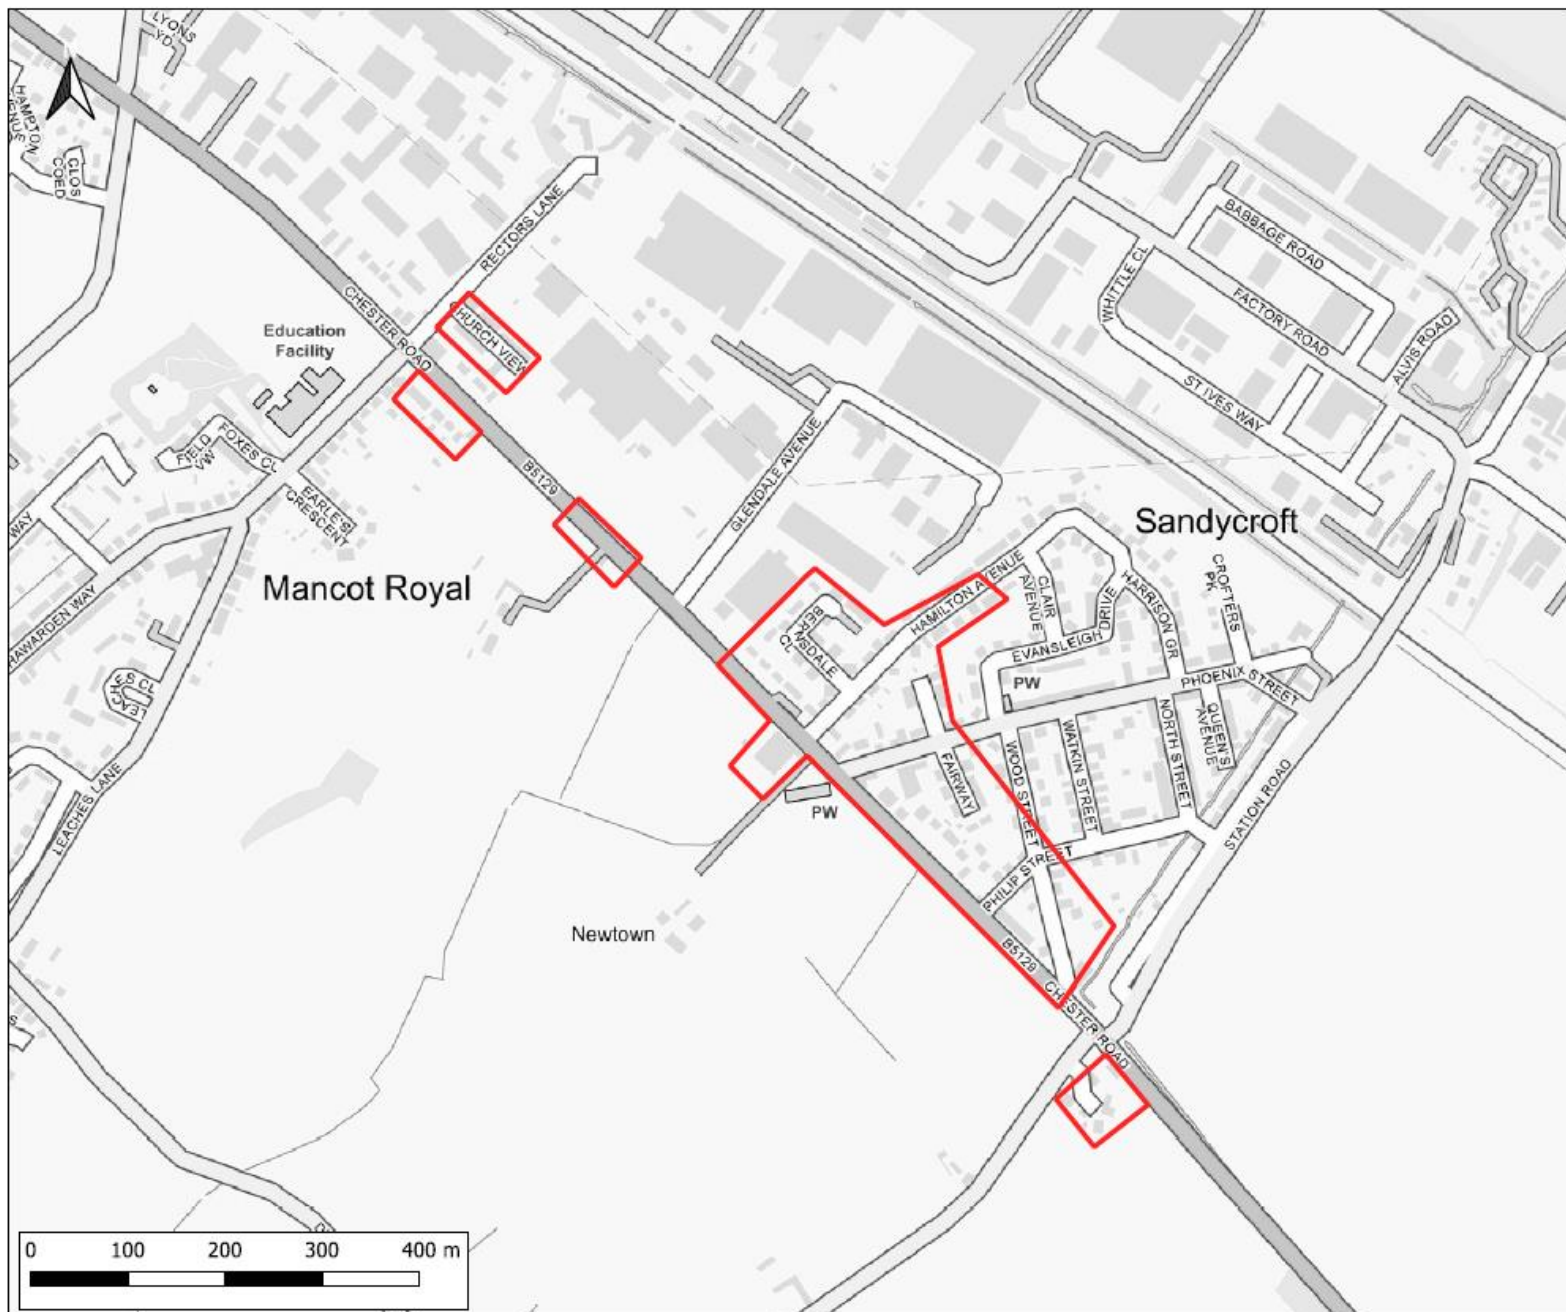
## **Reported Flooding Areas**

Confirmed flooding based on door knocking exercises and stakeholder engagement. Additional flooding may have occurred but not reported to Waterco
