Flood & Water Management Act 2010

Section 19 Flood Investigation Report FI0118

Location: Ffordd Dewi, Oakenholt
Incident Date: 5th – 6th January 2025

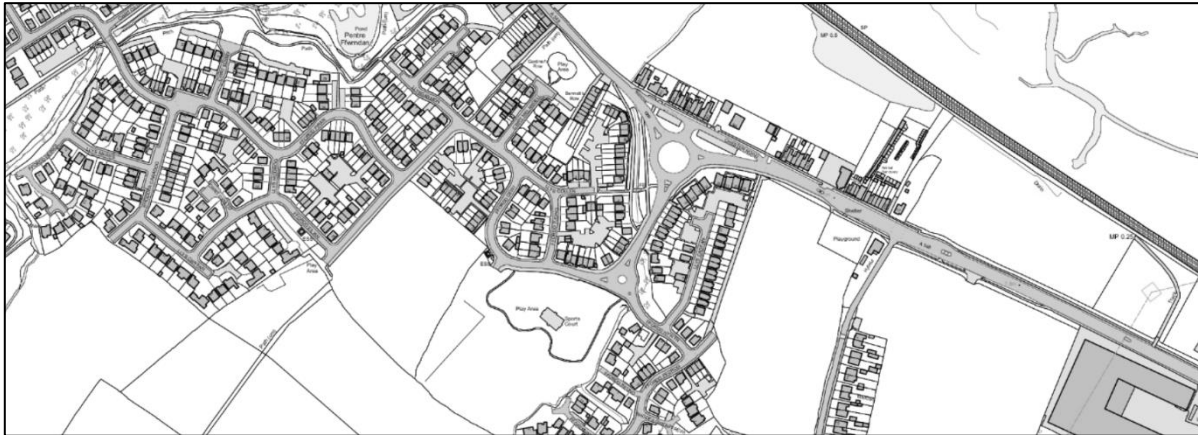
Figure 1 – Study area

- 2.1 The area reported to be affected by flooding during the rainfall between the 5th and 6th of January was limited to properties located along the road named 'Ffordd Dewi'. Figure 1 indicates the general study area.

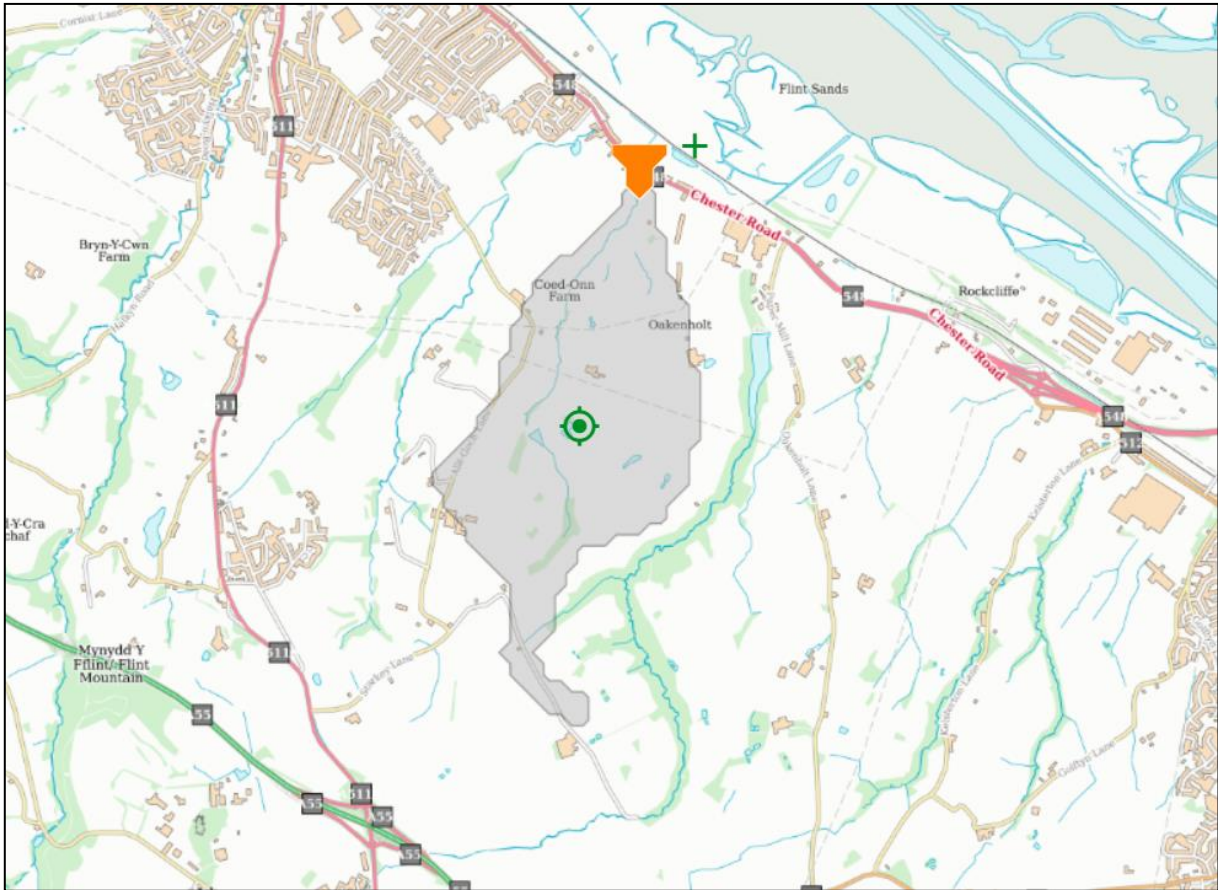
Figure 2 – Approximate catchment area of the Croes Onn watercourse.

- 2.4 An open watercourse referred to as the Croes Onn stream on plans is present within the study area and has an upstream catchment size of approximately 1.39 km² as indicated by Figure 2. Figure 3 outlines the topography of the study area using LiDAR data.
- 2.5 The catchment is primarily rural and used as agricultural land and has only recently seen development on it in the form of a housing estate. Water from this watercourse flows northwards and outfalls into the Dee estuary via a sluice gate.

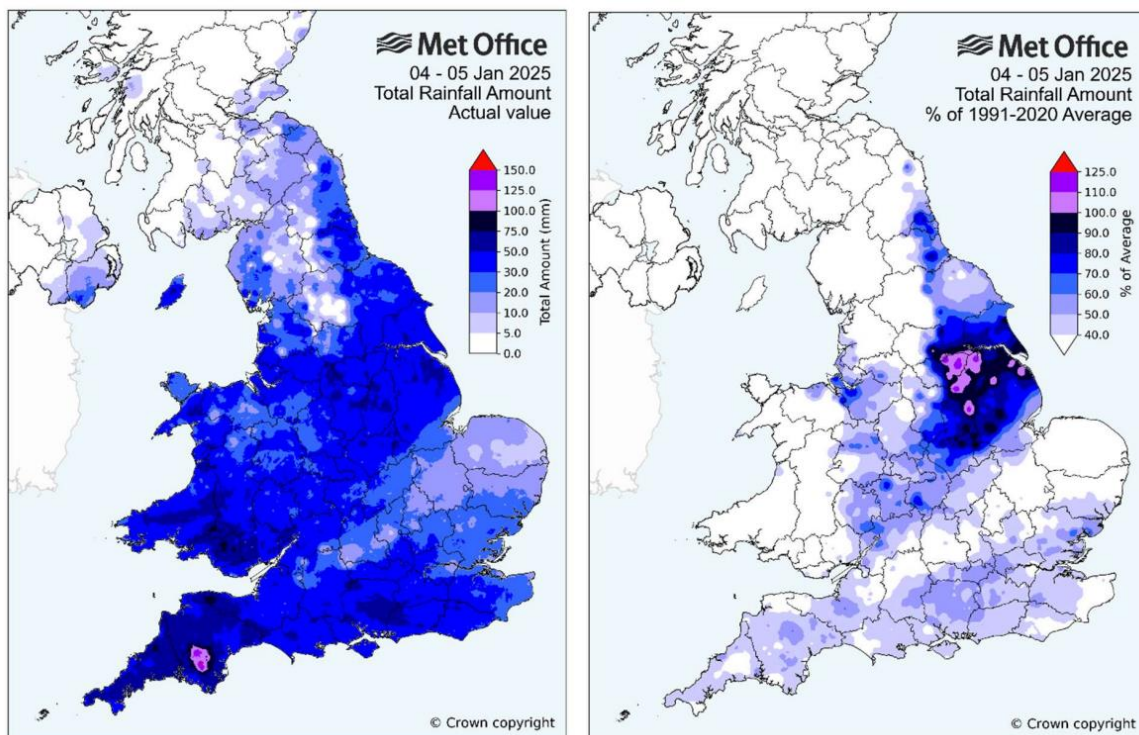
Figure 6 - Met Office Accumulated Daily Rainfall 4th – 5th January 2025⁵

3.1 On the 5th of January 2025, a low pressure weather system centred around the south-west of the UK brought snow and heavy rainfall to several parts of the UK. As shown in Figure 6, most of the UK received over 30mm of rainfall with parts of North Wales receiving between 20mm and 50mm. For the North-east of the UK, this rainfall equalled more than 90% of the expected rainfall for January with some areas recording their wettest ever January day since records began. This weather system led to several flooding problems across the UK most notably within Leicestershire and Lincolnshire. According to the environment agency approximately 800 homes were flooded because of this weather.

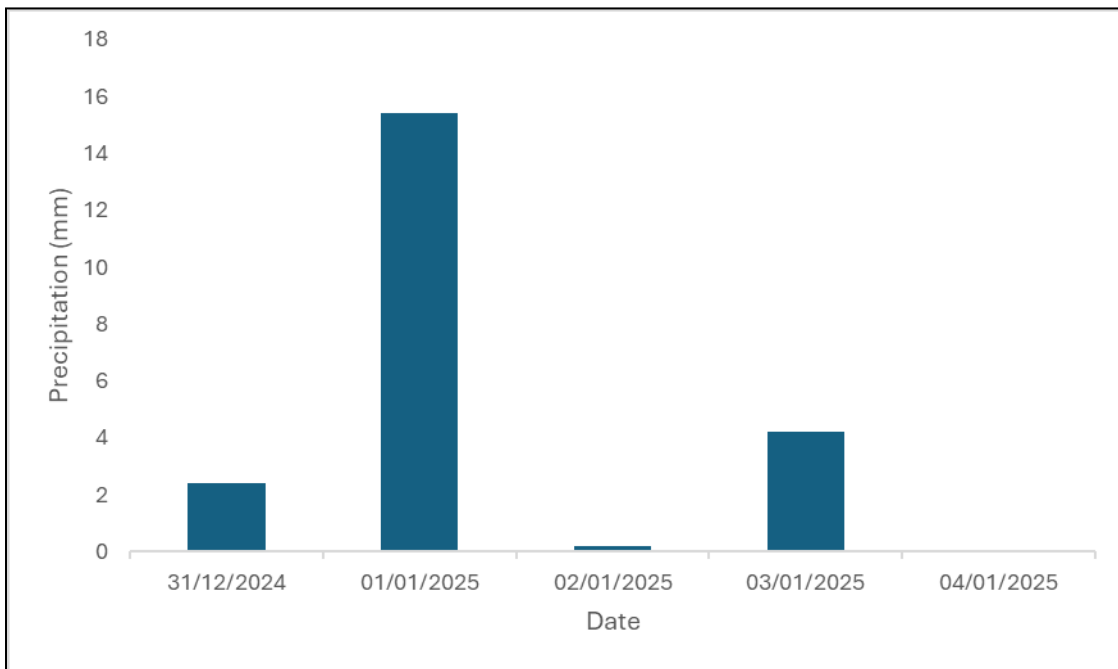
Figure 7 - NRW Northop Rain Gauge recordings of the days leading to the 5th

3.4 Figure 7 shows the precipitation which fell on the 5 days leading up to the 5th January based on Northop rain gauge.
